HE 1780 ,F133 MO, NTISB-RAR DEPARTMENT OF TRANSPORTATION 12-1 0.3 APR 18 1972 LINRARY SS-R-13 RAILROAD ACCIDENT REPORT. PENN CENTRAL TRANSPORTATION COMPANY FREIGHT TRAIN DERAILMENT PASSENGER TRAIN COLLISION WITH HAZARDOUS MATERIAL CAR SOUND VIEW, CONNECTICUT **OCTOBER 8, 1970** ADOPTED: DECEMBER 22, 1971 NATIONAL TRANSPORTATION SAFETY BOARD Washington, D. C. 20591 **REPORT NUMBER: NTSB-RAR-72-1**,

Adopted: December 22, 1971

PENN CENTRAL TRANSPORTATION COMPANY FREIGHT TRAIN DERAILMENT, PASSENGER TRAIN COLLISION WITH HAZARDOUS MATERIAL CAR SOUND VIEW, CONNECTICUT, OCTOBER 8, 1970

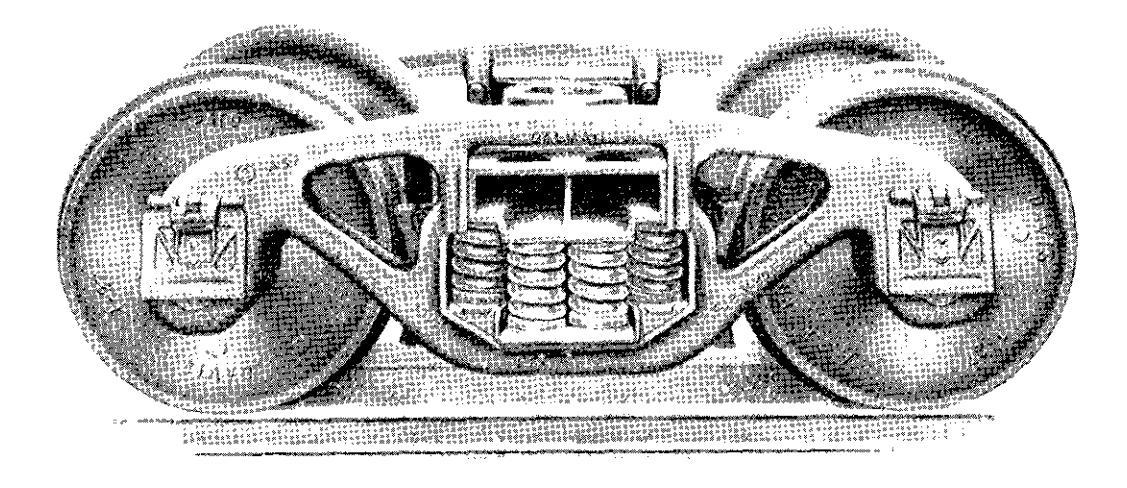
The broken truck side frame (see Figure 3) was one of 20,282 castings manufactured between January of 1927 and August of 1959. Of these castings 20,100 were furnished for new equipment in 1927, 1928, and 1929 The remaining 182 were manufactured for stock and repairs. This type of truck side frame has not been manufactured since August of 1959. The truck side frame was originally designed to accommodate the spring grouping portrayed in *Car Builder's Encyclopedia*, pages 773, 774, and 775 (see Appendix 2 and Figure 4).

Figure 4 – Side frame with spring arrangement similar to 7707 Photo of truck side frame from The Car Builder's Encyclopedia, 1928, depicting original spring arrangement on the 7707 side frame

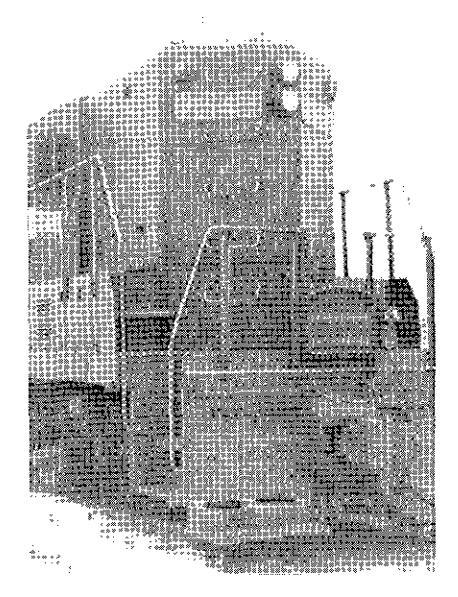
Figure 5.-Short hood end of Type ERS-17 Locomotive

forward in a straight line, and were 230,000 candlepower. The locomotive units were equipped with type "F" couplers. The pilot consisted of a breast plate with foot boards either riveted or welded to the frame of the locomotive The locomotive had a fuel tank capacity of 800 gallons (see Figure 5 and Appendix 4).

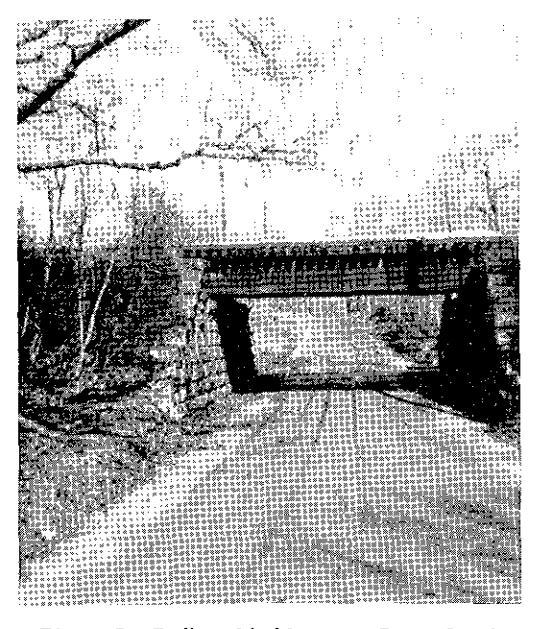
Figure 6.—Railroad bridge over Cross Road

lengths, and No. 2 track was 140-pound RE continuous welded rail. The track structure passed over Cross Road on a deck plate girder (open deck) bridge, 34 feet long and 31 feet wide (see Figure 6). At the time of the accident, inner track guardrails existed for both tracks, extending beyond the bridge for a distance of 39 feet

A pedestrian walkway was provided on one side of the bridge only, the north side of No. 1 track It had a tailing to prevent the users of the bridge from falling to the highway below Additionally, railings were provided to protect either end of the bridge abutment (see Figures 6 through 10). On the south side of the bridge, there was no pedestrian walkway, nor pedestrian railing. There are no Federal or industrywide standards for railroad bridge de sign, construction, installation of safety equipment, maintenence, or retirement

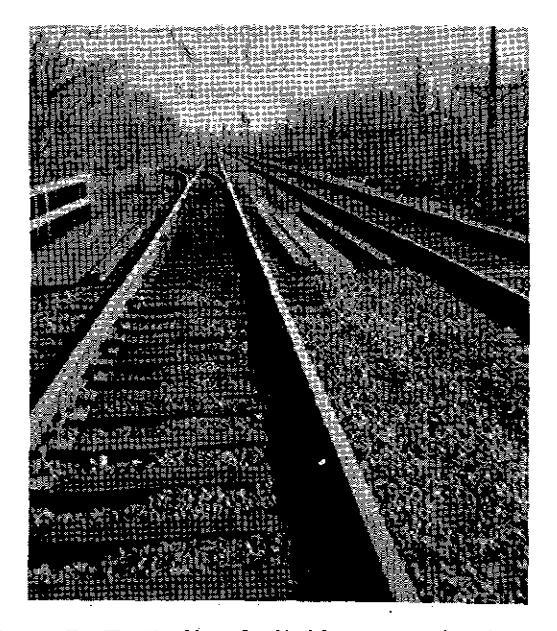
Figure 7.-Track No. 1, looking east, showing the switch leading to siding and bridge.

⁴The two views of track No 1, Figures 7 and 8, at the bridge over Cross Road were taken after the bridge was repaired

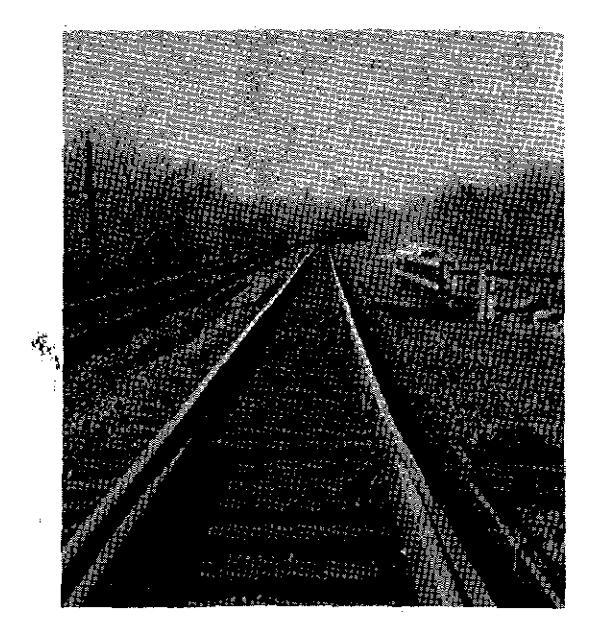
Figure 8.—Track No. 1, looking west, showing the direction of the freight train switch points to siding, the point of derailment, and bridge.⁴

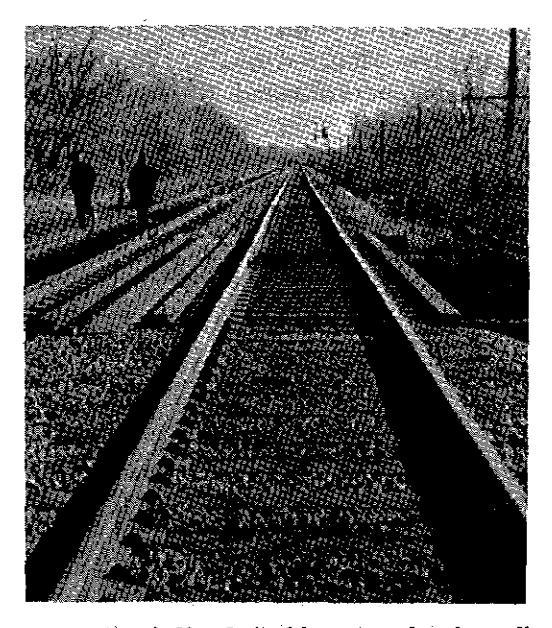
Figure 9.—Track No. 2, looking east, showing railroad bridge and the direction of the passenger train.

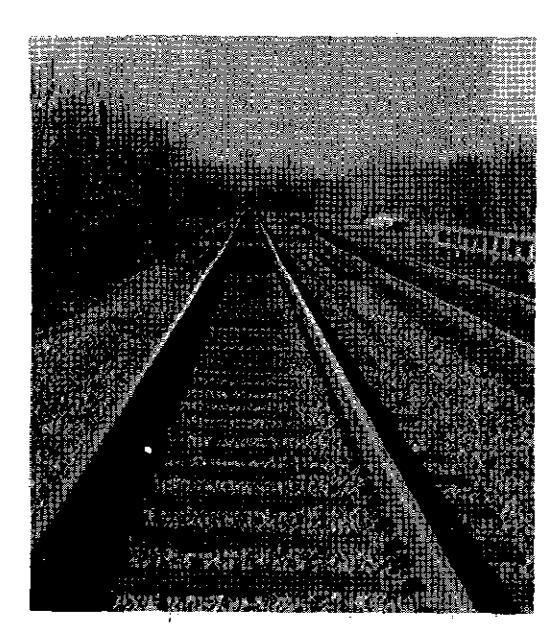
Figure 10.-Track No. 2, looking west, showing bridge.
