# RAILROAD ACCIDENT REPORT

PENN CENTRAL COMPANY  
Electrocution of Juvenile Trespasser  
On Penn Central Tracks  
at Washington, D.C.

May 14, 1971

NATIONAL TRANSPORTATION SAFETY BOARD  
Washington, D. C. 20591  
REPORT NUMBER: NTSB-RAR-72-3

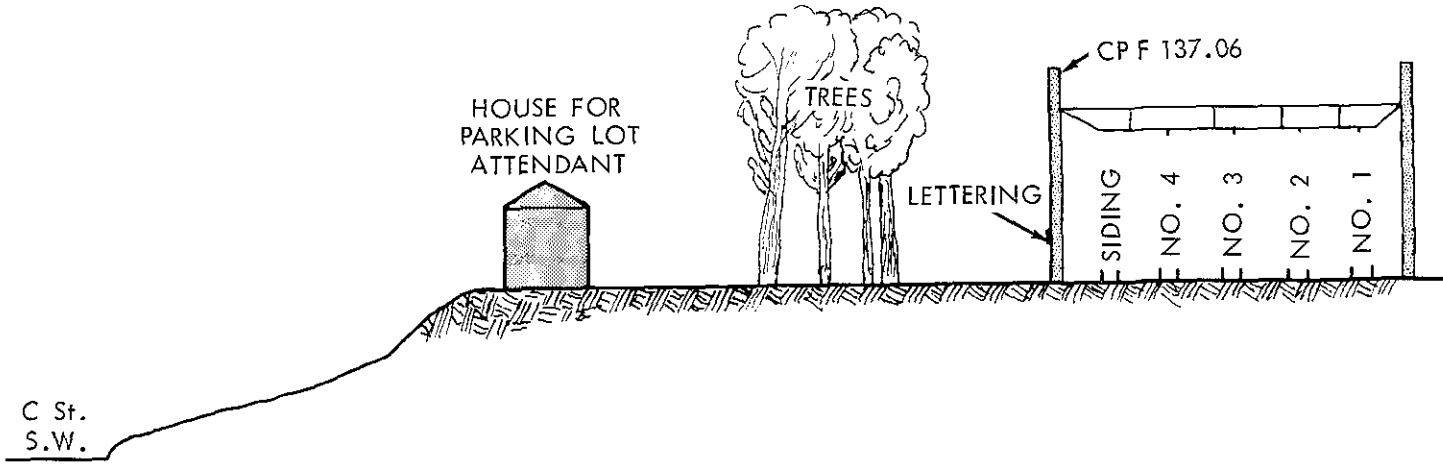
Figure 3.—Profile of section A-A of parking lot area—not to scale

track designated No. 1 track. Track Nos. 1, 2, 3, and 4 are electrified; that is, over each track is a trolley wire, part of an electrical catenary propulsion system by which the Penn Central powers its electric locomotive units. The side track has no overhead catenary system. Figures 2 and 3 are sketches of the parking lot area with some pertinent details and approximate distances shown. These will be further referenced in the analysis. Figure 4 shows the position of the last three cars in the draft of cars standing on No. 4 track, the cars on the adjacent siding, and affords an overall view of the area.
