RAILROAD ACCIDENT INVESTIGATION

Report No 4112

THE PENNSYLVANIA RAILROAD COMPANY

OCTOBER 26, 1966

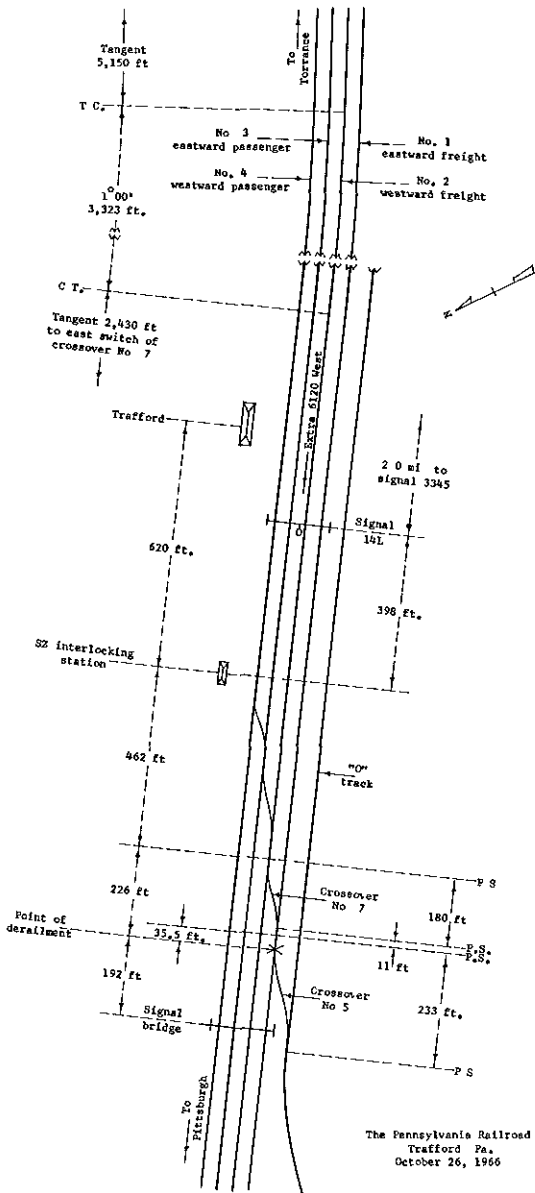
- Torrance, Pa 32.8 mi.
- CP Interlocking 3.6 mi
- Trafford 0.1 mi
- SZ Interlocking 0.1 mi.
- Point of derailment 16.6 mi.
- Pittsburgh, Pa
