RAILROAD ACCIDENT INVESTIGATION

Report No 3860

THE PENNSYLVANIA RAILROAD COMPANY

AUGUST 13, 1959

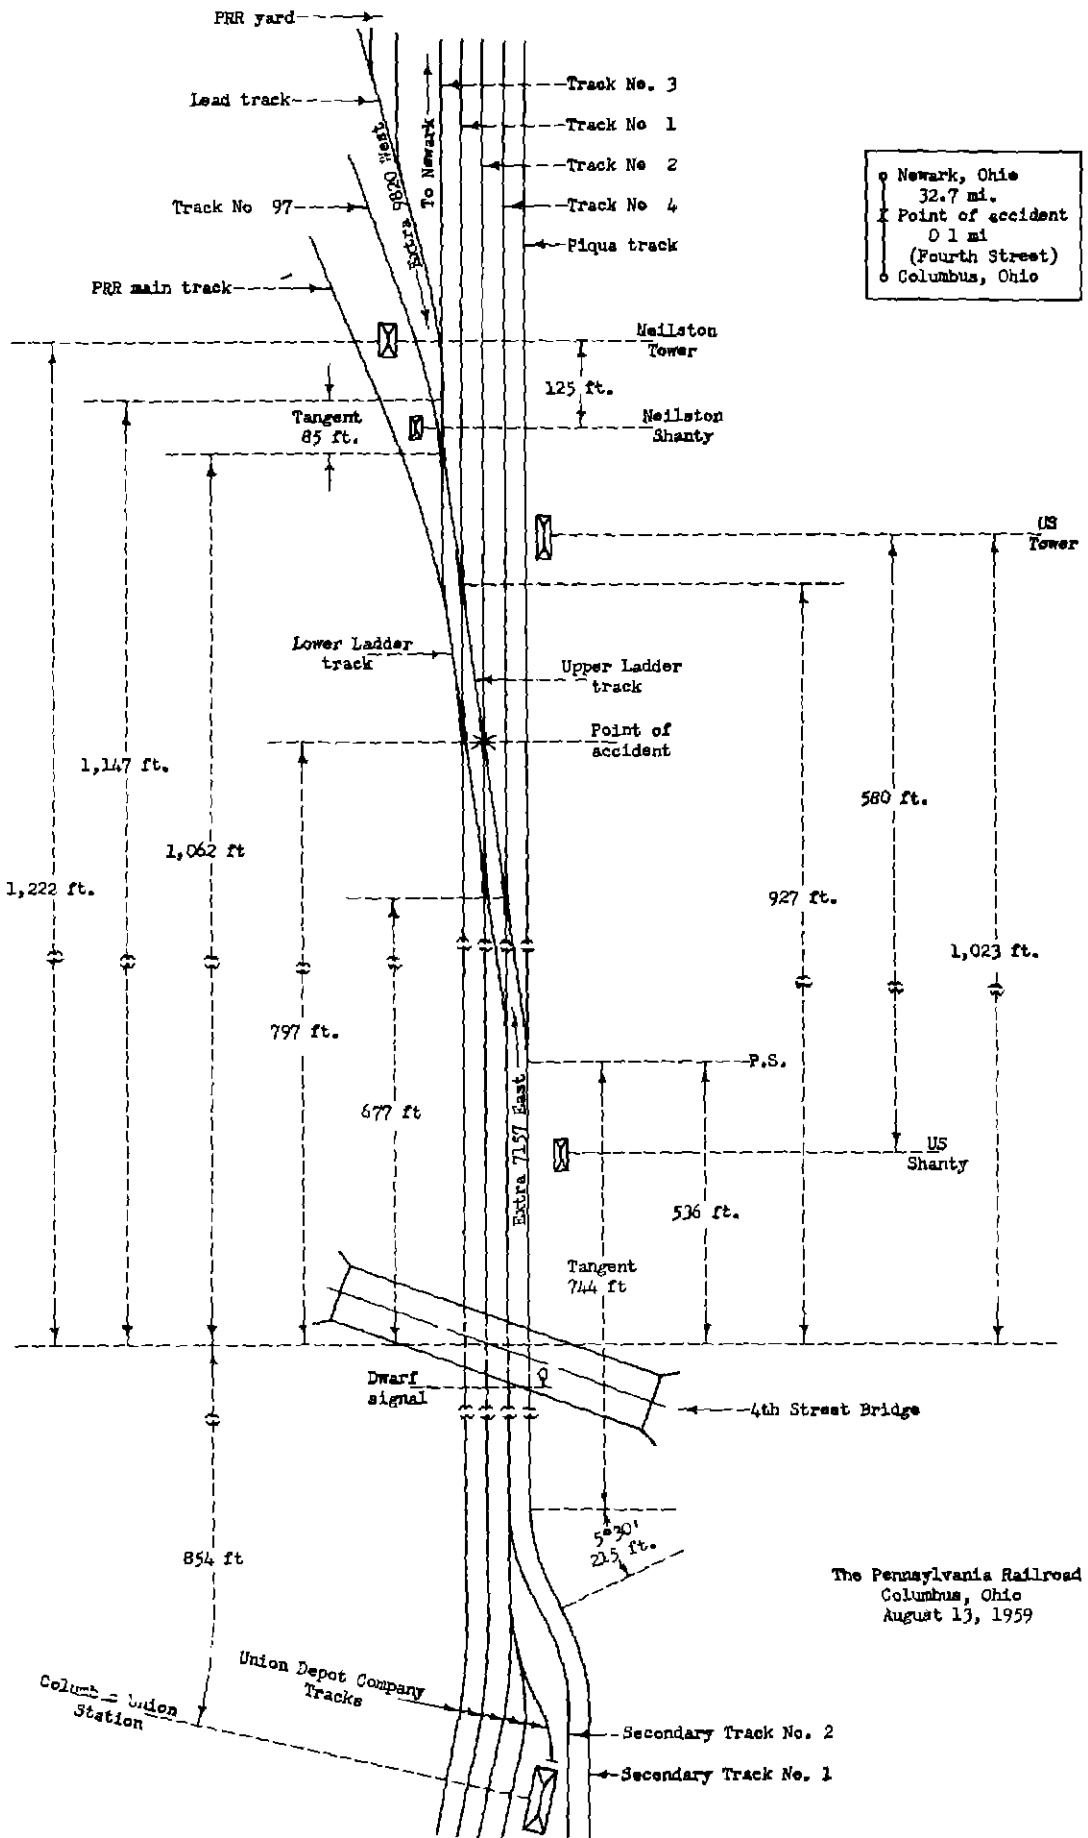
Location of Accident and Method of Operation

o Newark, Ohio
 32.7 mi.
 | Point of accident
 | 0.1 mi
 | (Fourth Street)
 o Columbus, Ohio

The Pennsylvania Railroad
 Columbus, Ohio
 August 13, 1959
