## INTERSTATE COMMERCE COMMISSION

REPORT OF THE DIRECTOR OF THE BUREAU OF SAFETY CONCERNING AN  
ACCIDENT ON THE PENNSYLVANIA RAILROAD AT DELPHOS, OHIO,  
ON FEBRUARY 26, 1934.

May 3, 1934.

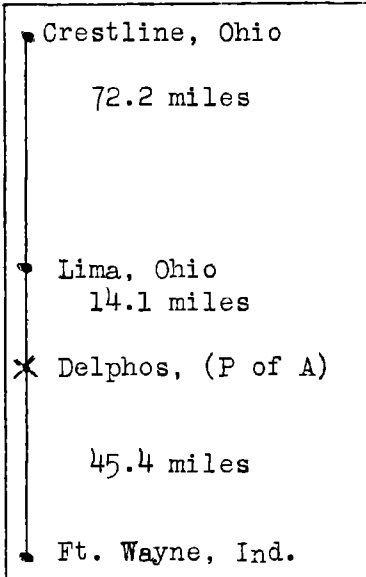
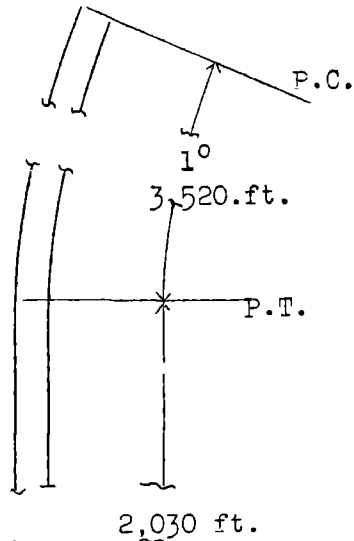
Inv. No. 1896  
Pennsylvania Railroad  
Delphos, Ohio  
Feb. 26, 1934

Main Street extends north and south and crosses the tracks at right angles; it is straight from a point about  $\frac{1}{2}$  mile north of the railroad to a point several hundred feet south thereof. The street is practically level until a point about 150 feet north of the crossing is reached; starting at that point a south-bound vehicle encounters an ascending grade, first traveling up 100 feet of 2.1 percent grade, and then 30 feet of 5.1 percent grade and 15 feet of 7.15 percent grade to within about 5 feet of the north rail of the west-bound track, following which the street is practically level across the tracks.
