RAILROAD ACCIDENT REPORT.

PENNSYLVANIA RAILROAD  
TRAIN PR-11A, EXTRA 2210 WEST AND TRAIN SW-6, EXTRA 2217 EAST  
DERAILMENT AND COLLISION  
DUNREITH, INDIANA  
JANUARY 1, 1968.

ADOPTED: DECEMBER 18, 1968

NATIONAL TRANSPORTATION SAFETY BOARD.  
DEPARTMENT OF TRANSPORTATION  
WASHINGTON, D. C.  
20591

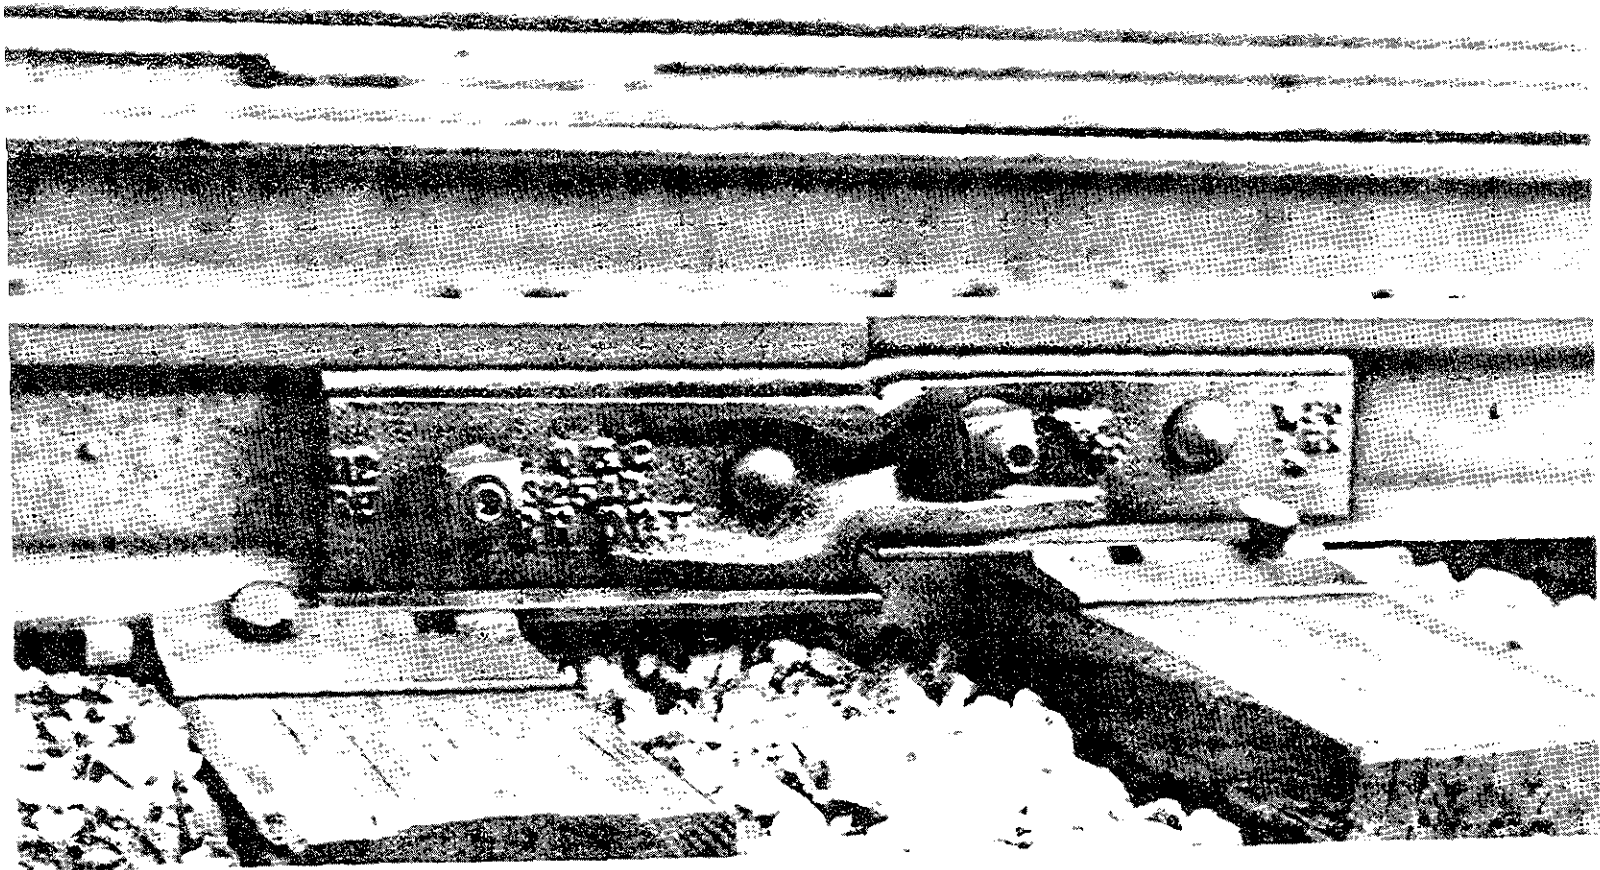
A TYPICAL AND PROPERLY INSTALLED COMPROMISE  
RAIL JOINT - FOUR BOLT HOLE  
THIS IS NOT THE COMPROMISE JOINT  
INVOLVED IN THE ACCIDENT

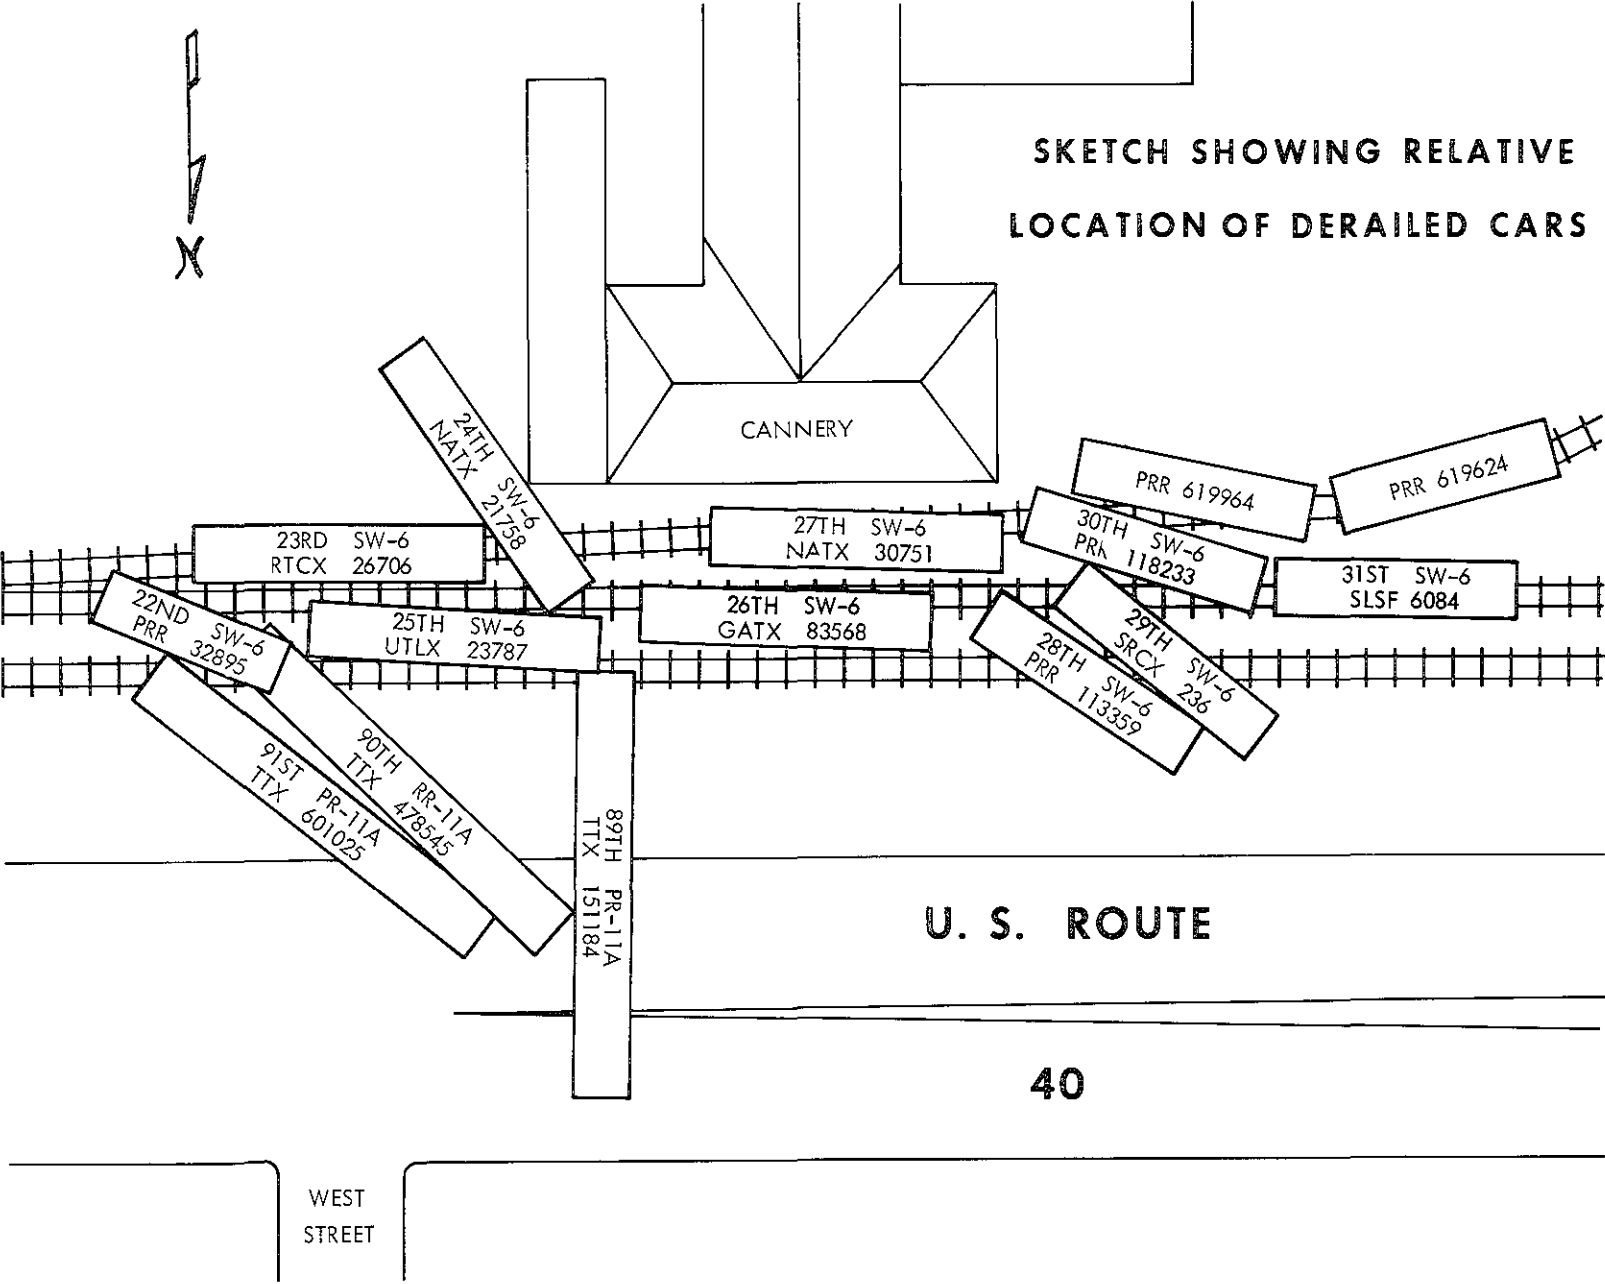
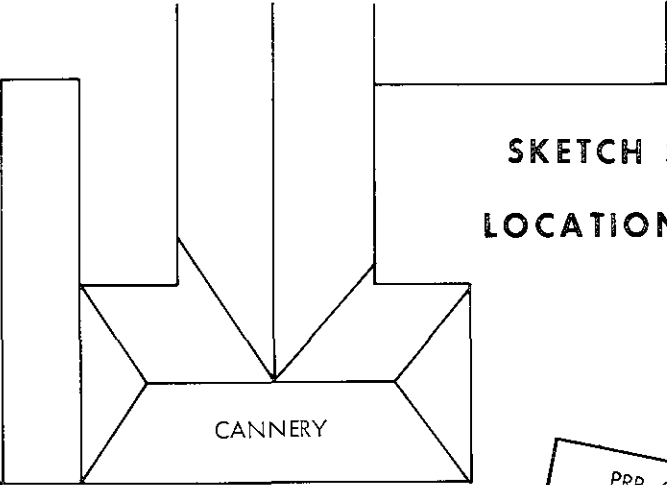
SKETCH SHOWING RELATIVE  
LOCATION OF DERAILED CARS

The major concentration of wreckage was located approximately 600 feet west of the Water Street grade crossing and adjacent to a cannery. The wreckage scene is shown by sketch at Appendix 7. The railroad track at this point was laid in a cut, bordered on the south by a retaining wall about 8 feet high. Fourteen cars of both trains were derailed here, including the five tank cars carrying hazardous materials in train SW-6. Three trailer-carrying cars in train PR-11A obstructed U. S. Route 40 running adjacent to the track at this point. The remaining six cars came to a stop in various positions on the railroad right-of-way. One gondola car, PRR 619964, not a part of either train and standing on a siding near the cannery, also was derailed.<sup>1/</sup>
