INVESTIGATION NO. 3249
THE PENNSYLVANIA RAILROAD COMPANY
REPORT IN RE ACCIDENT
AT FORT WAYNE, IND., ON
APRIL 28, 1949

Date: April 28, 1949
Railroad: Pennsylvania
Location: Fort Wayne, Ind.
Kind of accident: Derailment
Train involved: Passenger
Train number: 29
Engine numbers: Diesel-electric units
5852A and 5845A
Consist: 15 cars
Speed: 70 m. p. h.
Operation: Signal indications
Track: Double; tangent; level
Weather: Clear
Time: 6:23 a. m.
Casualties: 43 injured
Cause: Broken journal

Accident at Fort Wayne, Ind., on April 28, 1949, caused
by a broken journal.

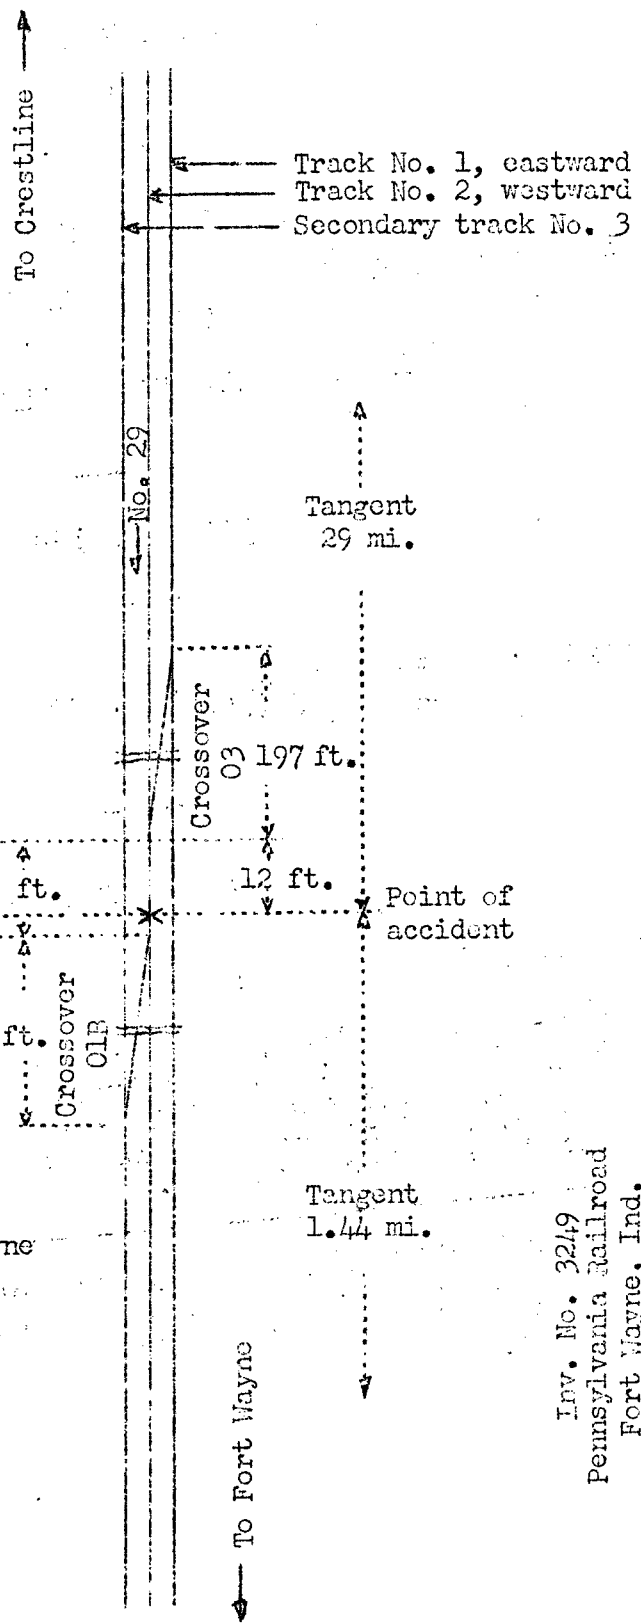
Sketch showing broken journal

Examination after the accident disclosed that the left front journal of the rear truck of the eighth car was broken, and as a result the front end of the left equalizer bar had dropped and had been in contact with the track structure. The equalizer bar and the left front pedestal tie-bar were considerably marked. Examination of the track disclosed a light scraping mark on the north side of the north rail of crossover O3 at a point 10.4 feet east of the west frog and 1.5 feet south of the south rail of track No. 2. The heel block and the point of the frog were battered. At a point 52 feet westward, scraping marks appeared on the south stock rail of the turnout at the west end of crossover O3, and the switch-point heel-block was battered. At a point 111 feet west of the first mark and 12 feet west of the west switch of crossover O3, a wheel mark appeared on the top surface of a tie at a point 5 inches inside the south rail of track No. 2. From this point westward flange marks on the tops of the ties extended diagonally northward and westward. These marks indicated that a derailed wheel had been in contact with the south rail of the east turnout of crossover O1B.

Examination of the failed journal disclosed that it had been overheated, then had become broken. The break in the journal occurred within the inner race of the inside set of the double-type roller bearing at a point 1-1/2 inches outward from the journal fillet. The portion of the journal remaining attached to the axle was ground into an oval shape stub, and it extended about 3-1/2 inches outward from the hub of the left wheel. The broken-off portion of the journal remained in the journal-box housing and was fused to the inner races. Both pieces of the journal and all parts of the bearing assembly were badly discolored by overheating. The inner assembly of the bearing was practically destroyed. The separator cages were badly broken, and the roller elements were deformed. Except for one broken separator prong, the outer assembly was intact. The rear enclosure of the journal housing was broken as a result of the breaking of the journal. All of the oil in this bearing had been burned. However, a sufficient amount of oil was found in all the other journal-bearing assemblies of this car.
