REPORT OF THE DIRECTOR
BUREAU OF SAFETY

ACCIDENT ON THE
PENNSYLVANIA RAILROAD
AT
JEWETT, OHIO
ON
NOVEMBER 14, 1935

INVESTIGATION NO. 2020

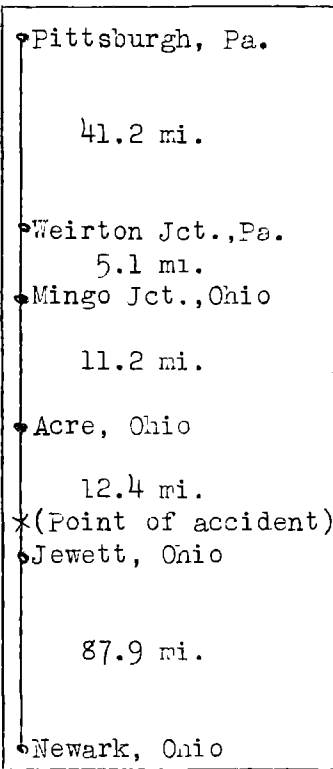
Inv. No. 2020
 Pennsylvania Railroad
 Jewett, Ohio
 Nov. 14, 1935

The highway involved parallels the tracks eastward from Jewett to a point about 370 feet from the crossing, and then it curves to the right and crosses the tracks at an angle of about 45° from northwest to southeast. Approaching the crossing from Jewett the grade is ascending, varying from 6 to 8.1 percent until a point about 90 feet from the crossing is reached, where it changes to 9 percent descending for about 60 feet, following which it again ascends a distance of 30 feet to the west-bound track, the highway being level over the crossing. The highway is of macadam construction and at the crossing the traveled portion of the roadway is about 15 feet wide.
