REPORT NO. 3425
THE PENNSYLVANIA RAILROAD COMPANY
IN RE ACCIDENT
NEAR NOTTAWA, MICH., ON
AUGUST 28, 1951

Date: August 28, 1951
Railroad: Pennsylvania
Location: Nottawa Mich.
Kind of accident: Derailment
Train involved: Passenger
Train number: 500
Engine number: Diesel-electric unit 5867A
Consist: 8 cars
Estimated speed: 55 m. p. h.
Operation: Timetable, train orders and manual-block system
Track: Single tangent; 0.33 percent ascending grade southward
Weather: Clear
Time: 12:50 a. m.
Casualties: 6 injured
Cause: Broken rail

Accident near Nottawa, Mich., on August 28, 1951, caused
by a broken rail.

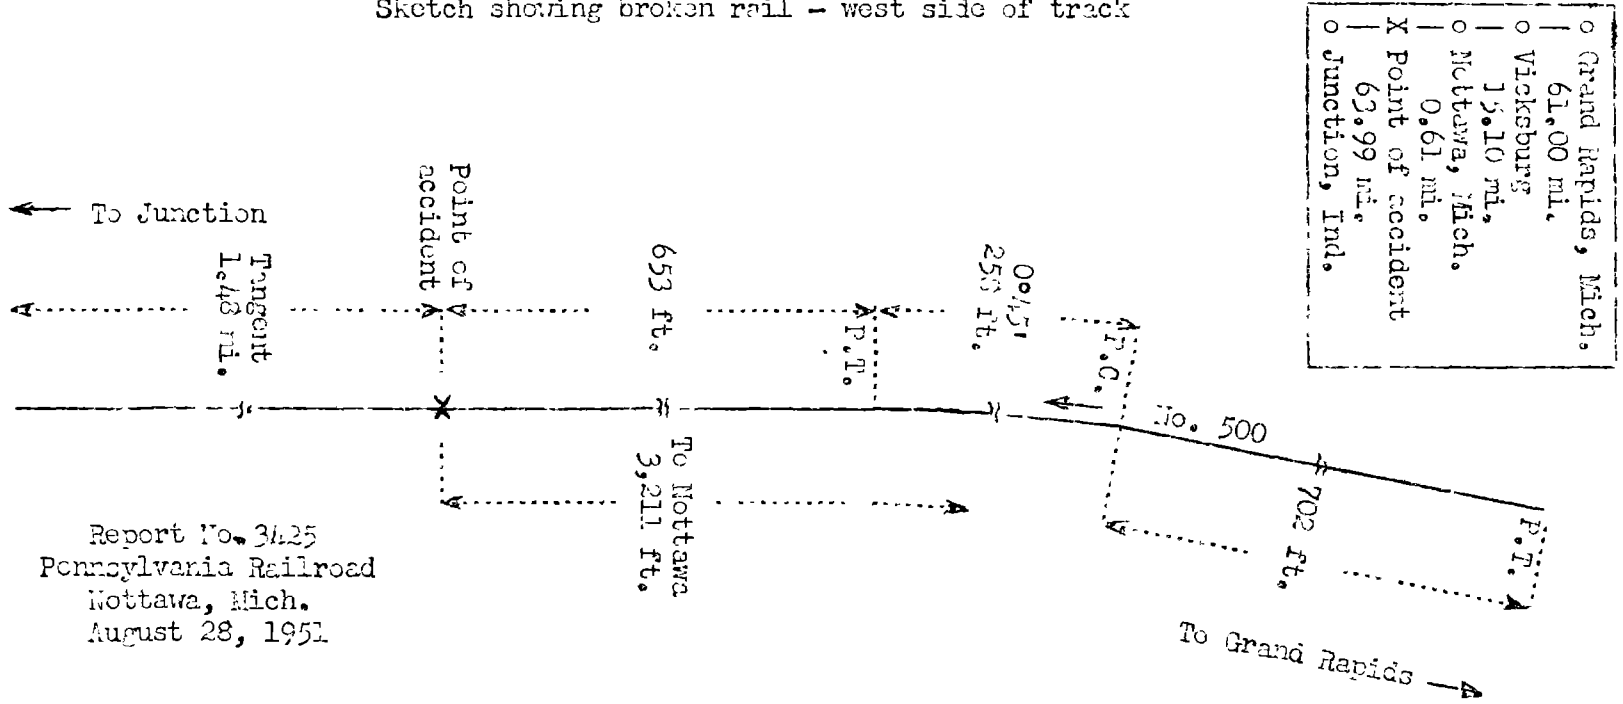
Sketch showing broken rail - west side of track

Examination of the track after the accident occurred disclosed no indication of dragging equipment nor of any obstruction having been on the track. The surface, alinement and gage were well maintained for the maximum authorized speed. At the point of derailment a broken rail was found on the west side of the track. This rail was broken into several pieces, three of which were recovered. From the north, in succession, the lengths of the three recovered pieces were 25 feet 8-1/8 inches, 3 feet 5-1/8 inches, and 11-13/16 inches. There was a portion between the second and the third pieces that was not recovered. The third piece of rail remained bolted in place. At the leaving end of this piece of rail, the head was broken out a distance of 7-1/4 inches. At the north end the head of the rail was battered downward a distance of about 5/8 inch. Small transverse fissures were found at

the break between the first and the second pieces, at the south end of the second piece, and at the north end of the third piece. None of the fissures extended to the surface of the rail. Flange marks on the pieces of rail which were recovered indicated that the section of rail immediately north of the third piece became displaced, and then the wheel flanges mounted the north end of the most southerly piece of rail.

The rail involved was rolled by the Illinois Steel Company in 1917, and bore heat number 30158-B. A rail-defect detector car was operated over this track on April 27, 1951, at which time two defective rails in the immediate vicinity were found. Another rail about 200 feet north of the point where the derailment occurred was removed on June 1 because of a fracture. It also bore heat number 30158, but there was no transverse fissure. Since January 1, 1951, three rails, all within 1 mile of the point where the derailment occurred, were removed because of split webs within the limits of the joint bars. The section foreman last inspected the track about 8 a. m. on the day before the accident occurred and no unusual condition was observed. A north-bound passenger train passed over the track about 1 hour 20 minutes before the accident occurred. The members of the crew observed no abnormal condition of the track at that time.

It is found that this accident was caused by a broken rail.
