INVESTIGATION NO. 2726
THE PENNSYLVANIA RAILROAD COMPANY
REPORT IN RE ACCIDENT
AT SHORE, PA., ON
SEPTEMBER 6, 1943

Railroad: Pennsylvania
Date: September 6, 1943
Location: Shore, Pa.
Kind of accident: Derailment
Train involved: Passenger
Train number: Passenger Extra 4930 East
Engine number: 4930
Consist: 16 cars
Speed: 56 m. p. h.
Operation: Interlocking
Track: Four; tangent; 0.61 percent
descending grade eastward
Weather: Clear
Time: 6:06 p. m.
Casualties: 79 killed; 129 injured
Cause: Broken journal

Accident at Shore, Pa., on September 6, 1943, caused by a
broken journal.

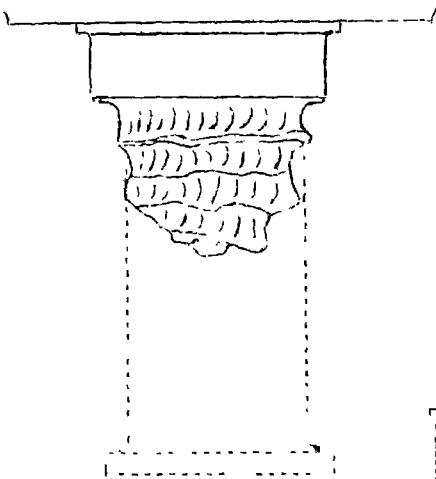
Broken journal
5-1/2" by 10"

After the accident it was found that the left front journal of the front truck of P. R. R. 1860, the seventh car, was broken off. Beginning at the heel of the west frog of the movable-point crossing and extending eastward 23 feet 4-1/4 inches, an angular flange-mark appeared on top of the head of the north rail. Extending from the east end of this mark a distance of 48 feet 8-1/4 inches to the heel block of the east movable point of the crossing, the ties bore wheel marks outside the north rail and inside the south rail. Immediately east of the heel block the track was torn up a distance of 480 feet, and from this point eastward it was damaged 1,056 feet.
