RAILROAD ACCIDENT INVESTIGATION

Report No. 4008

THE PENNSYLVANIA RAILROAD COMPANY

MARCH 1, 1964

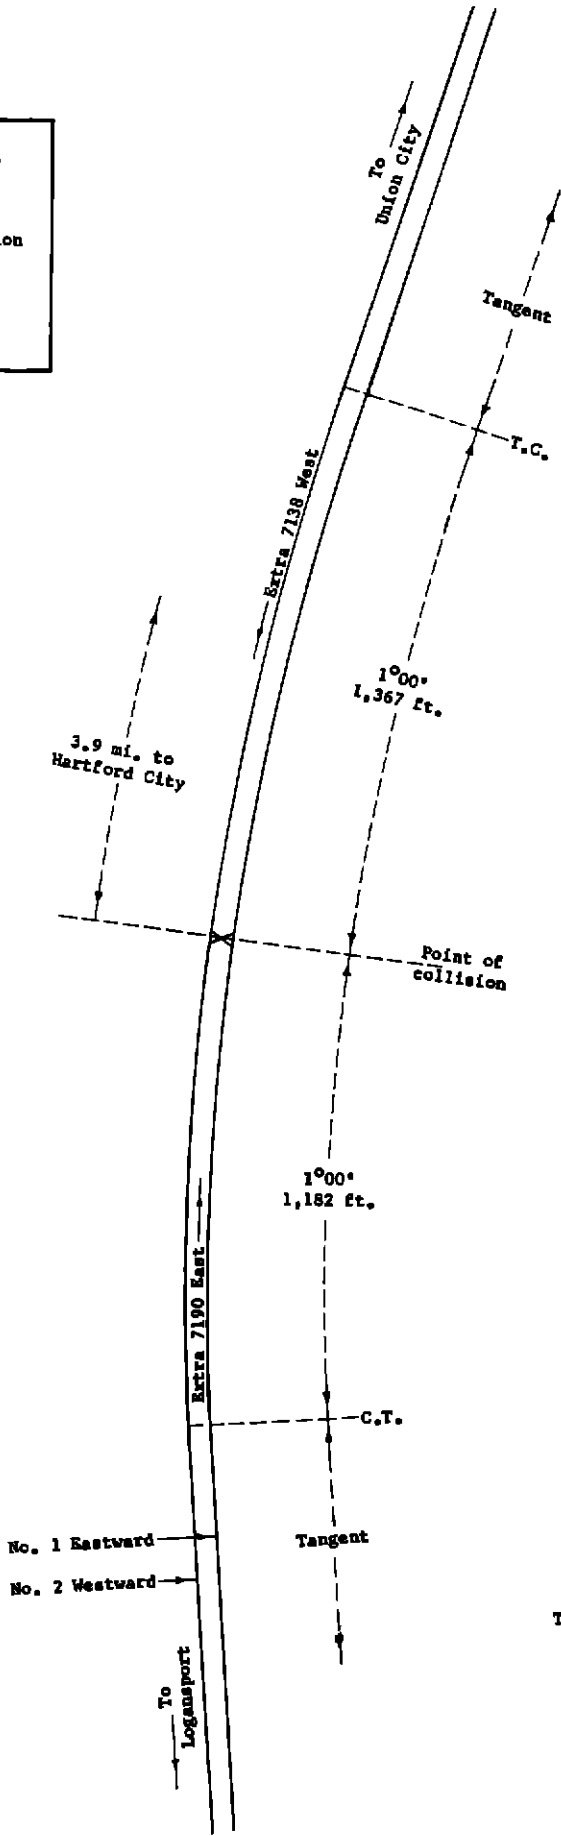
The Pennsylvania Railroad
Hartford City, Ind.
March 1, 1964

- Union City, Ind.
34.3 mi.
- Hartford City
3.9 mi.
- X Point of collision
14.9 mi.
- Kent
40.4 mi.
- Logansport, Ind.
