# RAILROAD ACCIDENT INVESTIGATION

Report No 3839

THE PENNSYLVANIA RAILROAD COMPANY

Accident near Vandalia, Ill , on March 14, 1959, caused by a broken wheel

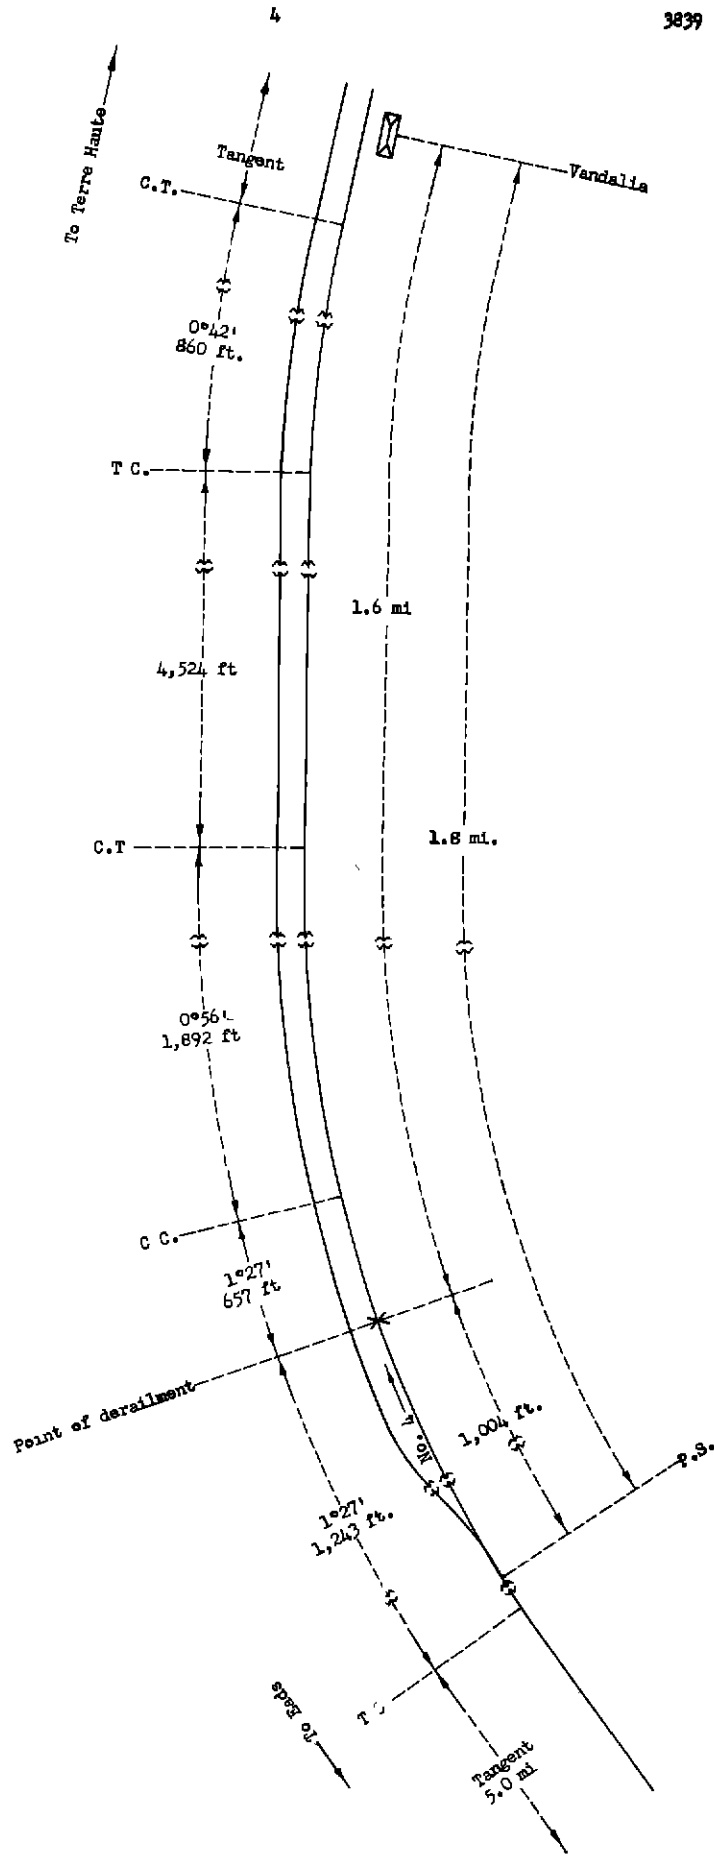
The Pennsylvania Railroad  
Vandalia, Ill  
March 14, 1959

- o Terre Haute, Ind  
99.4 mi
- o Vandalia, Ill  
1.6 mi.
- X Point of accident  
10.5 mi.
- o East Smithboro  
52.1 mi
- o Eads, Ill

The derailment occurred on the main track at a point 1,004 feet east of the west switch of the siding and 1 6 miles west of the station From the west there are, in succession, a tangent approximately 5 miles in length, a 1°27' curve to the right 1,243 feet to the point of accident and 657 feet eastward, a 0°56' curve to the right 1,892 feet, a tangent 4,524 feet, a 0°42' curve to the right 860 feet, and a tangent on which the train stopped The grade is 0 54 percent ascending eastward at the point of accident
