REPORT OF THE DIRECTOR

PERE MARQUETTE RAILWAY

BEECH, MICH.

INVESTIGATION NO. 2236

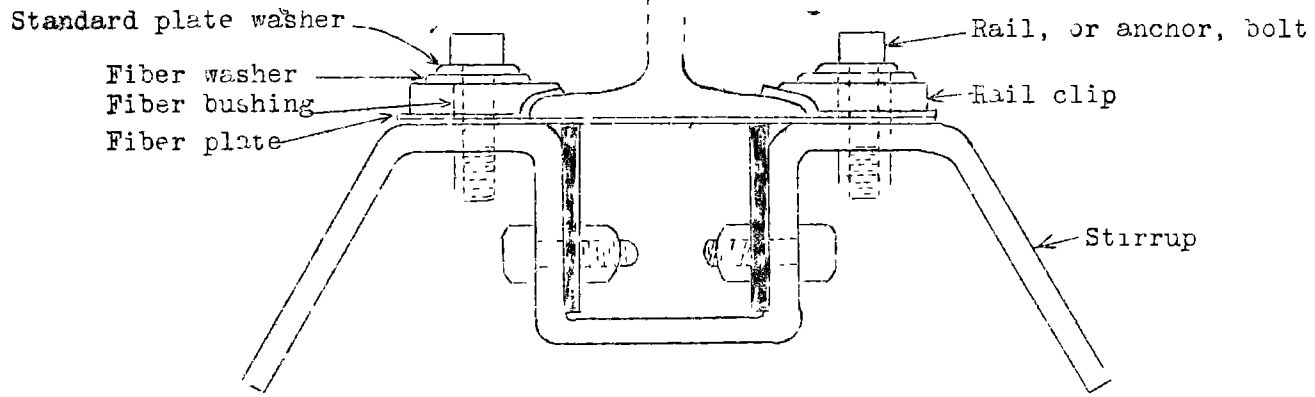
Detail of rail fastenings

For a distance of 1,716 feet westward, beginning at a point 1,719 feet west of Beech station, the track is laid on a concrete slab roadbed. Of this stretch, 1,326 feet on the east end was laid in 1926 while the balance was laid in 1929. The derailment occurred on the older stretch of this roadbed; the track structure consists of steel-reinforced concrete slabs 39 feet long, 10 feet wide and 21 inches thick. The steel reinforcement consists of a structural frame made up of two longitudinal trusses placed vertically in the plane of the two rails and secured by $\frac{3}{4}$ -inch tie-rods spaced at intervals of 6 feet along the top chord of the truss, and steel-bar cross-frames spaced 12 feet apart. At intervals of 27 inches $\frac{1}{2}$ by 2-inch steel stirrups are bolted to the top chord; these stirrups are designed to provide means for bolting rail-clips to each side of the rail for the purpose of securing the rail to the roadbed. These rail-clips are 2 by $3\frac{1}{4}$ by $\frac{3}{4}$ inches and the bottom face of each is chamfered along the edge in such manner as to fit the rail base. The track bolts used to secure the rail-clips to the stirrups are $2\frac{1}{2}$ by $\frac{5}{8}$ inches. In order to provide insulation for the rails, a fibre plate $\frac{1}{8}$ inch thick by $5\frac{1}{4}$ inches wide is placed beneath the base of the rail
