WASHINGTON, D.C. 20594

REAR-END COLLISION OF AMTRAK PASSENGER TRAIN 94, THE COLONIAL AND CONSOLIDATED RAIL CORPORATION FREIGHT TRAIN ENS-121, ON THE NORTHEAST CORRIDOR CHASE, MARYLAND JANUARY 4, 1987

NTSB/RAR-88/01

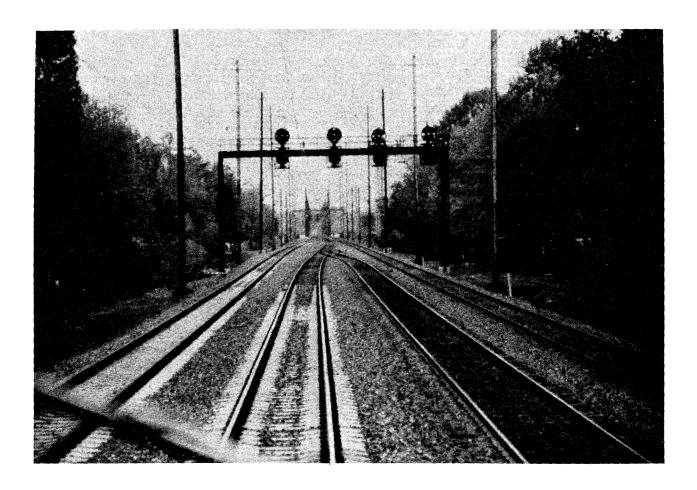
Figure 6. The northbound home signals at Gunpow as viewed from a northbound train moving at 125 mph on track 2. The aspect displayed for the train by signal 2N is "clear;" those displayed for the other tracks are "stop." From left to right, the tracks are 3, 2, 1, and A.

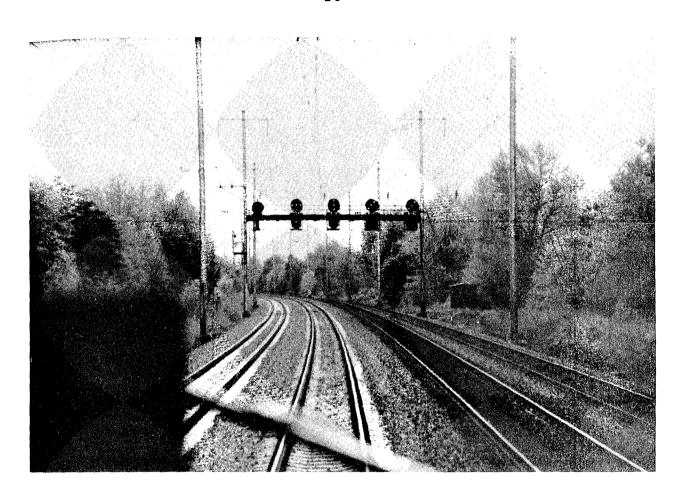
Figure 7. Distant signal 816/817 located 10,318 feet south of the home signals at Gunpow, as viewed from a northbound train moving at 125 mph on track 2. The aspect displayed for the train by signal 816-2 is "clear;" the aspects displayed for track 1 and track A to the right are "approach." A stop aspect is displayed for track 3 because the track is set up for a southbound train.

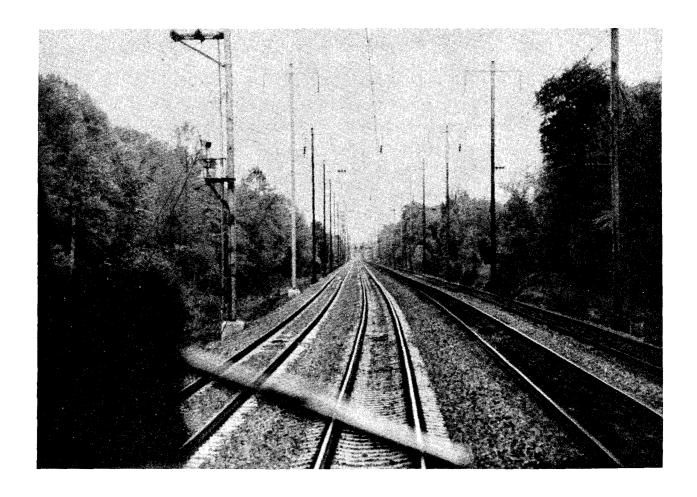
On high-speed track 2 approaching Gunpow, there is a cab signal code change point, identified as CS-826, 4,749 feet south of northbound distant signal 816-2. If signal 816-2 were to change to an "approach" aspect because home signal 2N had changed to a "stop" aspect, then the aspect of the cab signal of a northbound train that had been running on a "clear" aspect on track 2 would have changed to "approach medium" at CS-826. This code change point was installed when the Gunpow signals and track configuration were changed in 1985. In effect, it provides northbound trains with 15,067 feet of stopping distance compared with the 12,585 feet available before the modifications. There is no code change on track 1 at CS-826, but there is another code change point, CS-806, on all four tracks 4,450 feet south of the northbound home signals at Gunpow (see figure 10).

Figure 10. Code chande point CS-806 as seen from a northbound train on track 2. The nearest catenary support poles mark the location of the code change point. The Gunpow home signals are in the distance.
