RAILROAD ACCIDENT REPORT

RICHMOND, FREDERICKSBURG AND
POTOMAC RAILROAD COMPANY

TRAIN NO. 10/76
DERAILMENT WITH THREE
FATALITIES AND NUMEROUS
PERSONAL INJURIES
FRANCONIA, VIRGINIA
JANUARY 27, 1970

NATIONAL TRANSPORTATION SAFETY BOARD
Washington, D. C. 20591
REPORT NUMBER NTSB-RAR-71-1

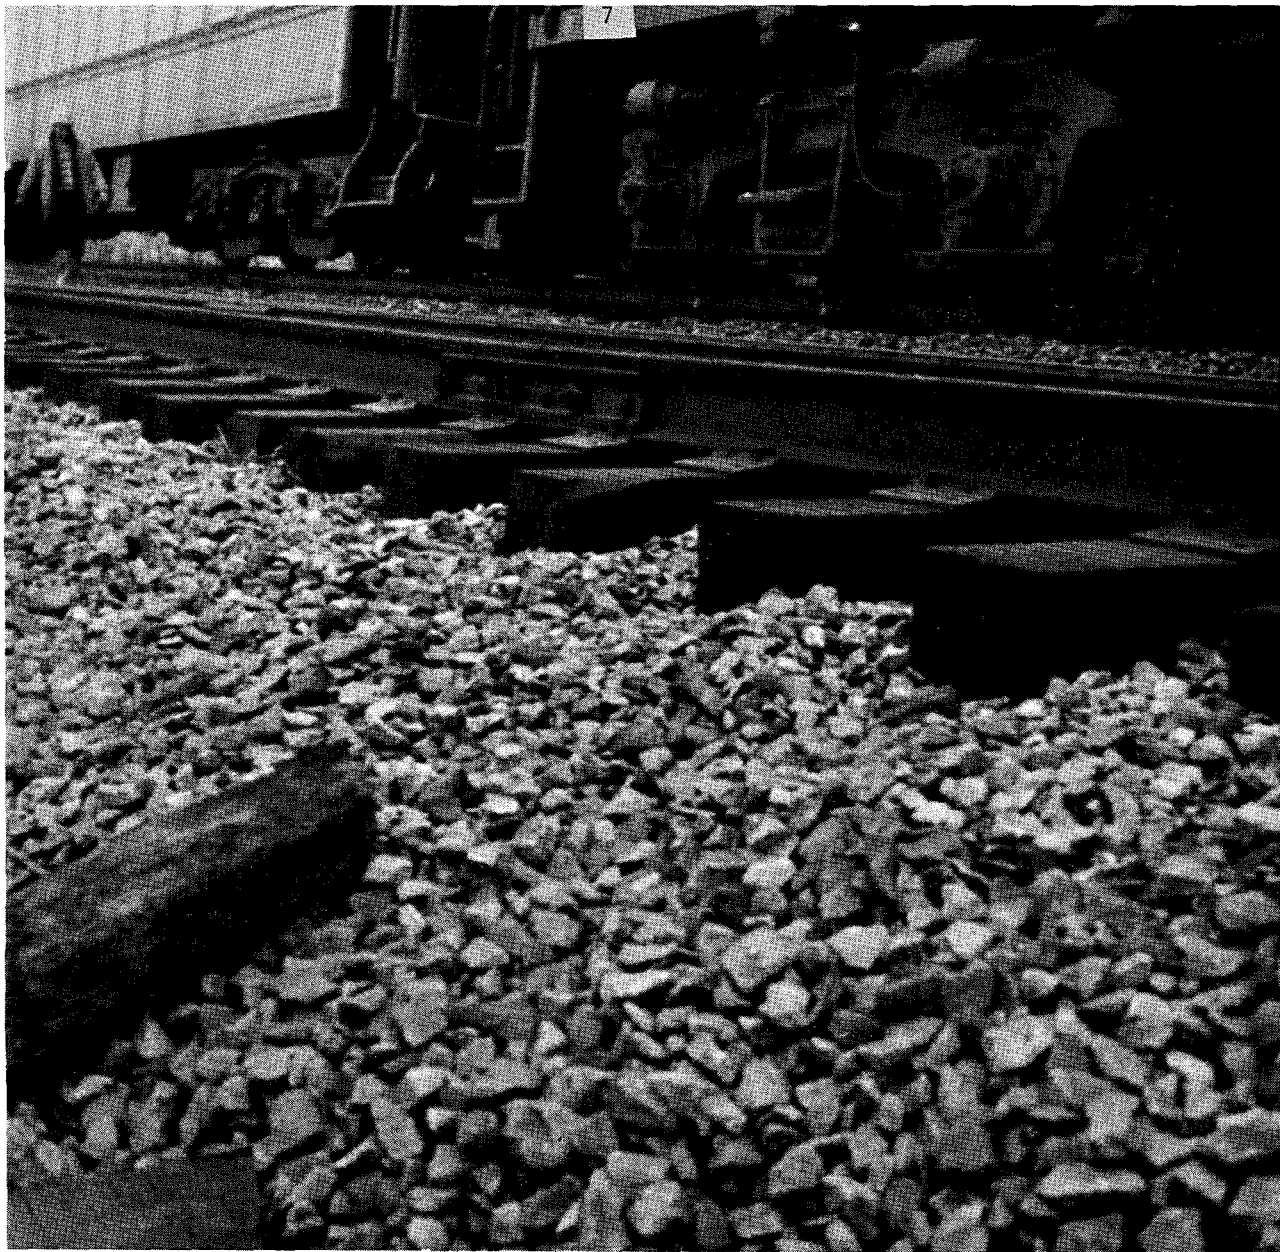
Figure 1

The track was ballasted with 3-inch to one-quarter inch crushed stone, laid to a depth of approximately 17 inches under the crossties. The crushed stone ballast was underlaid with old, washed gravel varying in size from 2 inches to sand, and in some areas contained some
