INVESTIGATION NO. 3225

RICHMOND, FREDERICKSBURG AND POTOMAC  
RAILROAD COMPANY

REPORT IN RE ACCIDENT

AT MILFORD, VA., ON

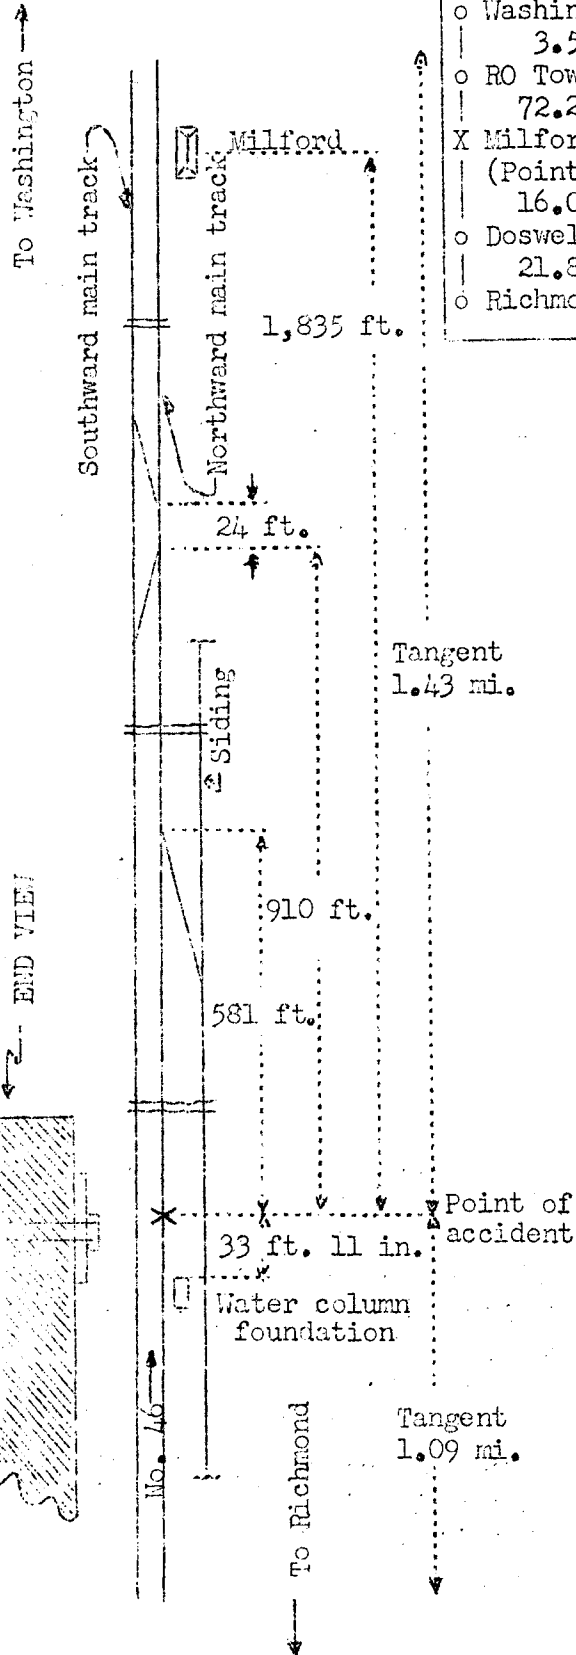
END VIEW

Examination after the accident disclosed that No. 46 had struck an obstruction on the track. The obstruction consisted of two parallel pieces of 130-pound rail, about 30 feet in length, bolted together with 8 one-inch bolts distributed evenly. The rails were spaced 8-1/2 inches between rail-centers with pipe sleeves over the bolts. A triangular section of the web, 18 inches in length, was cut away from each end of each rail and the head was bent downward to the base to form a ramp at each end. This pair of rails weighed approximately 2,600 pounds. These rails were broken into several pieces, most of which were recovered. The largest piece, consisting of 17 feet 3 inches of each rail, was found between the northward main track and the siding and about 50 feet north of the point of derailment. The north end was embedded in the ballast under the west ends of the ties of the siding. The south end was near the northward main track. The second largest piece, consisting of one rail 9 feet 10 inches in length, was found 28 feet east of the northward main track and about 350 feet north of the point of derailment. A third piece, consisting of one rail 9 feet in length, was found on the northward main track and about 820 feet north of the point of derailment. Smaller pieces of the rail were found at various locations throughout a distance of about 900 feet north of the point of derailment.
