INVESTIGATION NO. 3226  
SEABOARD AIR LINE RAILROAD COMPANY  
REPORT IN RE ACCIDENT  
AT BAY LAKE, FLA., ON  
JANUARY 11, 1949

Railroad: Seaboard Air Line  
Date: January 11, 1949  
Location: Bay Lake, Fla.  
Kind of accident: Derailment  
Train involved: Passenger  
Train number: 46  
Engine numbers: Diesel-electric units 3010,  
3103 and 3017  
Consist: 16 cars  
Speed: 75 m. p. h.  
Operation: Signal indications  
Track: Single, tangent, level  
Weather: Clear  
Time: 6.11 p. m.  
Casualties: 1 killed; 76 injured  
Cause: False flange resulting from  
slid-flat driving wheel

Accident at Bay Lake, Fla., on January 11, 1949, caused  
by a false flange resulting from a slid-flat  
driving wheel.

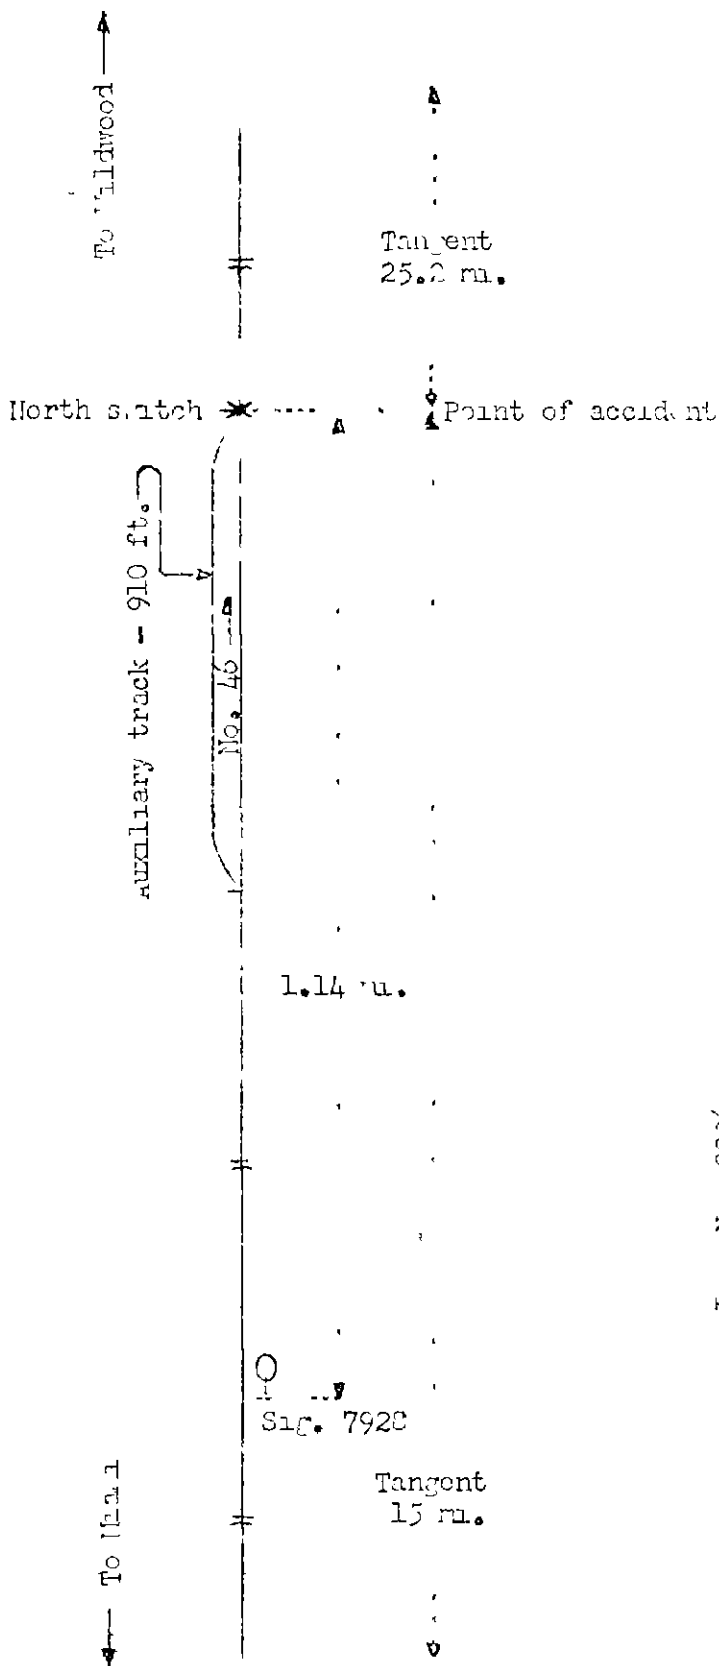
Inv. No. 2236  
Seaboard Air Line Railroad  
Bay Lake, Fla.  
January 11, 1949

Location of Accident and Method of Operation
