INVESTIGATION NO. 3074
SEABOARD AIR LINE RAILROAD COMPANY
REPORT IN RE ACCIDENT
NEAR MAXVILLE, FLA., ON
FEBRUARY 14, 1947

March 4, 1947

Accident near Maxville, Fla., on February 14, 1947, caused
by a broken rail.

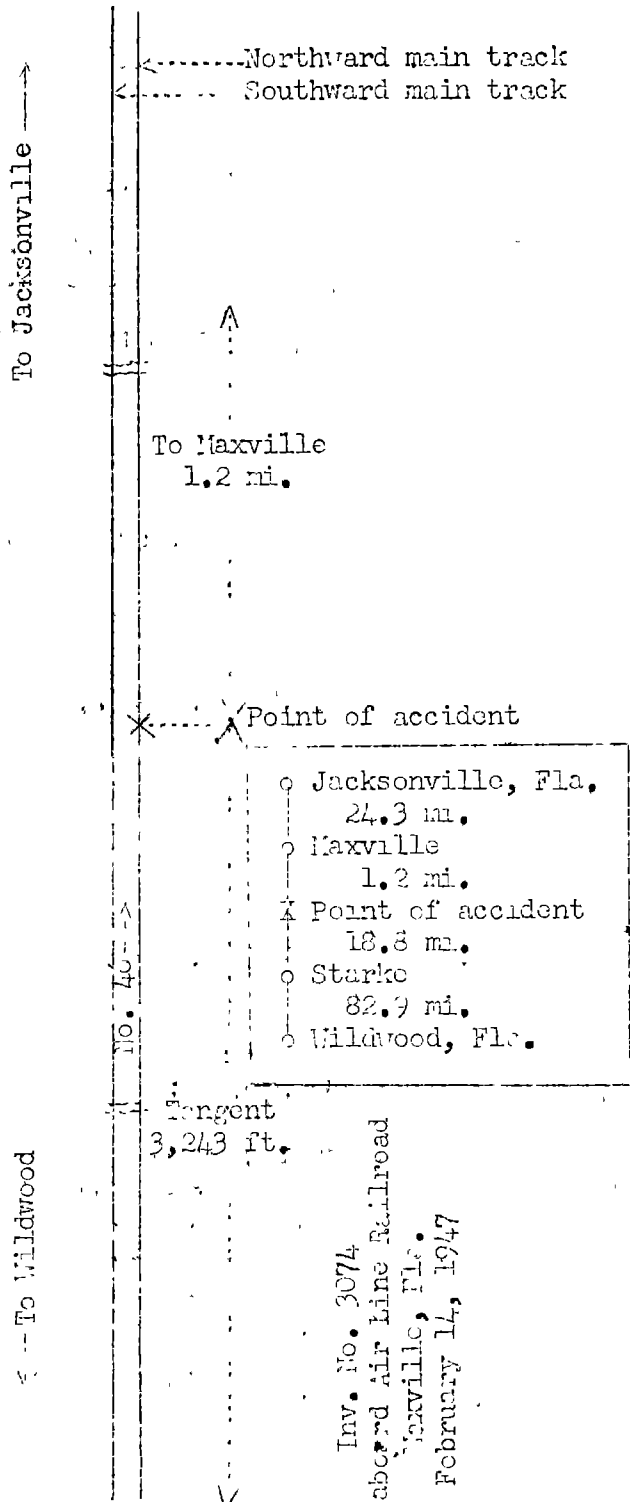
Sketch showing broken rail - west side of northward main track

After the accident a broken rail was found on the west side of the northward main track. This rail was broken into five pieces. The first break occurred between two ties at a point $3\text{-}\frac{3}{4}$ feet north of the receiving end of the rail. The second, third and fourth breaks occurred at points, respectively, $2\text{-}\frac{1}{2}$ inches, 10 feet 8 inches and 20 feet $9\text{-}\frac{3}{4}$ inches north of the first break. The receiving ends of the first, third and fourth breaks were battered considerably, and there were flange marks on the head of the rail at the first and second breaks. At the first break there was a transverse fissure covering 18 percent of the cross sectional area of the head of the rail, which did not extend to the surface of the rail. The remainder of the breaks in the head, and the breaks in the web and the base of the rail were new.

A north bound freight train passed over this track about 1 hour before the derailment occurred, and the crew did not observe any abnormal condition of the track. Apparently the failure of the rail at the first break occurred when the first Diesel-electric unit passed over it, then the succeeding breaks

occurred, the broken pieces became displaced and the derailment followed.
