RAILROAD ACCIDENT REPORT

DERAILMENT OF AUTO-TRAIN NO. 4
ON SEABOARD COAST LINE RAILROAD
FLORENCE, SOUTH CAROLINA
FEBRUARY 24, 1978

NTSB/RAR-84/03
(SUPERSEDES--NTSB-RAR-78-6)

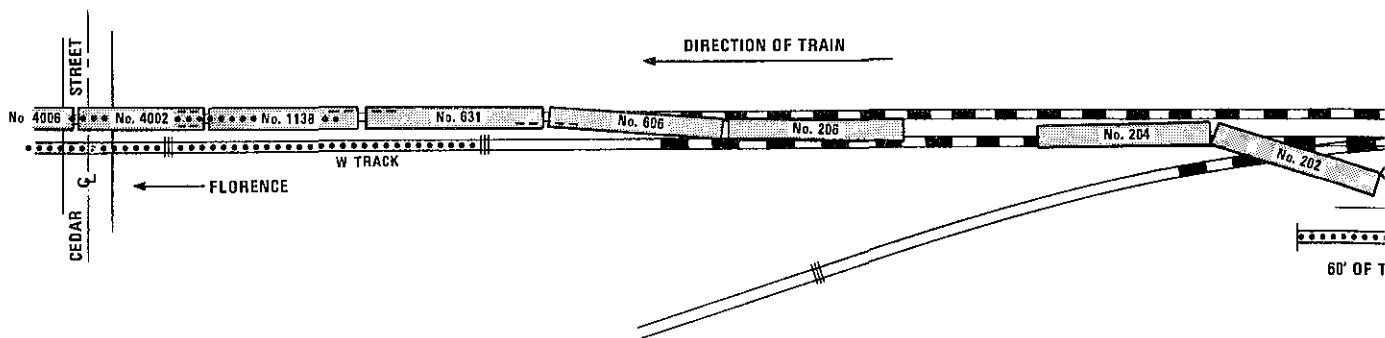
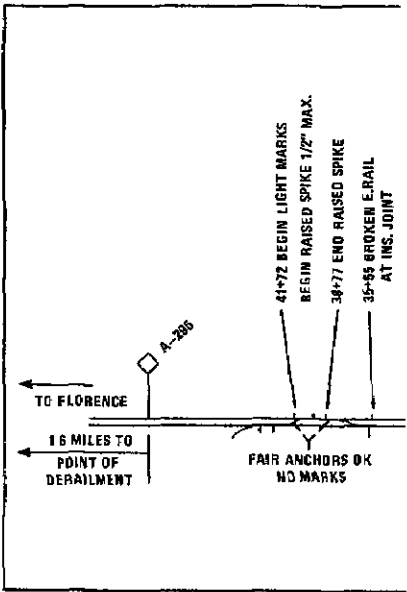
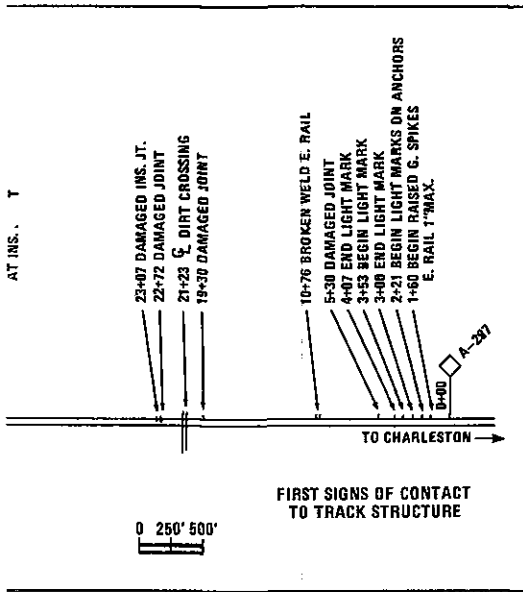
FIGURE 1

At the accident site, the northbound track was paralleled on the west by the southbound track and on the east by a stub-ended industrial siding. (See Figure 1.) The switch to the siding was located at its north end. Approaching the accident point from the south, the grade ascends 0.56 percent, and the track alignment is straight.

SEABOARD COAST LINE RAILROAD
FLORENCE DIVISION
AUTO—TRAIN DERAILMENT
ON FEB. 24, 1978
FLORENCE, S.C.
