NATIONAL TRANSPORTATION SAFETY BOARD

DERAILMENT OF
SEABOARD SYSTEM RAILROAD TRAIN NO. F-690
WITH HAZARDOUS MATERIAL RELEASE
JACKSON, SOUTH CAROLINA
FEBRUARY 23, 1985 AND COLLISION OF
SEABOARD SYSTEM RAILROAD TRAIN NO. F-481
WITH STANDING CARS
ROBBINS, SOUTH CAROLINA
FEBRUARY 25, 1985

NTSB/RAR-85/12

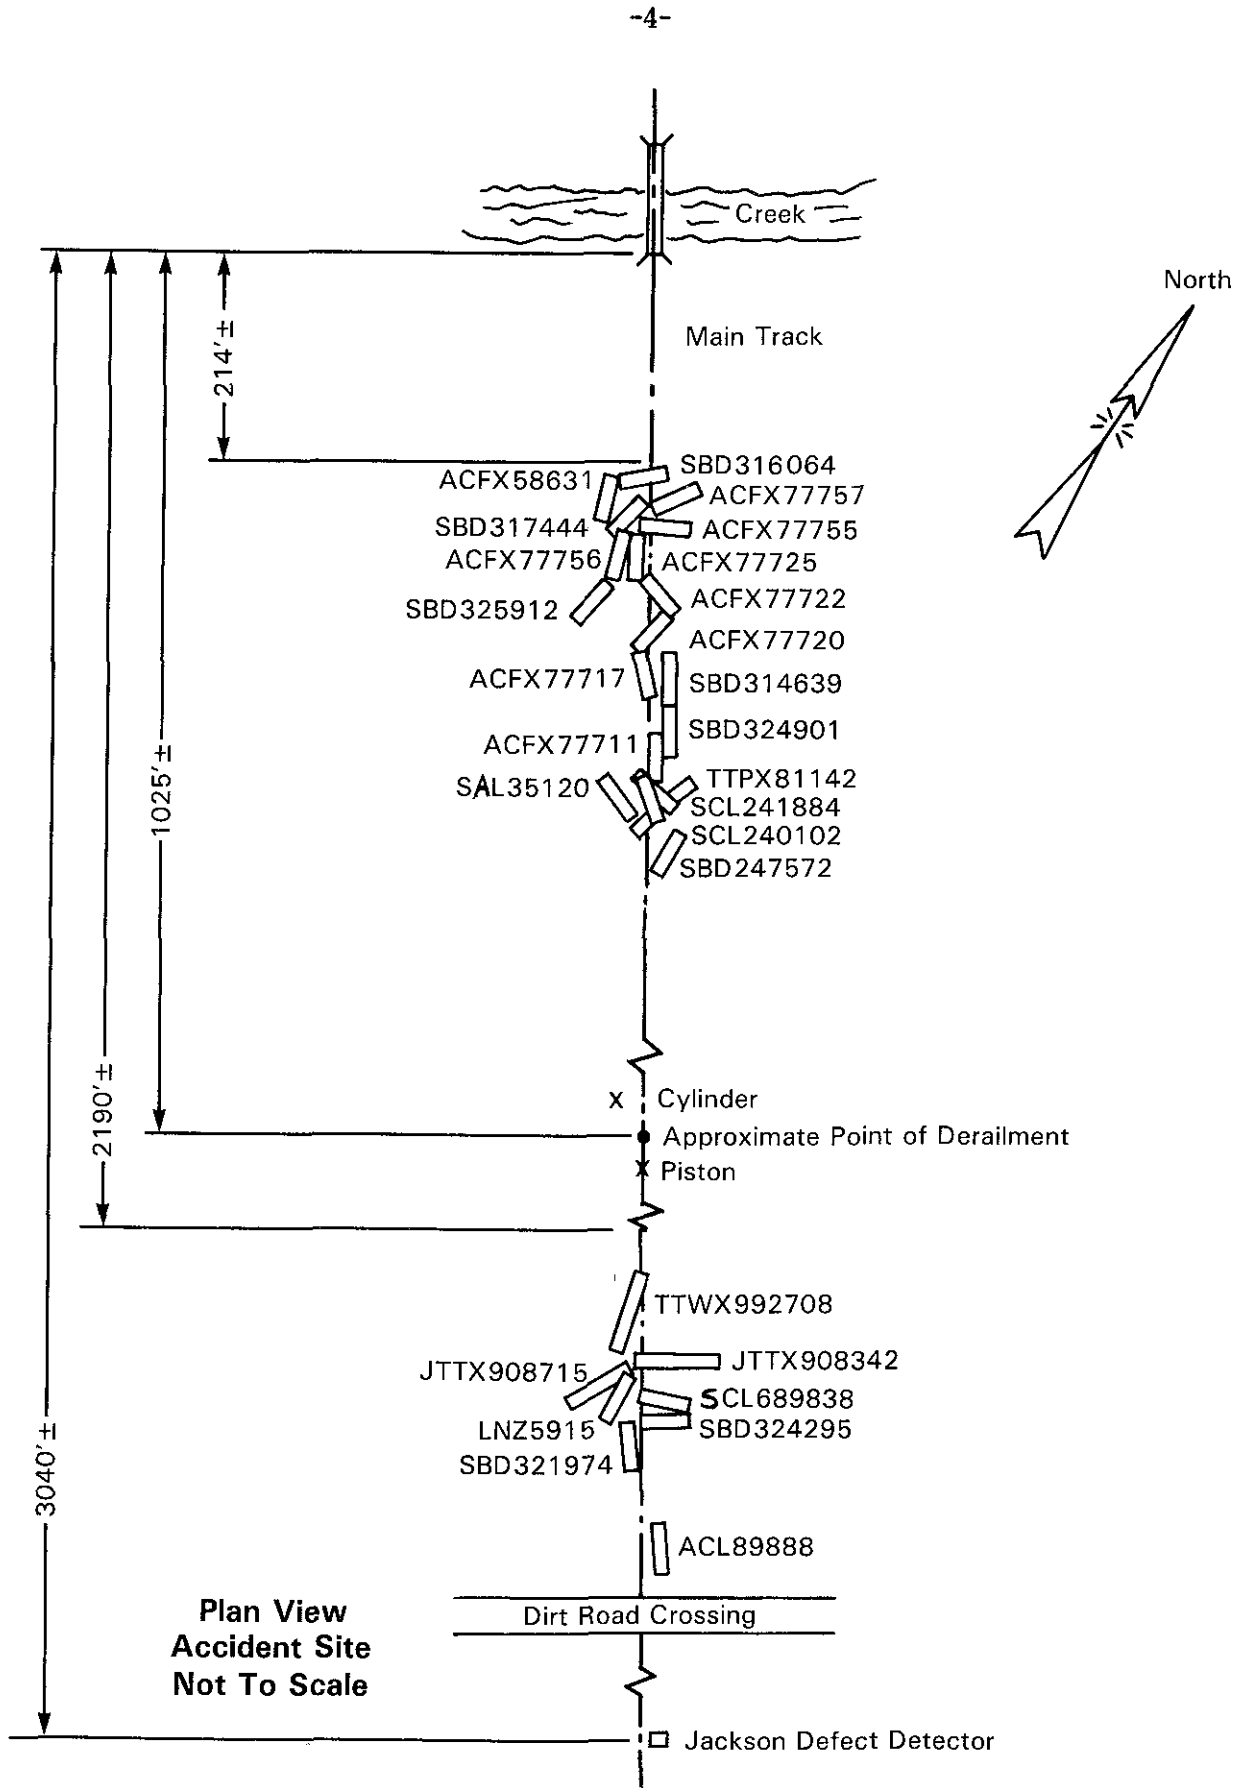
Figure 2.--Plan view of Jackson accident site.

About 7:15 a.m., SBD train No. F-690, a run-through train with no cars to be set out or picked up en route, was passing through Jackson, en route from Savannah to Augusta. The engineer stated that his locomotive had just passed the defect detector and he had sounded the warning whistle signal for an at-grade road crossing near the defect detector when he got up from his seat to get a drink of water. "When I sat down, I felt and heard us hit something," the engineer stated. "When I looked out my window, I saw an object rolling out into the woods. I saw it come from underneath the train and go out into the woods and it looked about the size of a crosstie. But I couldn't tell you exactly what it was because there was debris flying all around it." Almost immediately afterwards, the train automatic airbrake applied in emergency. Twenty-seven cars--18 cars (the 2nd through the 19th cars) near the front of the train and 9 cars (the 40th through the 48th cars) further back in the train--were derailed. (See figure 2.) The five-unit locomotive and one car which remained coupled to the locomotive came to a stop after traveling about three-fourths of a mile. The engineer stated that the speed of train No. F-690 was about 49 miles per hour (mph) when the derailment occurred. (The defect detector recorded the train speed at 53 mph.) Located among the derailed cars near the front of the train were eight tank cars containing cyclohexane, a flammable liquid. All of the tank cars were severely damaged, leading to the release of cyclohexane, which ignited immediately. (See figure 3.)

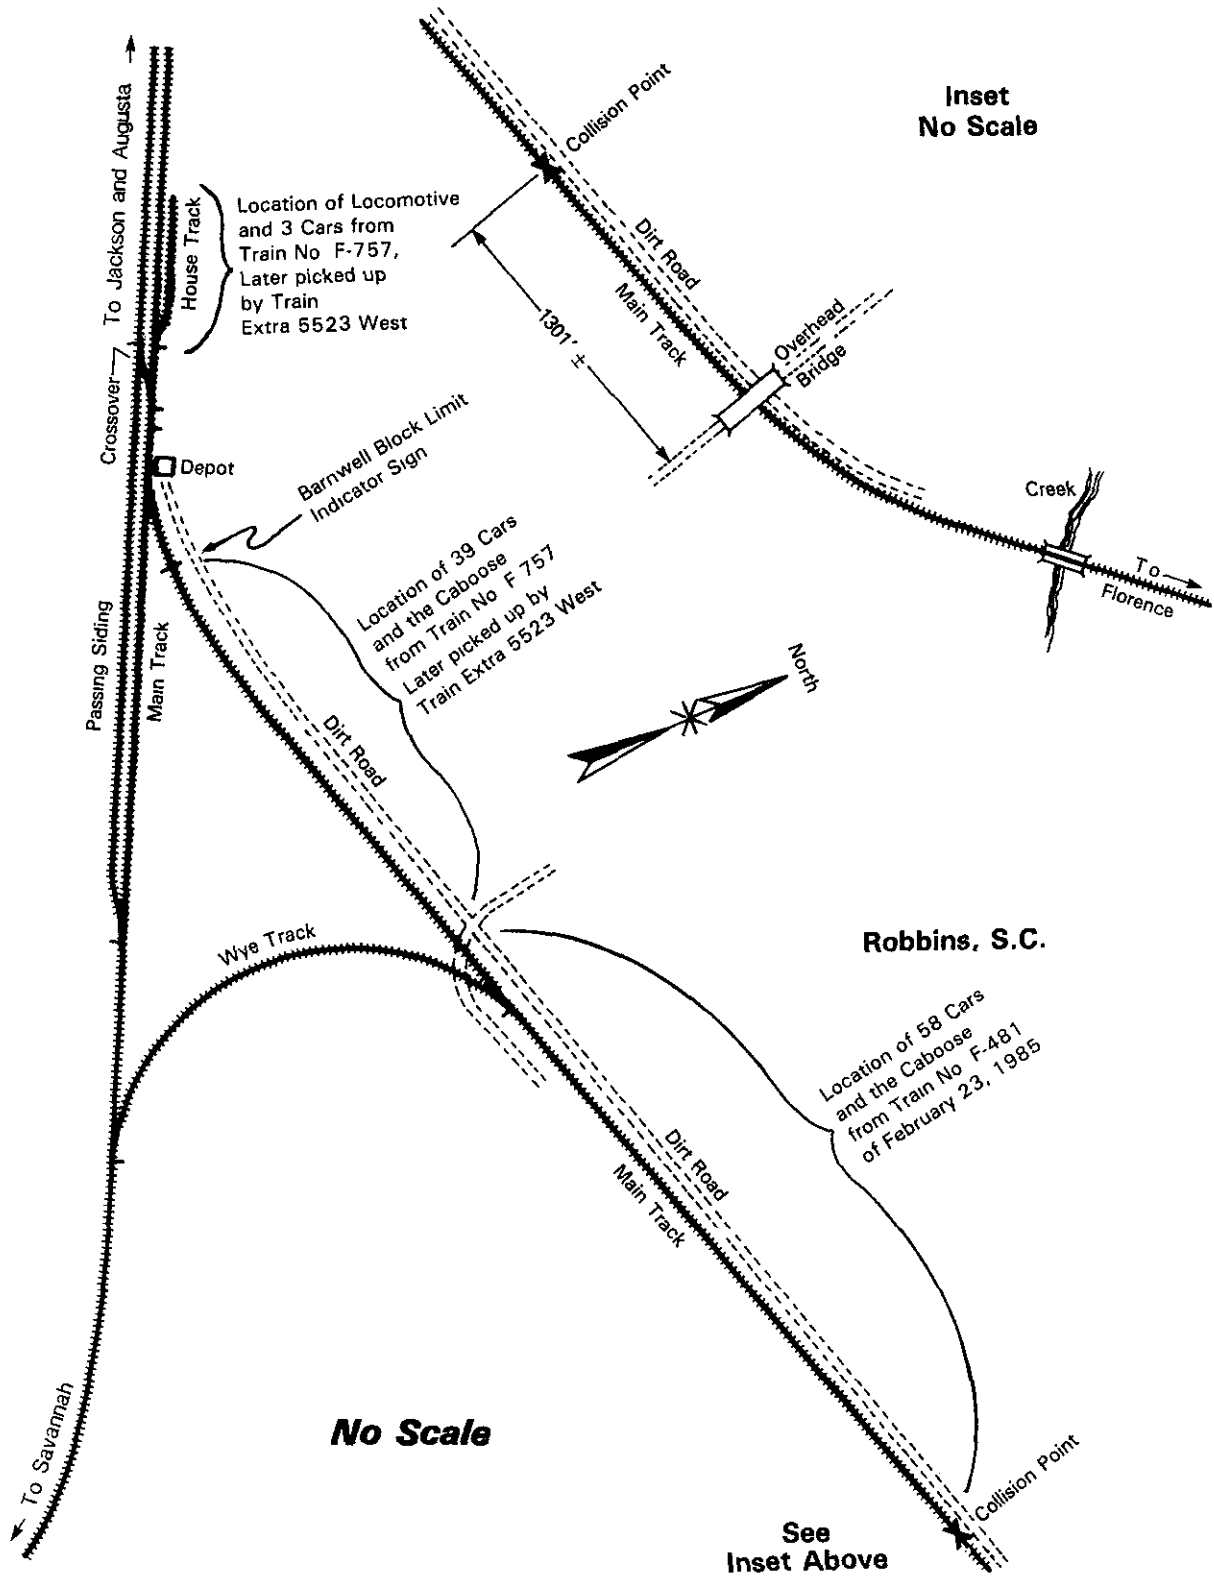
Figure 4.--Plan view of Robbins accident site.

The crew of train No. F-481 backed their train so that its freight cars were clear of a dirt road at-grade crossing at Robbins. (See figure 4.) The cars consisted of 25 loaded and 33 empty cars and a caboose, and included 2 piggyback cars. Handbrakes were applied on several cars at the head end of the train, and the two-unit locomotive was uncoupled from the cars. The lead car was left about four or five car lengths east of the dirt road crossing, according to the crew. The cars of train No. F-481 were left in the Barnwell manual block under an absolute block ^{5/} authority, while the crew on the two-unit locomotive was given verbal permission by the dispatcher to proceed to the accident site at Jackson, about 14 miles west. At the accident site, the crew was instructed to pull the rear underdetailed portion of train No. F-690, consisting of 97 freight cars, back to a siding at Ellenton, South Carolina. (See figure 1.) After returning to the accident site, they assisted in re-railing a car and placed two freight cars and their two-unit locomotive in a siding east of the accident site. The crew then reported off duty and were taxed to Augusta, where they delivered the waybills and train consist from train No. F-481 to the trainmaster's office.
