# NATIONAL TRANSPORTATION SAFETY BOARD

## ✓ RAILROAD ACCIDENT REPORT, ///

REAR END COLLISION  
OF SEABOARD SYSTEM RAILROAD  
FREIGHT TRAINS EXTRA 8051 NORTH  
AND EXTRA 1751 NORTH  
SULLIVAN, INDIANA  
SEPTEMBER 14, 1983

✓  
NTSB/RAR-84/02,

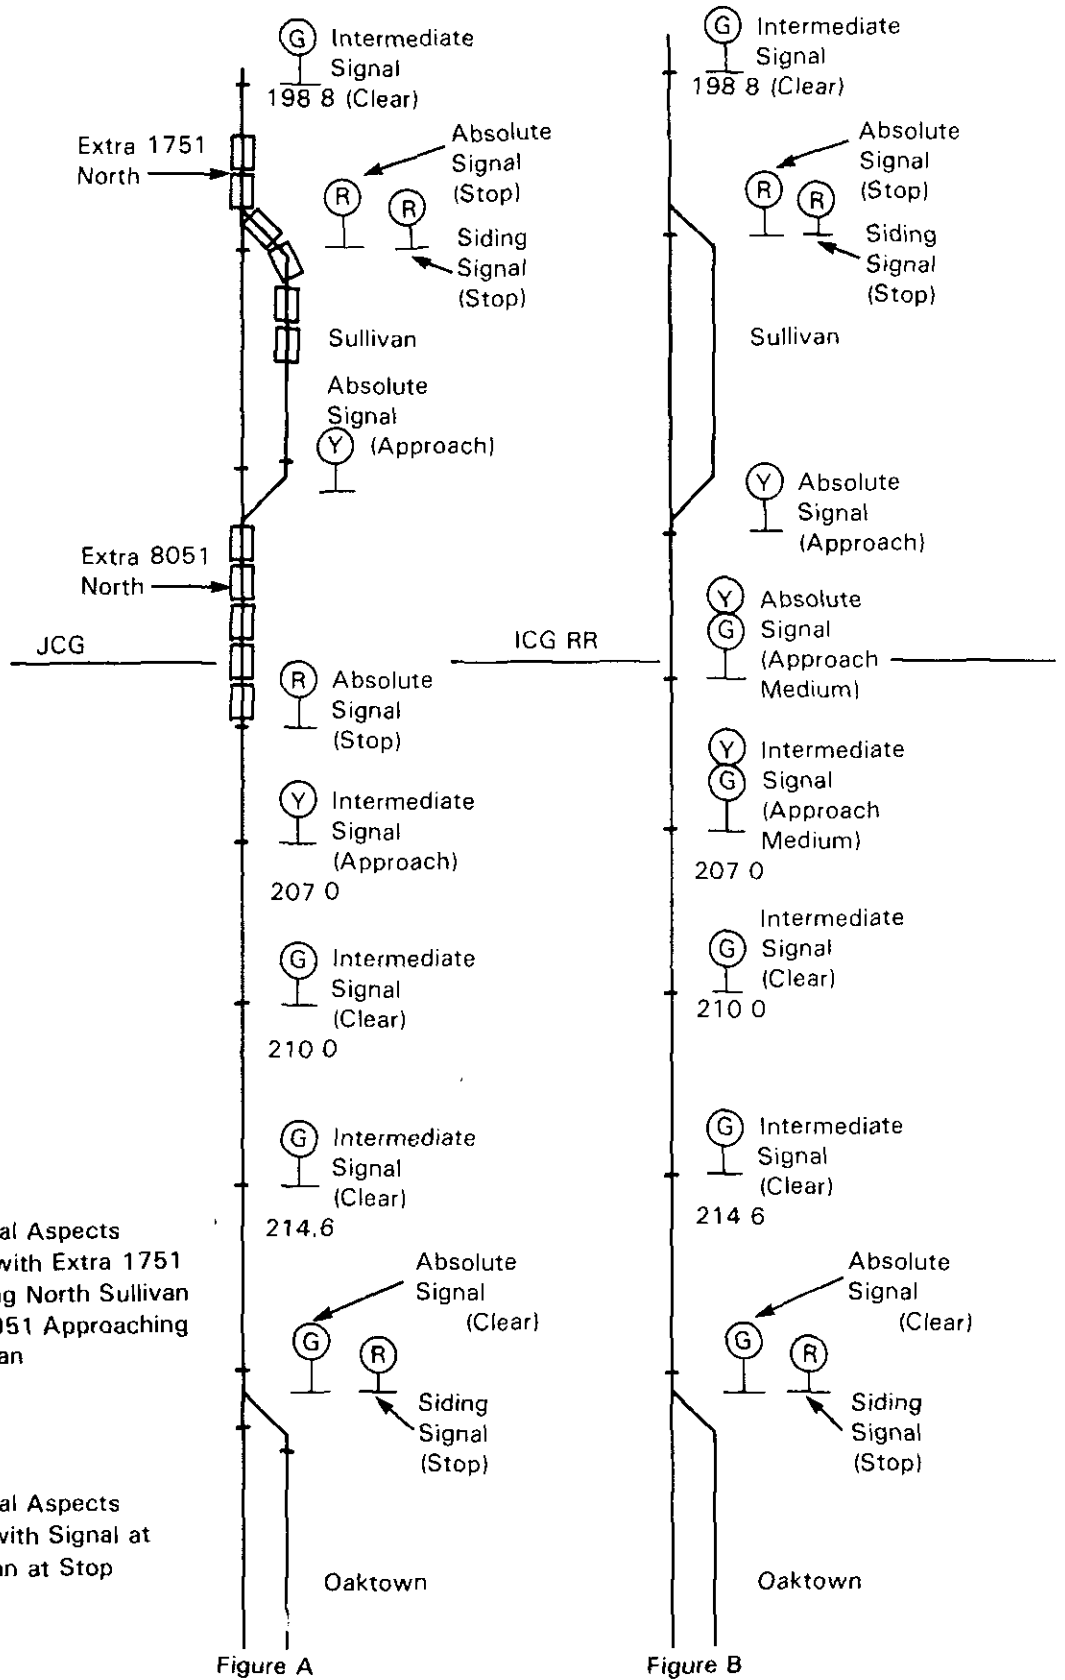
Figure A  
Depicts Signal Aspects  
Southward with Extra 1751  
North Leaving North Sullivan  
and Extra 8051 Approaching  
South Sullivan

Figure B  
Depicts Signal Aspects  
Southward with Signal at  
North Sullivan at Stop
