Department
of Transportation
**Railroad
Administration**

Railroad Accident Investigation Report, No. 12-88.

**Southeastern Pennsylvania Transportation Authority
Norristown, Pennsylvania
January 12, 1988**

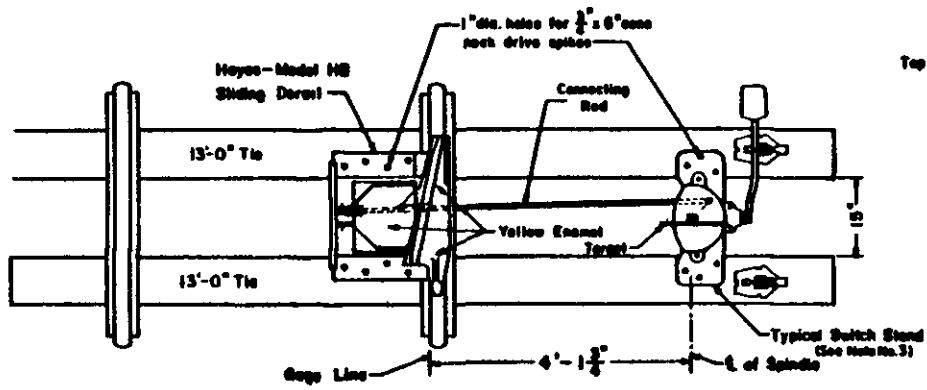
LOCATION OF DERAIL

An inspection was made of the derail at the Matlack Company siding. The rod connecting the derail to its operating stand was found to be broken at the point where it would attach to the stand. The break appeared to be 100 percent new, and the separated piece was found several feet away against a property fence. This would indicate sudden failure due to impact forces being applied.

There were marks that would indicate that the derail shoe was hit by a wheel and pushed back out of the way, but they were slightly rusty. In any case, failure of the device was caused by Conrail's failure to replace a bent screw jaw whenever it occurred which forced the full impact of a rolling car onto the one undamaged side of the screw jaw which was unable to sustain the stress.

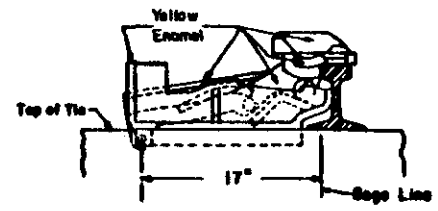
SWITCH STAND AND DERAIL INSTALLATION

The Matlack Company siding is located about 1/4 mile north of the turnout which begins the Stoney Creek Branch of Conrail and also leads to the Elm Street SEPTA Station. The attached sketch shows the track arrangements in the general area. The Matlack siding was equipped with a Hayes sliding derail, operated by a hand-throw stand of a design used widely by the old Reading Company, which originally owned this trackage. The investigation found the derail in the "off", or non-derailing, position. Examination revealed a broken screw jaw on the end of the connecting rod which attaches to the hand throw crank with a steel pin. The break appeared to be a 100 percent new break. The piece broken off was found several feet away against a fence, indicating a sudden failure due to high impact forces being applied, most likely by the lead wheels of the runaway car as it passed over the derail. The screw jaw at that end of the connecting rod were flared, or spread apart, enough to not allow the connecting pin to go through both, thus placing the full impact force onto one screw jaw. The screw jaw broke rather than the pin because the screw jaw is cast steel and the pin is forged.
