INVESTIGATION NO. 3100
SOUTHERN PACIFIC COMPANY
REPORT IN RE ACCIDENT
AT GUASTI, CALIF., ON
APRIL 27, 1947

Railroad: Southern Pacific
Date: April 27, 1947
Location: Guasti, Calif.
Kind of accident: Derailment
Train involved: Passenger
Train number: 6
Engine number: 4438
Consist: 18 cars
Speed: 65 m. p. h.
Operation: Timetable, train orders, and
automatic block-signal system
Track: Single; tangent; 0.514 percent
ascending grade eastward
Weather: Clear
Time: 9:48 p. m.
Casualties: 77 injured
Cause: Broken switch-rail

Accident at Guasti, Calif., on April 27, 1947, caused
by a broken switch-rail.

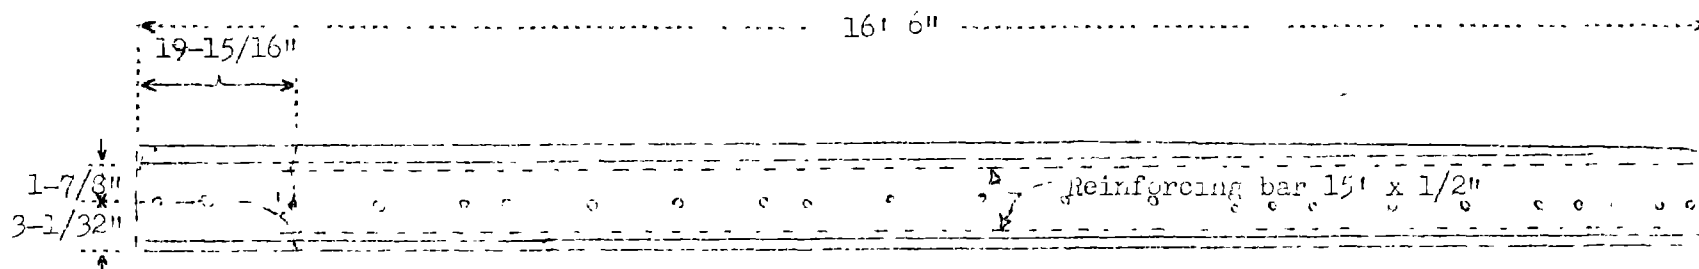
Sketch showing broken switch-rail

After the accident the south switch-rail of the east siding-switch at Guasti was found overturned toward the center of the track. It was broken into five pieces, four of which were recovered. The first break was an irregular break at a point 2-5/8 inches east of the heel of the switch-rail. This break extended diagonally downward and westward to a point where it broke out at the heel-end 1-7/8 inches below the head of the rail. The other breaks were a result of a horizontal fracture in the web which started at the heel-end and progressed eastwardly in an irregular line through both angle-bar bolt holes and the most westwardly of the rivet holes for securing the reinforcing bar. This rivet was located 19-1/2 inches east of the heel-end of the switch-rail. At this latter point the break separated into two legs, one of which progressed upward through the head of the rail in practically a square break at a point 19-15/16 inches east of the heel, and the other extended downward at a slight angle through the base of the rail at a point about opposite the break through the head. The receiving end of the second break through the head of the switch-rail was considerably battered by the flanges of wheels. The surfaces of the horizontal break were somewhat battered and were so polished by friction that it could not be determined if a progressive fracture had existed. However, there was some discoloration of metal on the surfaces of the horizontal fracture in the area between the two angle-bar bolt holes. Prior to the accident, this discoloration had not reached the

outer surfaces of the web of the rail. The remainder of the breaks were new. The division engineer said that in his opinion a hair-line horizontal fracture had existed between the angle-bar bolt holes and had progressed until breaks occurred through the head, the web and the base of the switch-rail at a point 19-15/16 inches east of the heel-end. Apparently, the portion above the horizontal fracture dropped inward during the passage of the wheels of the engine and the first two cars of No. 6, then the front wheels of the third car became derailed.

An east-bound passenger train, moving at a speed of 60 miles per hour, passed over the switch involved about 13 minutes before the derailment occurred, and the crew of this train observed no indication of defective track. However, the fracture could have existed prior to the passage of No. 6, as the portions of the rail might have been held in place some time by the heel-block and the inside angle bar and the reinforcing bar.
