RAILROAD ACCIDENT REPORT

SOUTHERN PACIFIC TRANSPORTATION CO.

FREIGHT TRAIN 2ND BSM 22 MUNITIONS EXPLOSION

BENSON, ARIZONA

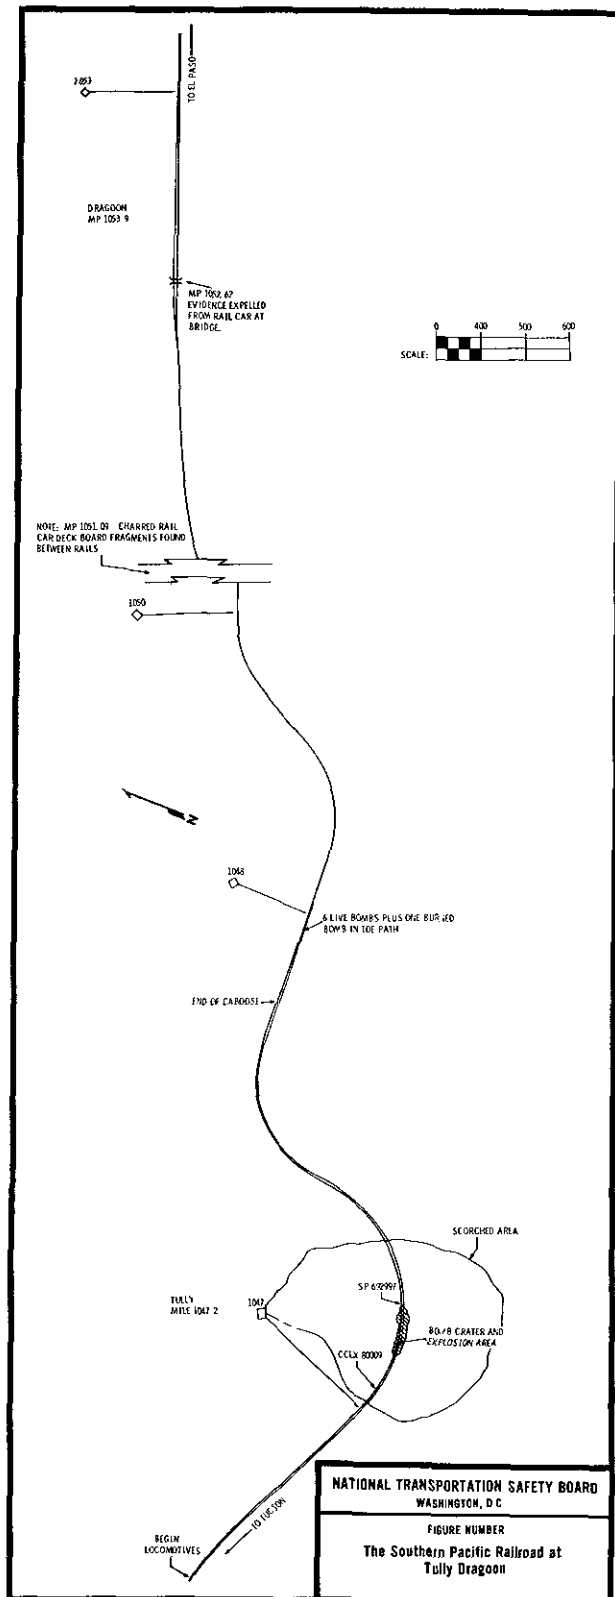
Figure 1. Main Crater Area.

The cars which followed the last car of bombs, containing zinc ash, clays, fiberboard, water heaters, auto tires, and asbestos, were severely damaged, and most of their cargoes spilled onto the right-of-way. The locomotives stopped at MP 1046.7; the caboose stopped at MP 1047.8. (See Figures 1 and 2.)

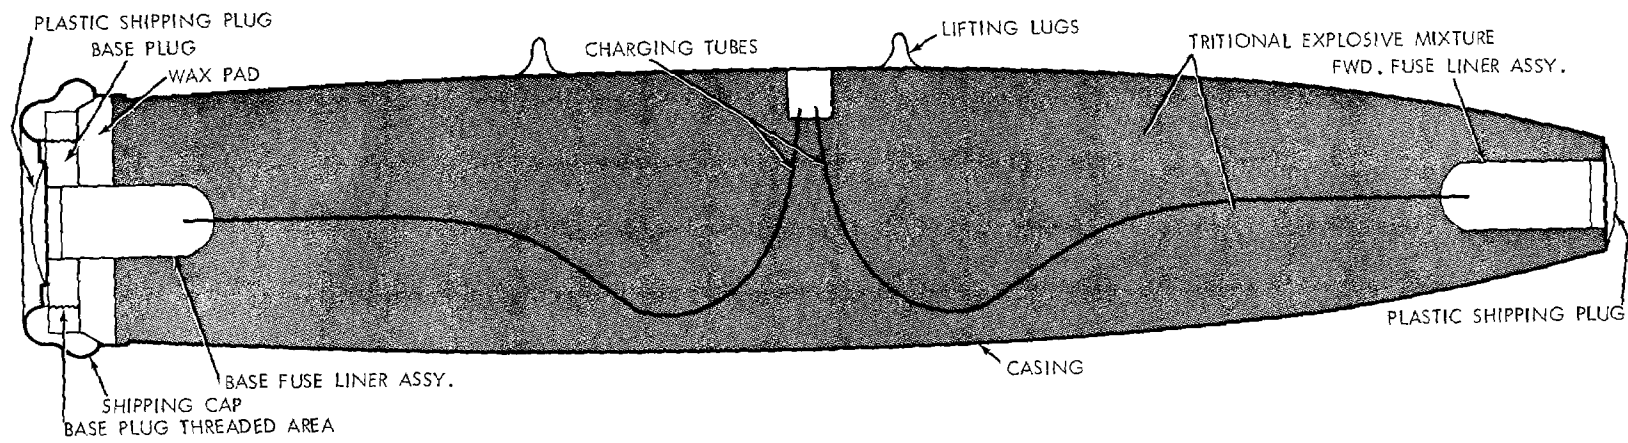
Figure 5. Diagram of MK 82 Bomb.

The MK 82 bombs -- The MK 82 bombs consisted of coated steel casings filled with tritonal (80 percent TNT and 20 percent aluminum powder), fuse wells and charging tubes for arming the bombs, and plastic plugs in each opening. (See Figure 5.) The tritonal was cast in place hot and allowed to partially solidify by ambient air cooling. After the tritonal solidified, its shrinkage required the addition of more tritonal to the base area. This procedure resulted in internal voids in the cast tritonal. Hot wax was poured on top of the tritonal to seal the casting.
