RAILROAD ACCIDENT INVESTIGATION,

✓
REPORT NO. 4187,

SOUTHERN PACIFIC TRANSPORTATION COMPANY

APRIL 28, 1973

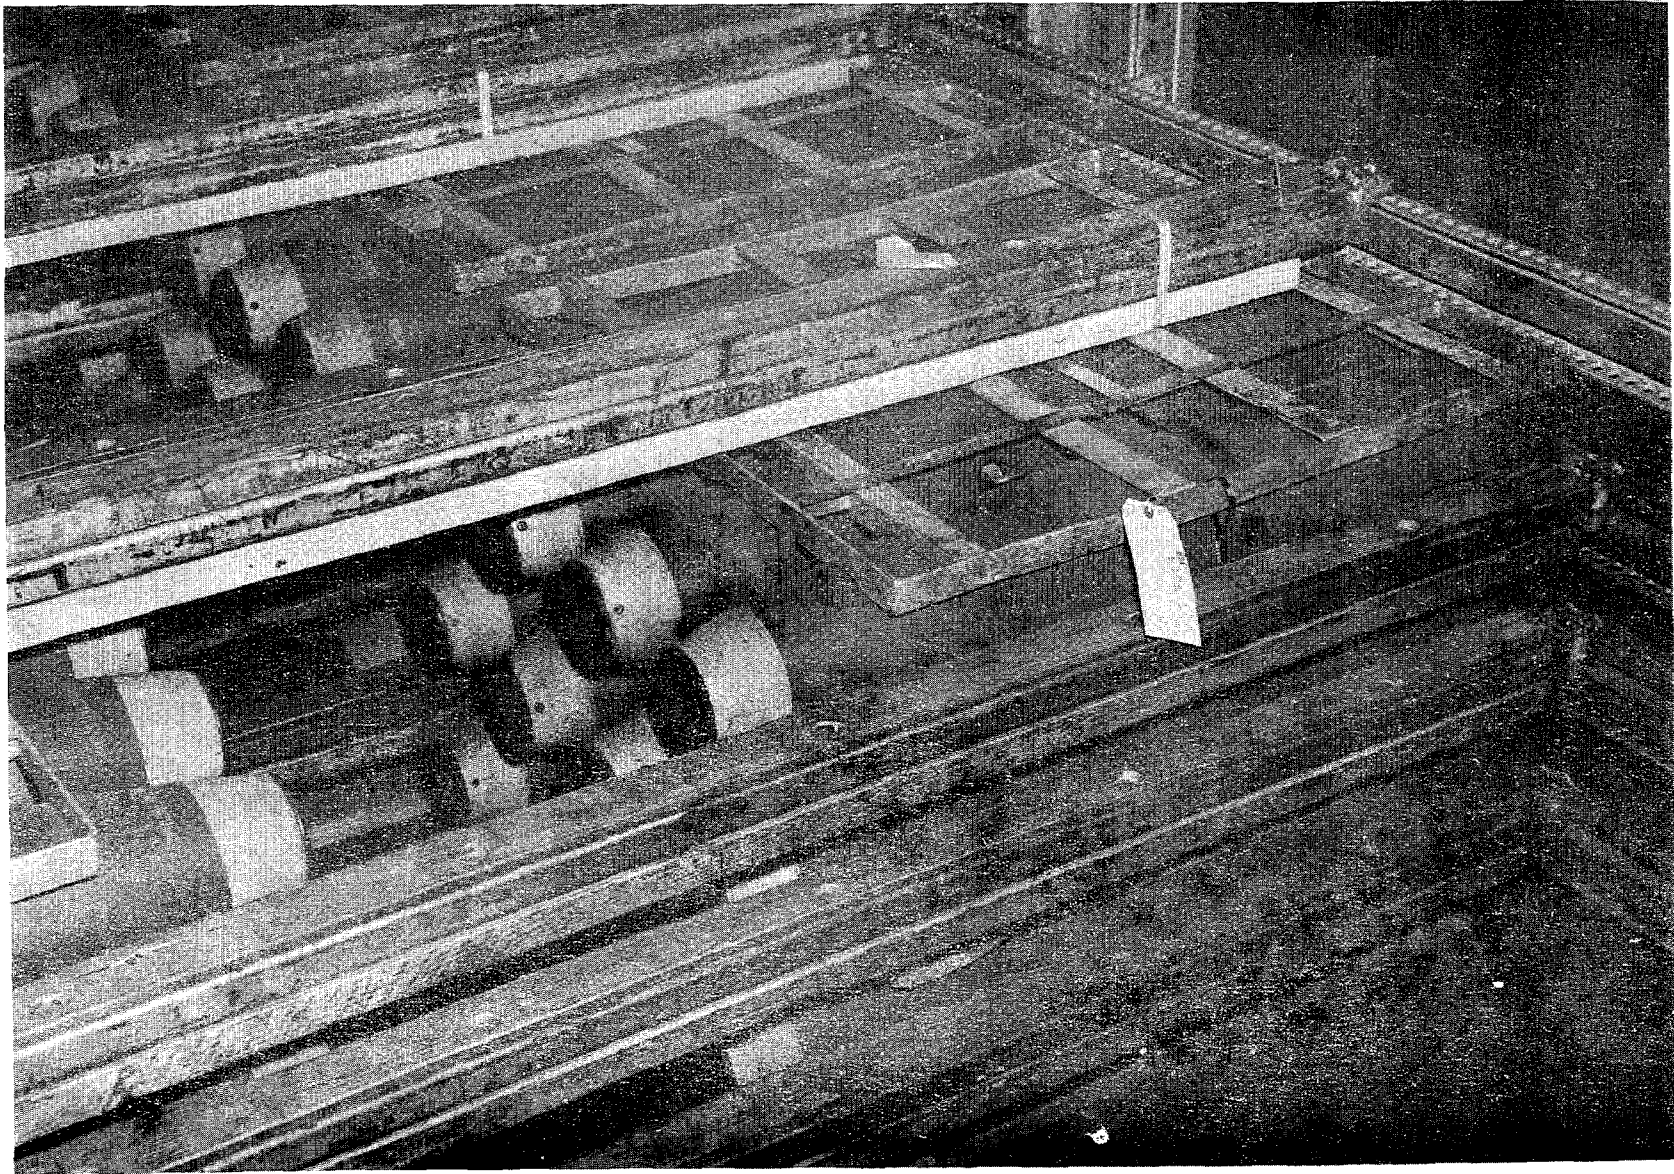
PLATE NO. 2

250-pound tritonal bombs secured in DODX box car by Evans DF-1 equipment.

Each car carried 336 unfuzed bombs loaded in 28 metal pallets. Each pallet contained 12 bombs. The pallets were loaded in two longitudinal rows inside the car, with the bomb noses facing the car centerline. The bombs were secured to the pallets with steel strapping. Evans DF-1 equipment was used to block and brace the load. Four bars were used to secure each set of two pallets. Each bar extended across the car, alongside a set of two pallets, and was secured at both ends to metal belt rails fixed to the inner side walls of the cars. See Plate 2 for method used to block and brace the load of bombs.
