# NATIONAL TRANSPORTATION SAFETY BOARD

## RAILROAD ACCIDENT REPORT

DERAILMENT OF SOUTHERN PACIFIC  
TRANSPORTATION COMPANY  
TRAIN NO. 01-BSMFF-05  
CARRYING RADIOACTIVE MATERIAL  
AT THERMAL, CALIFORNIA  
JANUARY 7, 1982

NTSB-RAR-83-1

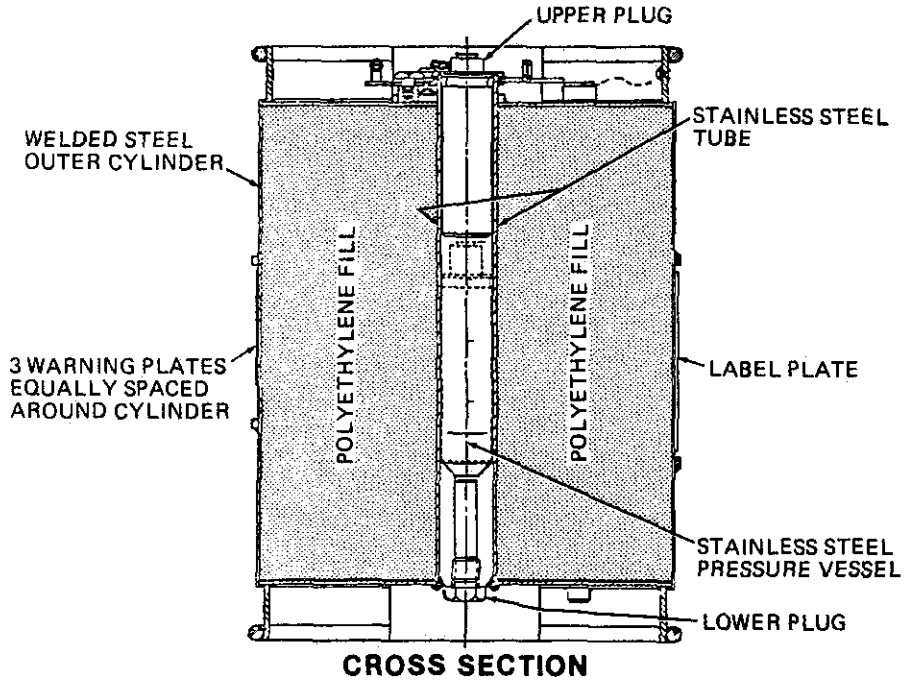
Figure 9.—RAM container.

During shipment, the RAM was enclosed in a container which had been certified for use by the U.S. Nuclear Regulatory Commission and the U.S. Department of Transportation. The container consisted of a welded mild steel closed cylinder, approximately 20.5 inches long and 17.3 inches in diameter. An inner 2-inch-diameter stainless steel tube containing a pressure vessel was centered in the cylinder. The interior void was filled with polyethylene, an absorbent shield for the radiation emitted by the RAM. The container's top closure was a plug secured by a locking scissors-type toggle arm assembly, and the bottom closure was a solid plug. The gross weight of this container was approximately 155 pounds. (See figure 9.) The stainless steel pressure vessel was approximately 7 inches long and 1 11/16 inches in diameter. The pressure vessel was designed to facilitate handling and to protect the RAM during the oil well explorations. The RAM was not intended to be removed from this pressure vessel during field operations. The third and innermost container contained the encapsulated radioactive material itself. This third double walled container was 4.835 inches long and 0.983 inches in diameter.
