RAILROAD ACCIDENT REPORT .

SOUTHERN RAILWAY COMPANY
TRAIN 154
DERAILMENT WITH FIRE AND EXPLOSION
LAUREL, MISSISSIPPI
JANUARY 25, 1969,

ADOPTED OCTOBER 6, 1969

U.S. NATIONAL TRANSPORTATION SAFETY BOARD,
DEPARTMENT OF TRANSPORTATION
WASHINGTON, D. C. 20591

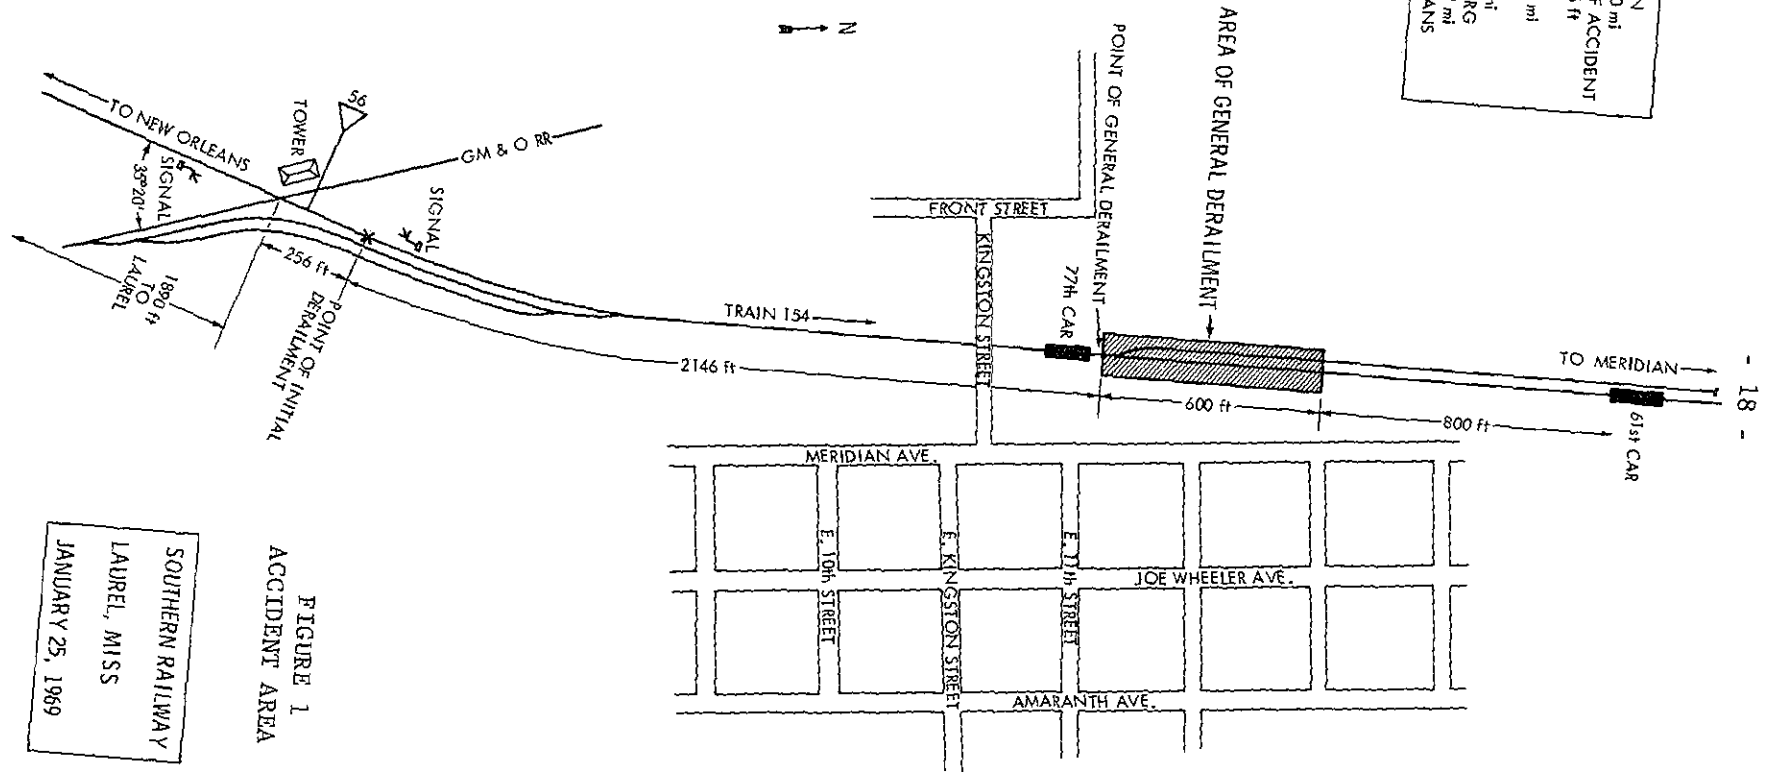
FIGURE 1
ACCIDENT AREA

The initial derailment occurred 256 feet north of the G M &O crossing, and the general derailment and resulting wreck occurred at the facing point switch 2, 402 feet north of the crossing. (See the diagrammatic sketch, Figure 1, on page 18)

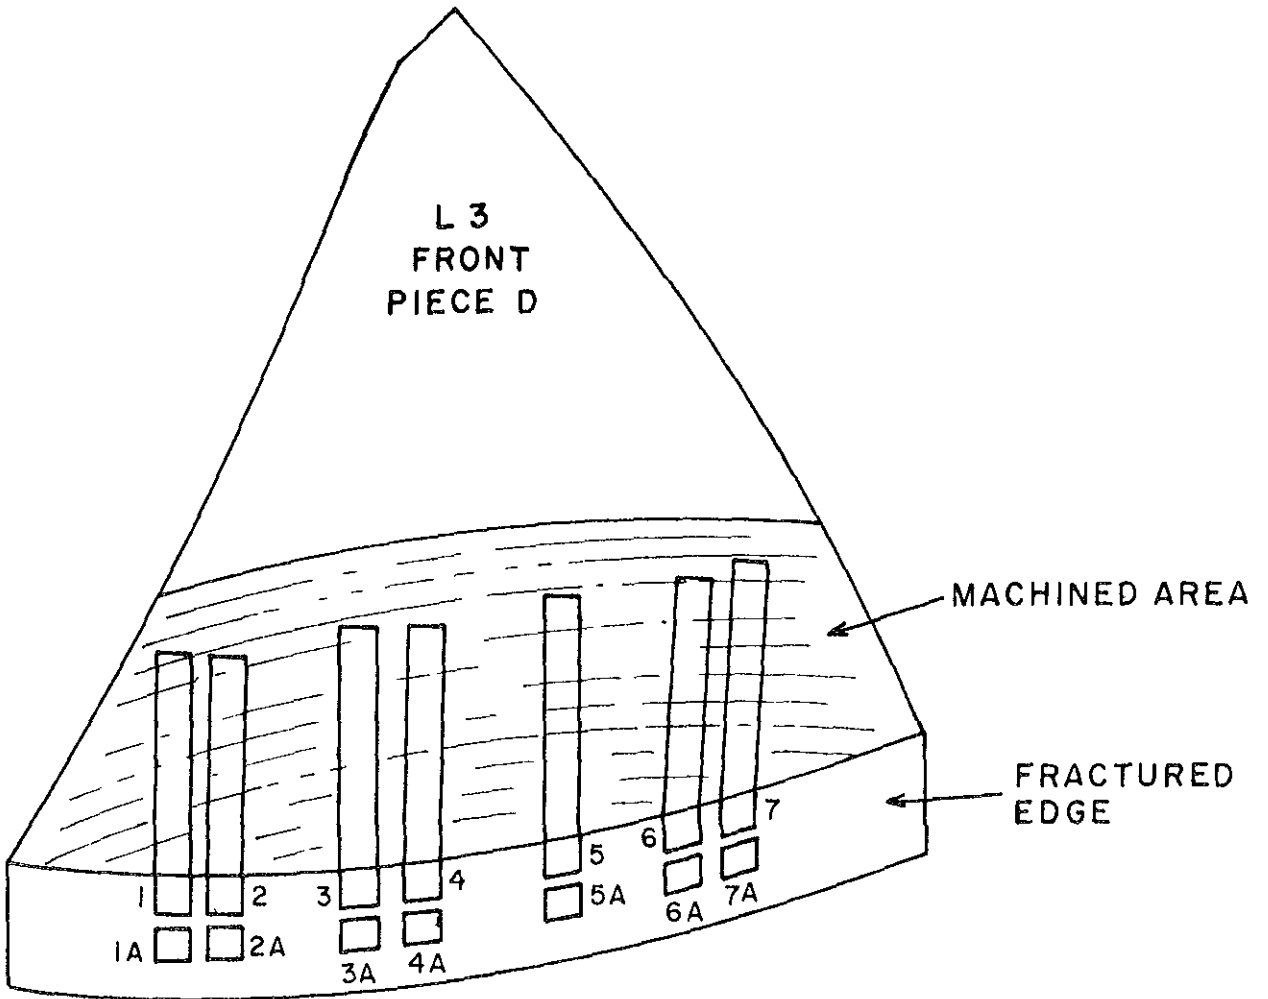
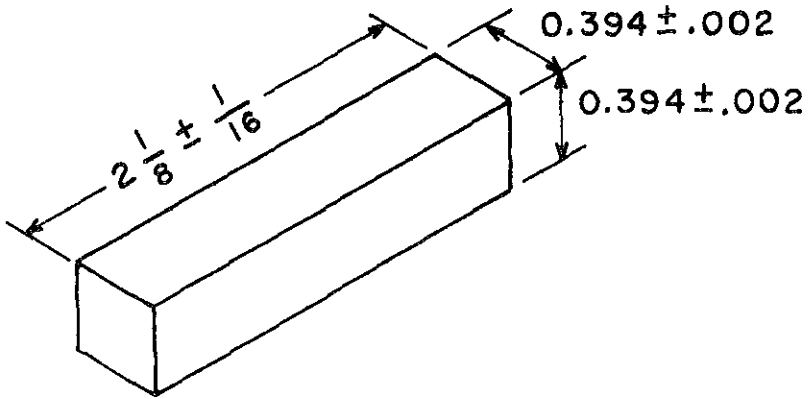
Fig. 10 - Schematic Diagram of Test Piece Locations.

IITRI performed Charpy impact tests on 14 specimens from piece D of the L-3 wheel. Seven of the Charpy specimens had the rough machining on one surface and seven were ground smooth on all surfaces. (See Figure 10, page 41.) Charpy tests were made at temperatures of 75°F., 32°F., and 0°F.

Results of these tests indicated that the specimens with the fine-machined surfaces had not entered the transition stage of 0°F. The rough-machined finish caused the transition to be far advanced

at 0°F., showing that the rough surface behaved like a relatively sharp notch with consequent reduction in the ability to resist impact.
