RAILROAD ACCIDENT INVESTIGATION

REPORT NO. 4160

SOUTHERN RAILWAY COMPANY

OCTOBER 26, 1969

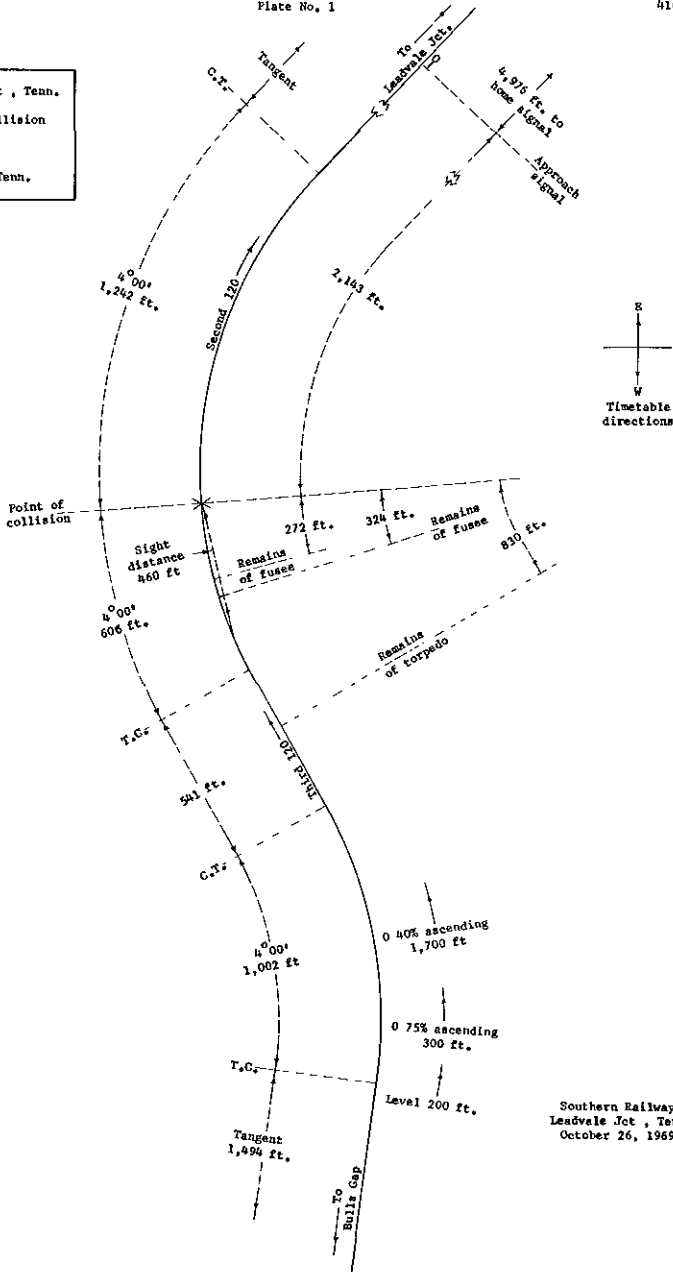
PLATE NO. 2

Because of track curvature and trees along both sides of the railroad, the maximum range of vision between a caboose standing at the collision point and an approaching eastbound locomotive is 460 feet (see Plate No. 2).
