NATIONAL TRANSPORTATION SAFETY BOARD

RAILROAD ACCIDENT REPORT

**SIDE COLLISION OF
SOUTHERN RAILWAY COMPANY
TRAINS NOS. 1 AND 152
SPENCER, NORTH CAROLINA
OCTOBER 8, 1977**

REPORT NUMBER: NTSB-RAR-78-3

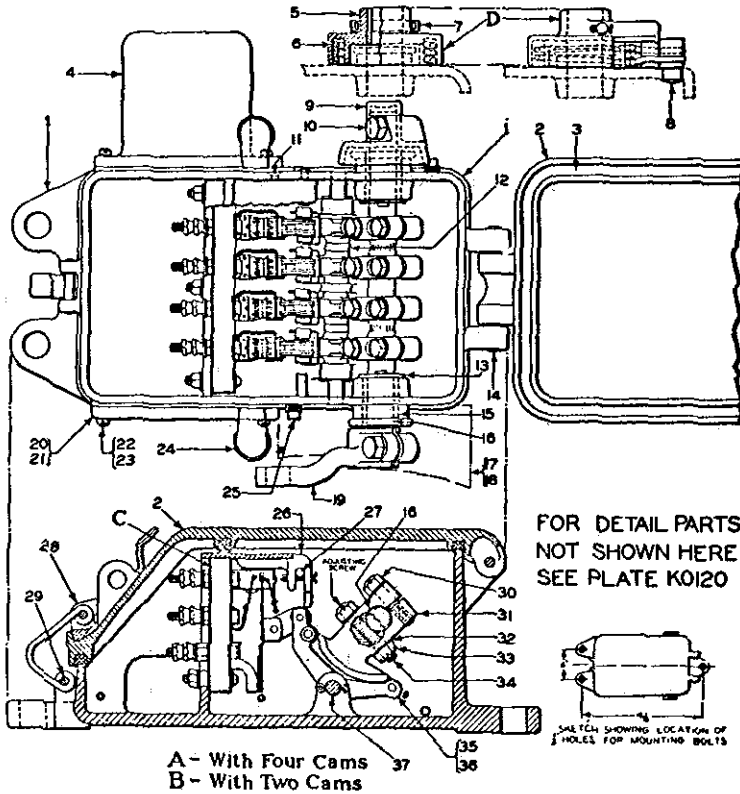
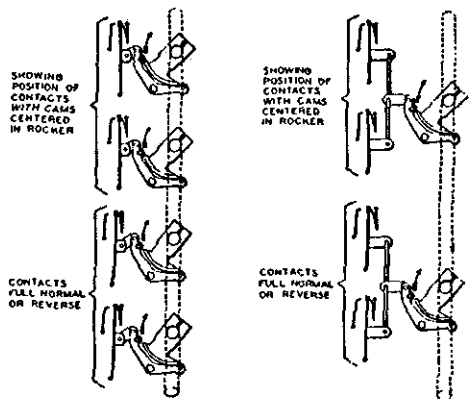
The circuit controller, a General Railway Signal (GRS) model 5, was tested in its installed position on October 8, 1976, and on a test bench on October 12, 1977. (See Appendix C.) The postaccident inspection disclosed that the box was undamaged. It was securely and properly mounted and neither the switch points nor the rods attached to the controller were damaged. Before the circuit controller was removed from service, a signal supervisor observed that one contact appeared not to close properly; the supervisor could not identify the contact later, however. (See figure 3.)

ARRANGEMENT OF CAMS AND CONTACTS IN FIG A

ARRANGEMENT OF CAMS AND CONTACTS IN FIG B
