RAILROAD ACCIDENT INVESTIGATION

REPORT NO. 4174

SOUTHERN RAILWAY SYSTEM

OCTOBER 24, 1970

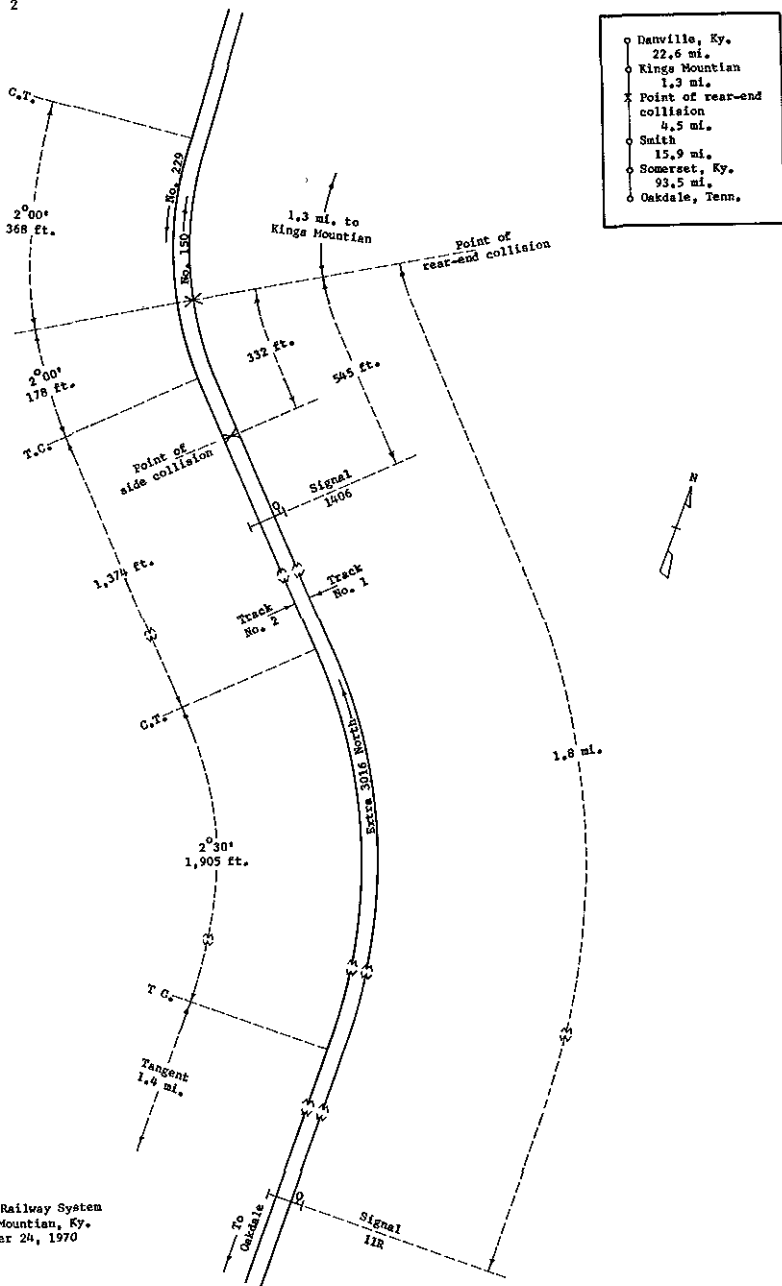
caboose, were derailed. The derailed cars jackknifed from the train and stopped on the east side of track No. 1. The caboose overturned on one side, and stopped on an embankment on the east side of track No. 1 (see following photograph). The caboose and two of the derailed cars were destroyed or heavily damaged.
