INTERSTATE COMMERCE COMMISSION
WASHINGTON

ACCIDENT ON THE
ST. LOUIS-SAN FRANCISCO RAILWAY

QUINCY, MISS.

INVESTIGATION NO. 2332

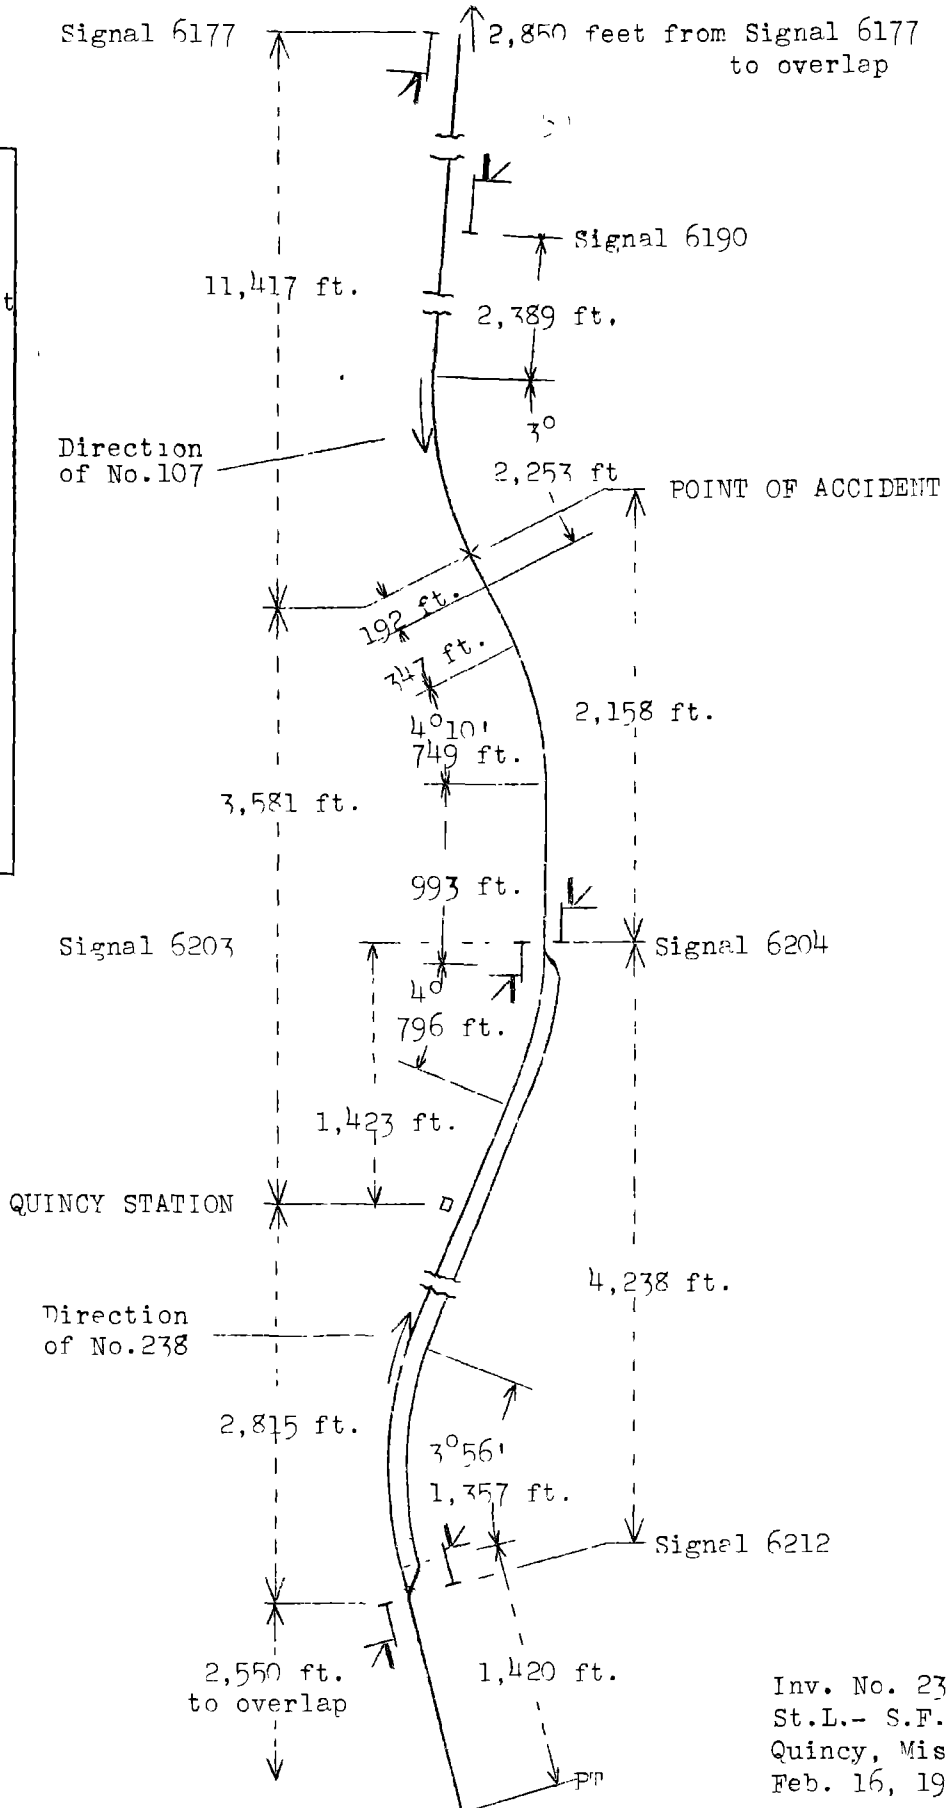
Inv. No. 2332
 St.L.- S.F. R.R.
 Quincy, Miss.
 Feb. 16, 1939

Signals 6212 and 6204, governing north-bound movements, are located 6,396 and 2,158 feet, respectively, south of the point of accident, and signal 6177, an intermediate signal governing south-bound movements, is located 11,417 feet north of the point of accident. The overlap for signal 6204 extends to a point 2,850 feet north of signal 6177; when a south-bound train passes that point, signal 6204 displays a stop indication and signal 6212 displays an approach indication. When a north-bound train reaches a point 2,550 feet south of signal 6212, signal 6203, located at the north siding switch at Quincy, displays a stop indication, and signal 6177 displays an approach indication.
