RAILROAD ACCIDENT INVESTIGATION

REPORT NO. 4161

THE TEXAS AND PACIFIC RAILWAY COMPANY

MARCH 3, 1969

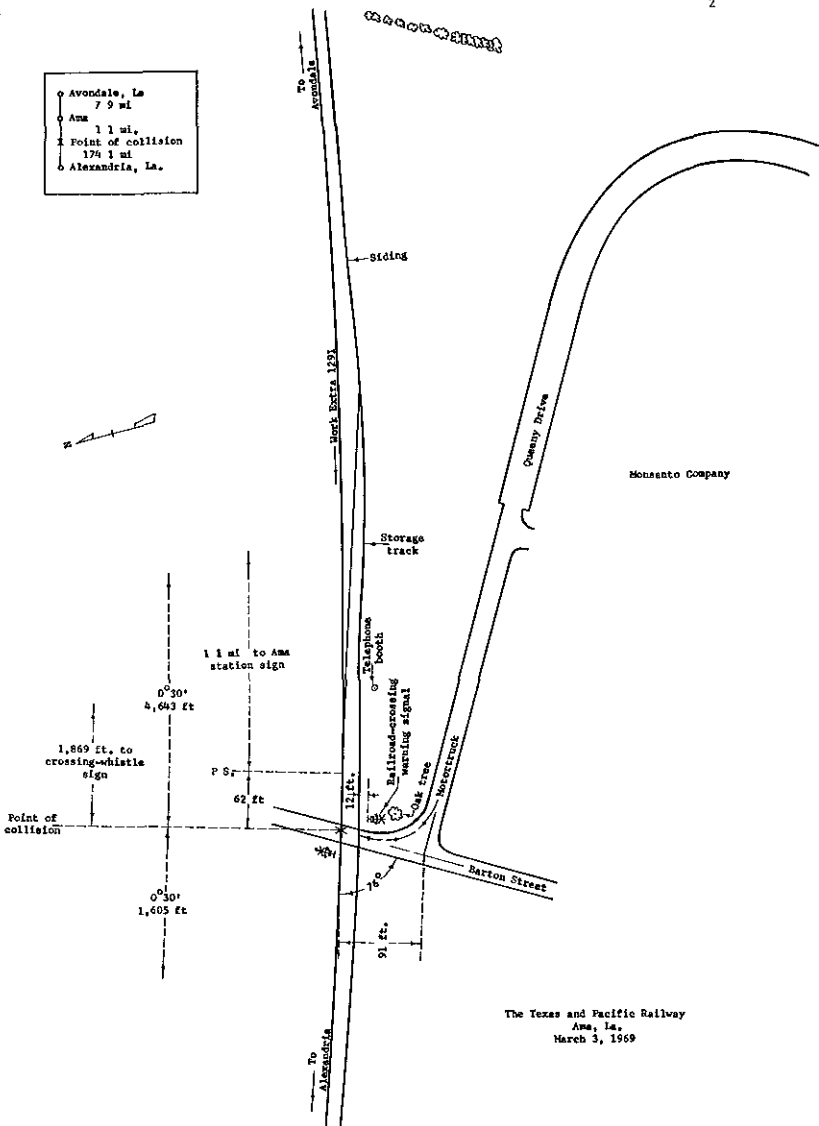
The Texas and Pacific Railway
Ama, La.
March 3, 1969

The collision occurred on the main track, 1.1 miles west of the Ama station, where the main track and auxiliary track are crossed at grade by Barton Street, a private road.

From the east on the main track there is a 0°30' curve to the right 4643 feet to the Barton Street crossing and 1605 feet westward. The grade in this area is practically level.

- Avondale, La
7.9 mi
- Ama
1.1 mi.
- × Point of collision
174.1 mi
- Alexandria, La.
