RAILROAD ACCIDENT INVESTIGATION

REPORT NO 4072

THE TEXAS AND PACIFIC RAILWAY COMPANY

DECEMBER 24, 1965

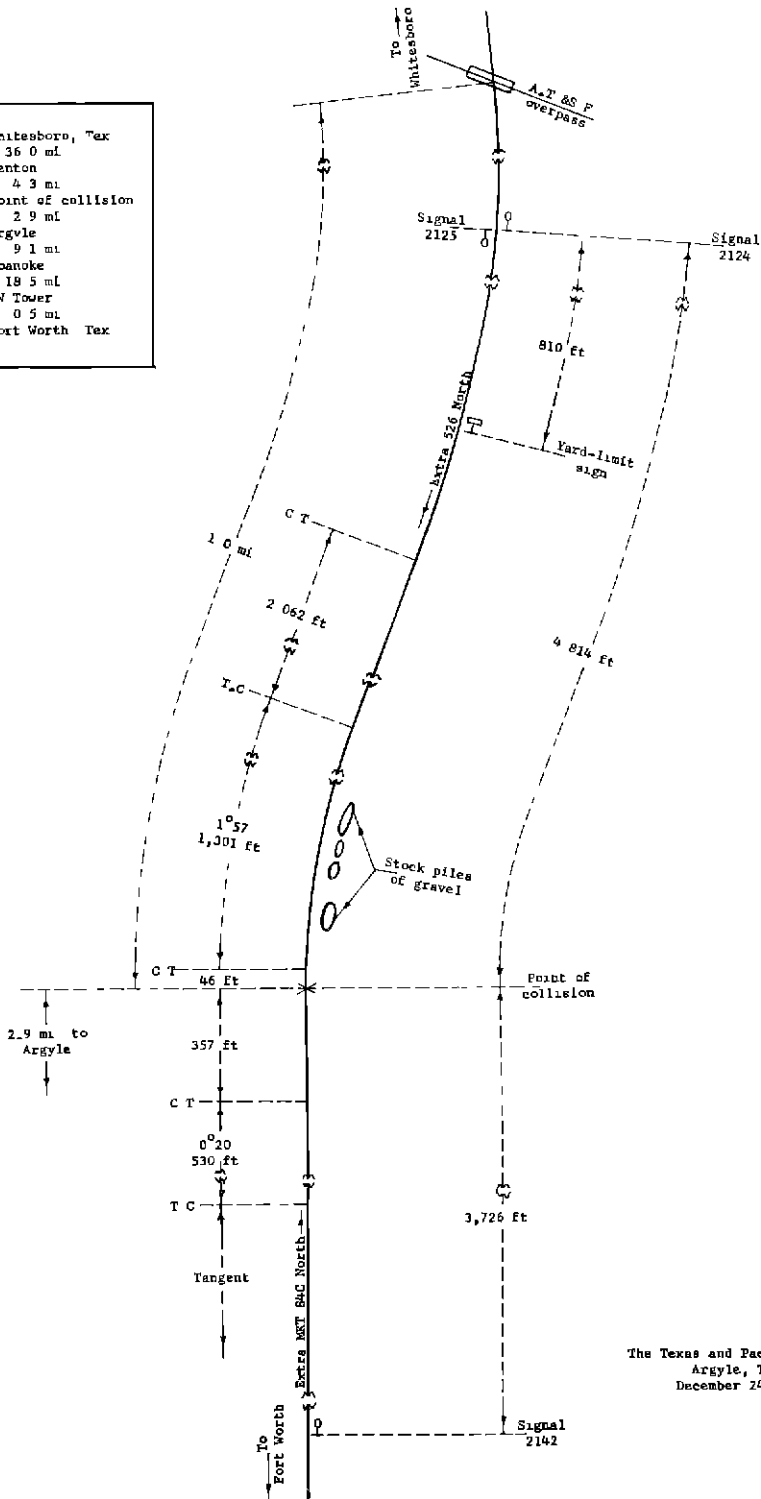
- Whitesboro, Tex
36.0 mi
- Denton
4.3 mi
- ✕ Point of collision
2.9 mi
- Argyle
9.1 mi
- Roanoke
18.5 mi
- FW Tower
0.5 mi
- Fort Worth, Tex
