# NATIONAL TRANSPORTATION SAFETY BOARD

## RAILROAD ACCIDENT REPORT

REAR-END COLLISION OF  
UNION PACIFIC RAILROAD COMPANY  
FREIGHT TRAINS  
NEAR HERMOSA, WYOMING  
OCTOBER 16, 1980

NTSB-RAR-81-3

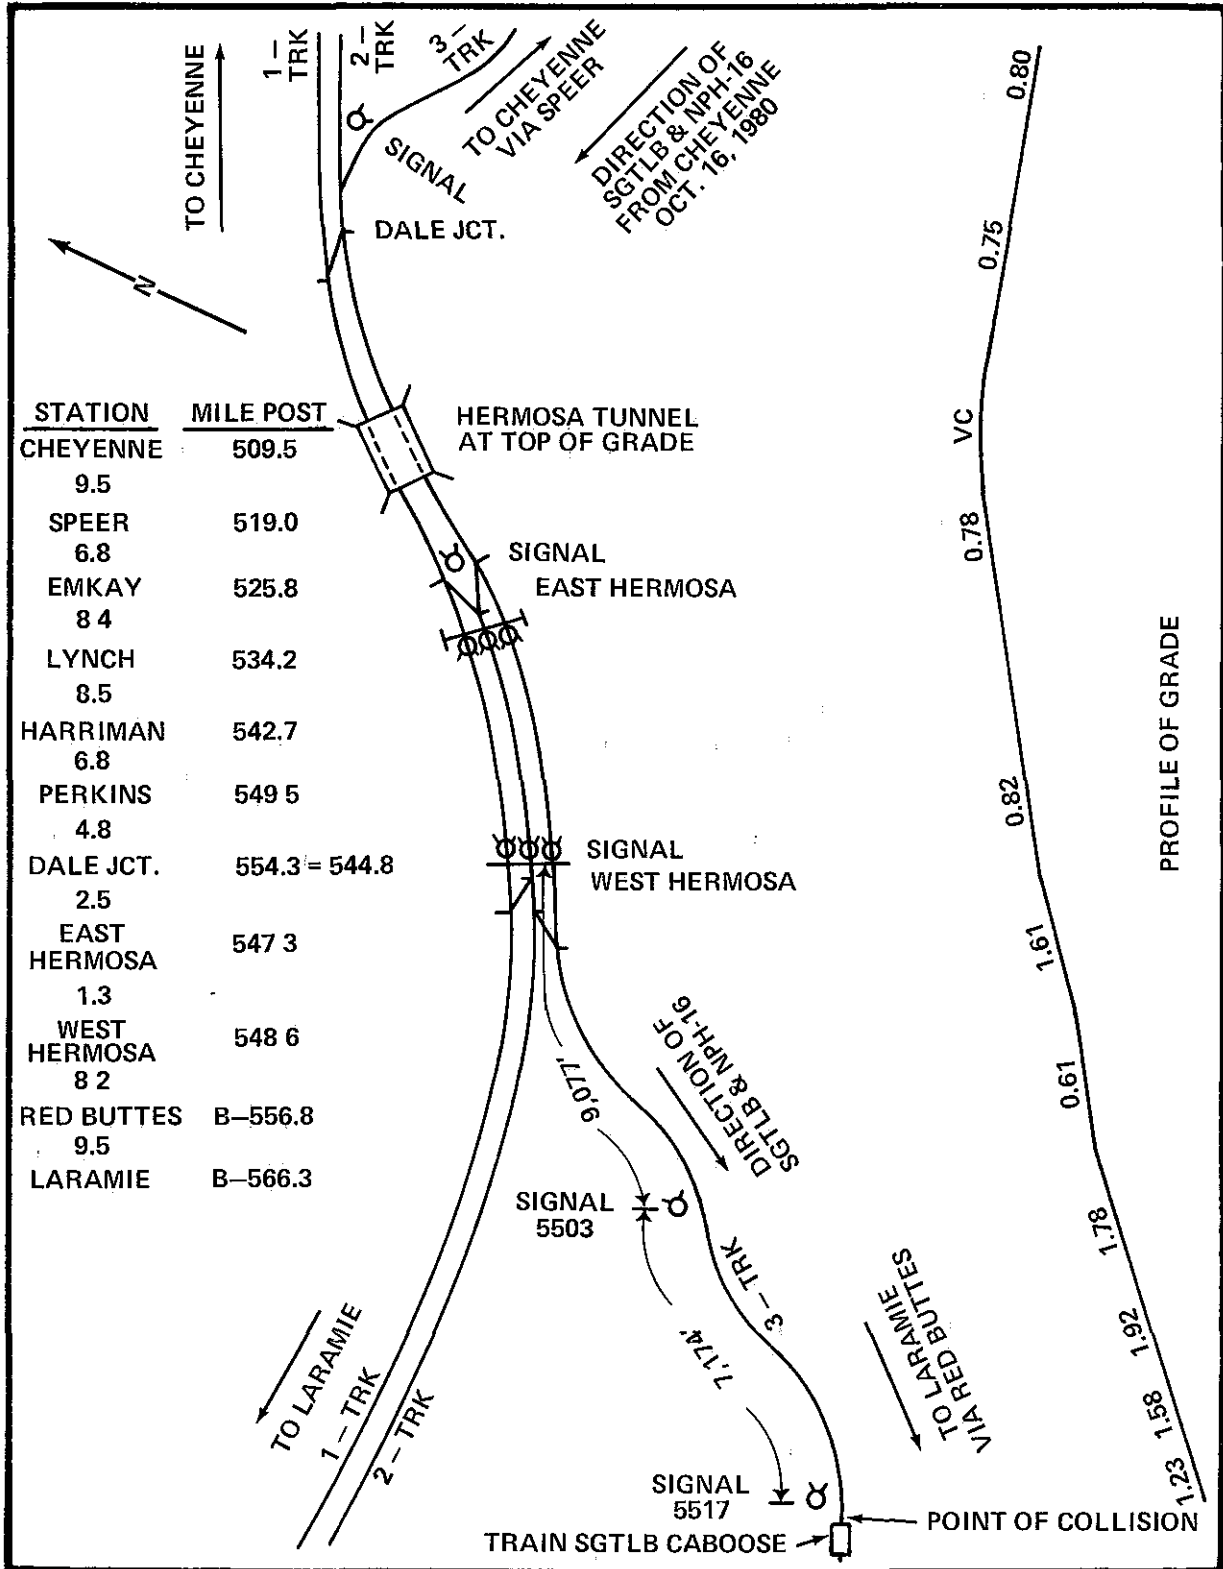
Figure 1.--Sketch of Hermosa area track alignment and grade.

On October 16, 1980, Union Pacific Railroad Company (UP) westbound grain train Extra 3557 West (SGTLB-635), consisting of 3 locomotive units, 76 loaded cars, and a caboose, departed Cheyenne, Wyoming, at 10 a.m. for Rawlins, Wyoming. Between Cheyenne and Dale Junction, Wyoming, SGTLB-635 operated over main track No. 3. At Dale Junction, SGTLB-635 was routed by the dispatcher onto the No. 2 track as it continued to East Hermosa, Wyoming. (See figure 1.)
