**RAILROAD ACCIDENT INVESTIGATION**

**Report No 4039**

UNION PACIFIC RAILROAD COMPANY

RAWLINS, WYO

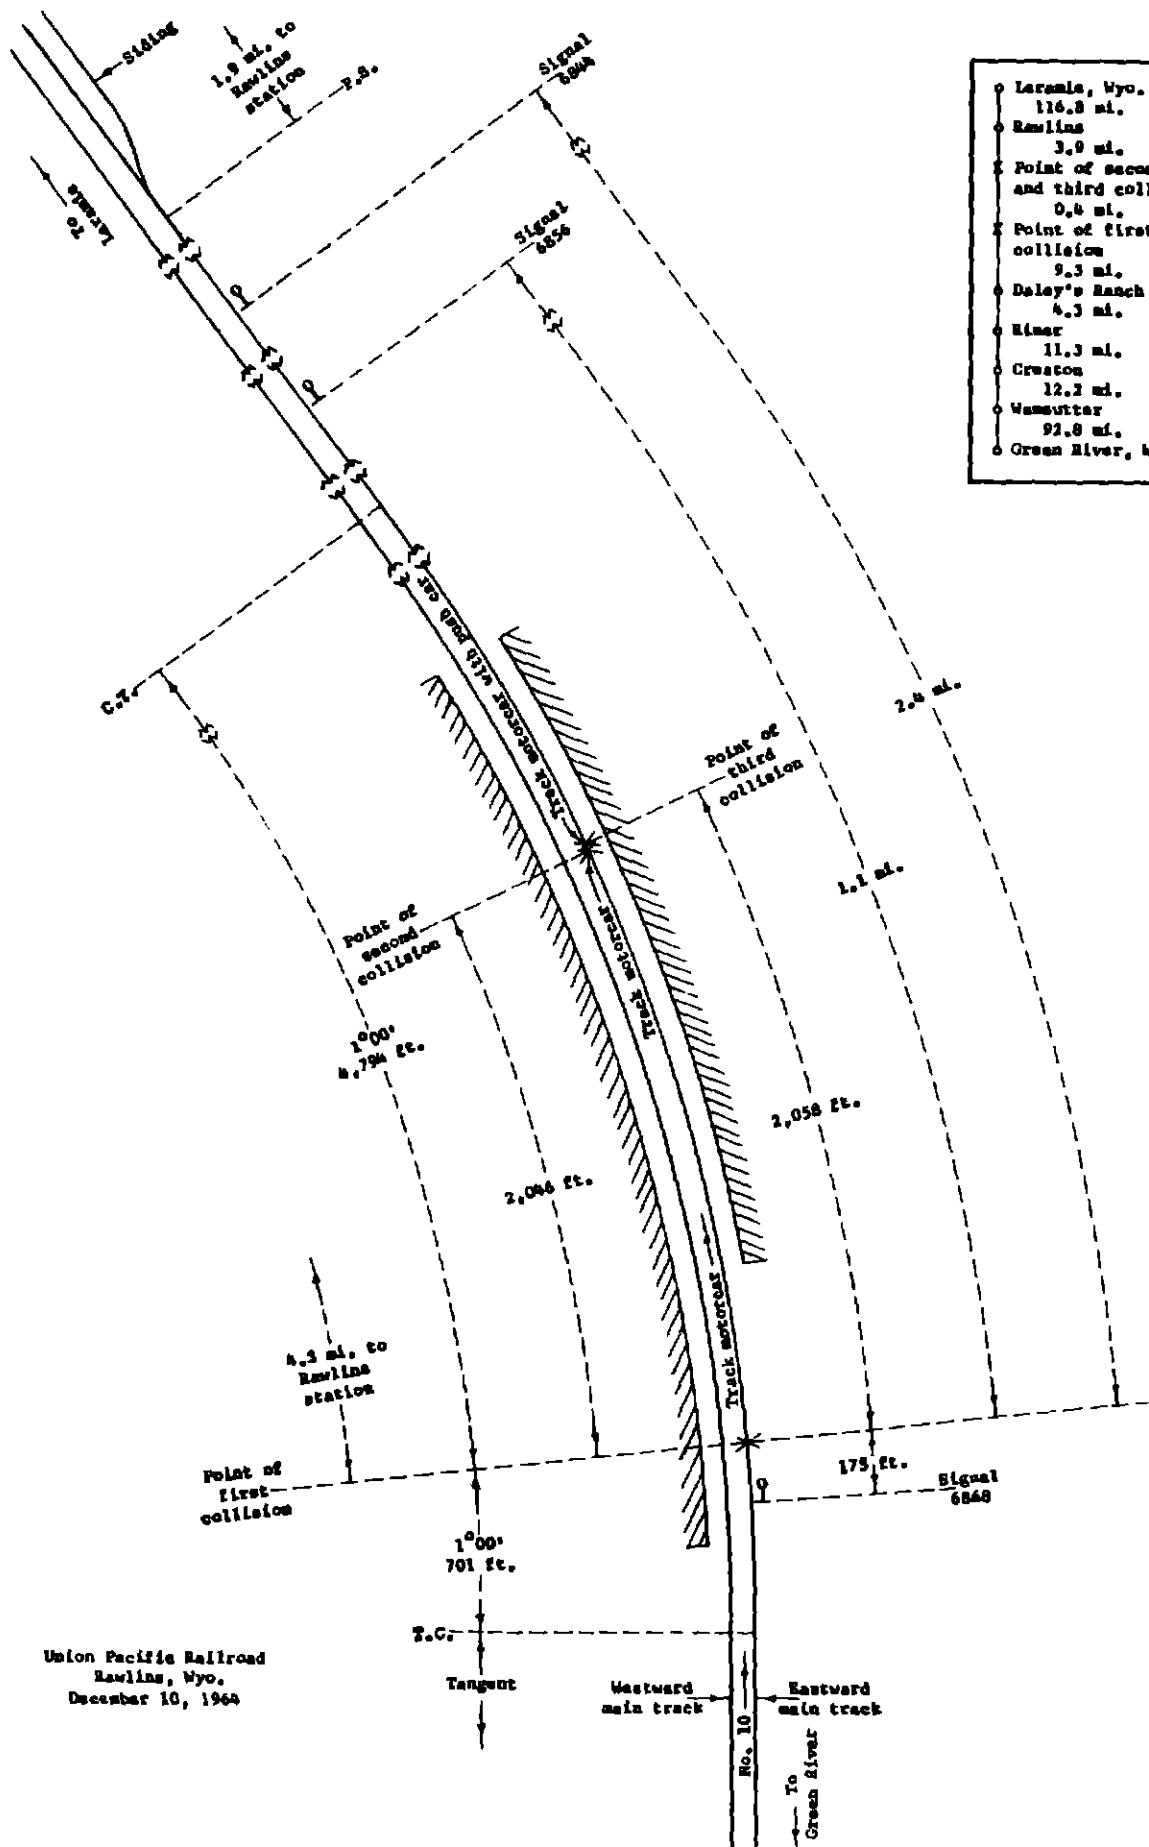
*Eastward main track and signal 6868 at right First collision occurred on eastward main track 175 feet east of signal 6868 Second and third collision occurred in cut and curve farther eastward*
