INTERSTATE COMMERCE COMMISSION

REPORT OF THE CHIEF OF THE DIVISION OF SAFETY, COVERING THE INVESTIGATION OF AN ACCIDENT WHICH OCCURRED ON THE BALTIMORE & OHIO RAILROAD NEAR QUAKER CITY OHIO, ON FEBRUARY 20, 1917

AUGUST 20, 1917

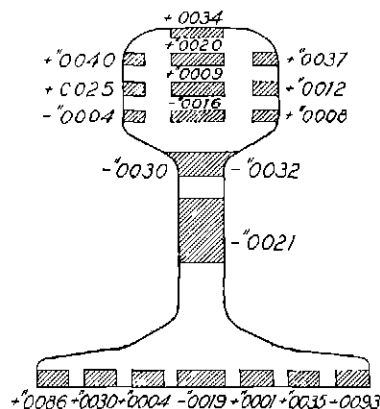
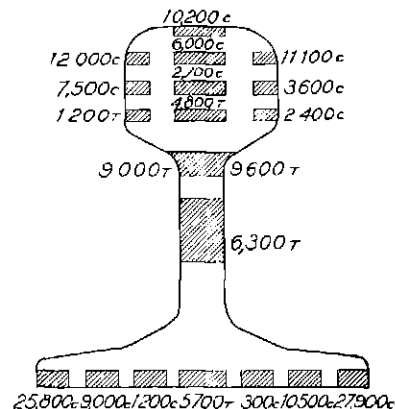
Diagram No. 14 shows the results of the examination of a companion rail of the same weight as before, after accelerated cooling, accomplished by means of an air blast directed upon the head. The cooling was done immediately after the last pass in the rail mill. The manner of dissection was nearly the same as in the previous example, measurements being taken at each stage. Accelerated cooling caused the introduction of higher strains throughout the cross section than witnessed in the section of normal rate of cooling. The

Diagram No. 14 —Cross section of a new 92.7 pound rail. Internal strains and stresses after accelerated cooling with air blast on head of rail was dissevered, with stresses corresponding to total strains released.
