## INTERSTATE COMMERCE COMMISSION

### REPORT OF THE DIRECTOR OF THE BUREAU OF SAFETY IN RE INVESTIGATION OF AN ACCIDENT WHICH OCCURRED ON THE CHICAGO, MILWAUKEE & ST PAUL RAILWAY NEAR SACRED HEART, MINN., ON NOVEMBER 15, 1925

DECEMBER 10, 1925

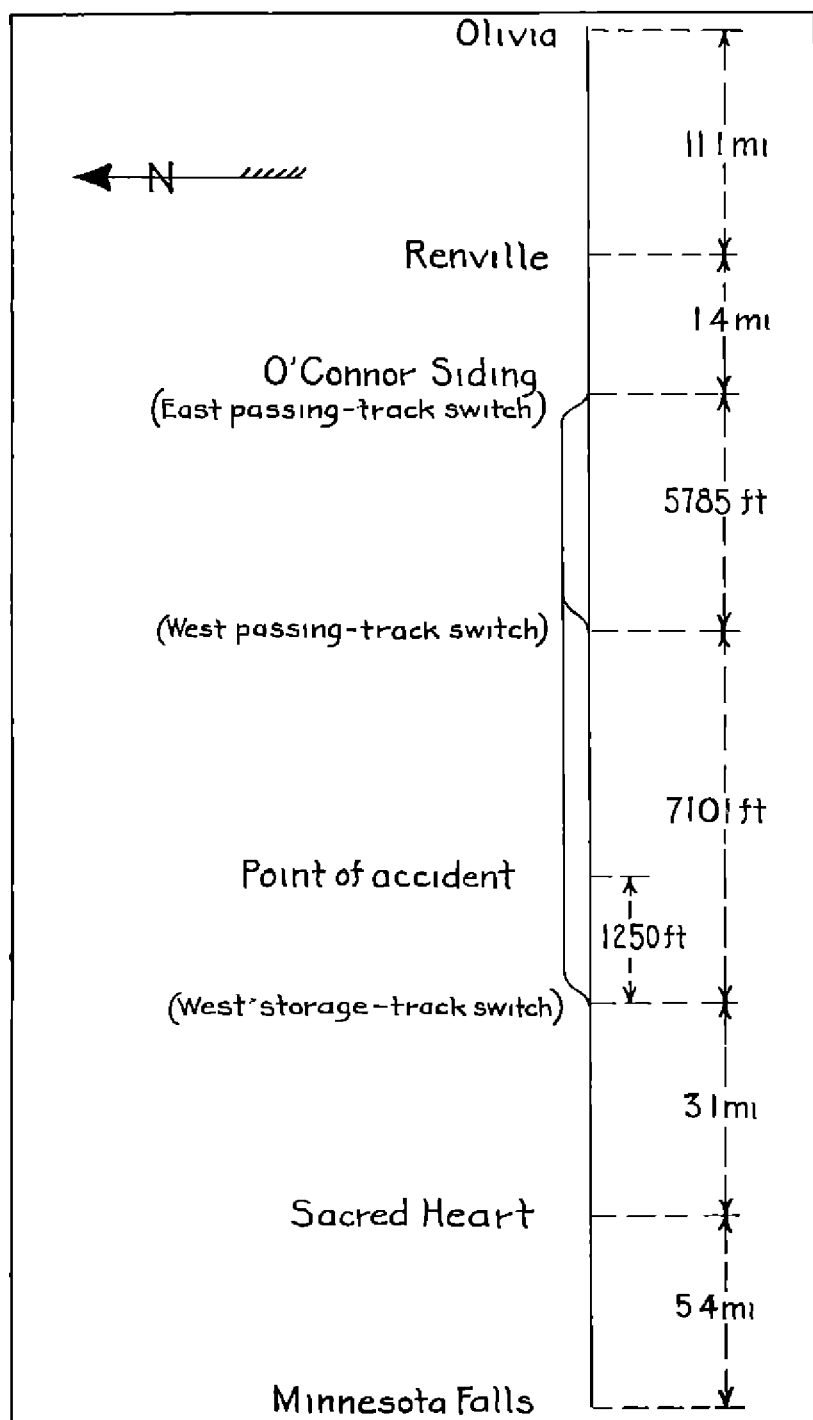
Between Sacred Heart and Renville, a station 6.9 miles east of Sacred Heart, there is a sidetrack more than 2 miles in length, which is shown on the time-table as O'Connor Siding; the eastern end of this sidetrack is 1.4 miles from Renville. At a point 5,785 feet west of the east sidetrack switch there is a crossover connecting with the main track, while the west sidetrack switch is 7,101 feet west of the crossover. That part of the sidetrack west of the crossover is used as a storage track while that part east of the crossover is used as a passing track. The switch at the extreme western end of O'Connor Siding will be referred to in this report as the west storage-track switch. The point of accident was on the main track.

Diagram showing relative location of points mentioned in this report
