# INTERSTATE COMMERCE COMMISSION

## REPORT OF THE CHIEF OF THE DIVISION OF SAFETY COVERING THE INVESTIGATION OF AN ACCIDENT ON THE CHICAGO, ST PAUL, MINNEAPOLIS & OMAHA RAILWAY NEAR BIGELOW, MINN., ON FEBRUARY 9, 1914

NOVEMBER 5, 1914

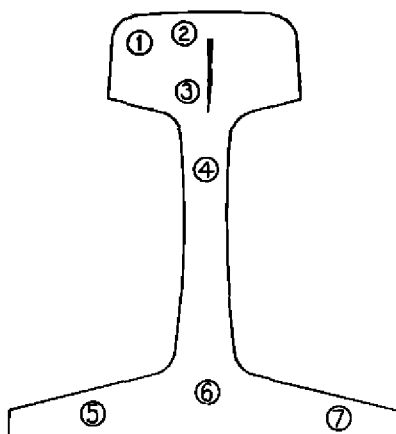
Hardness numeral in kilograms required for a 0.1 millimeter indentation (10 millimeters diameter ball), for positions						
	1	2	3	4	5	6	7
East end	749	772	834	931	644	672	658
West end	755	768	818	814	672	724	680

Diagram showing places on the cross section of the rail where hardness tests were made

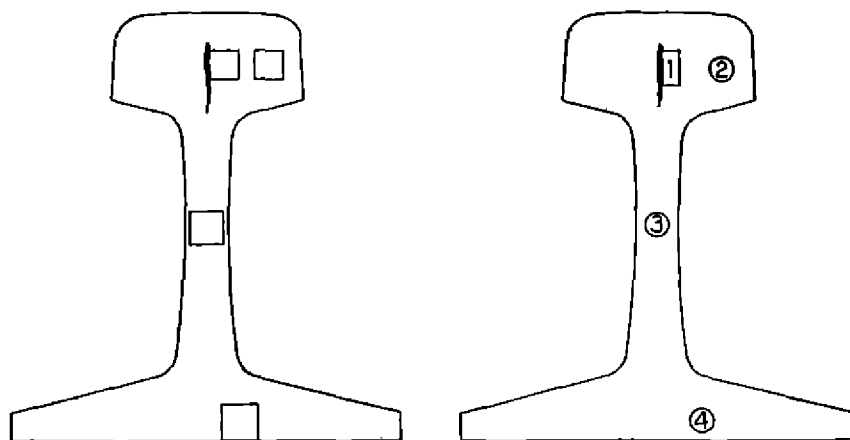
Though the percentage of carbon varies noticeably in the central and outer portions of the rail, the variation does not differ much from that allowed by most standard specifications for Bessemer rails of this weight. The phosphorus content of the inner portions of the rail is considerably above the maximum specified for rails of this type and weight (0.10)

Diagram on the left indicates position of specimens for microscopic examination, that on the right side the position of samples used in the chemical analysis of the metal
