REPORT OF ACCIDENT ON
THE GREAT NORTHERN RAILWAY NEAR
SHARON, N. DAK., DECEMBER 30, 1911

BY THE CHIEF INSPECTOR OF
SAFETY APPLIANCES

REPORT OF THE ENGINEER-PHYSICIST OF THE
BUREAU OF STANDARDS

REPORT OF THE CHIEF INSPECTOR OF SAFETY APPLIANCES COVERING HIS INVESTIGATION OF AN ACCIDENT WHICH OCCURRED ON THE GREAT NORTHERN RAILWAY NEAR SHARON, N DAK, DECEMBER 30, 1911, ACCOMPANIED BY REPORT OF THE ENGINEER-PHYSICIST OF THE BUREAU OF STANDARDS COVERING HIS INVESTIGATION OF THE BROKEN RAIL CAUSING THIS ACCIDENT

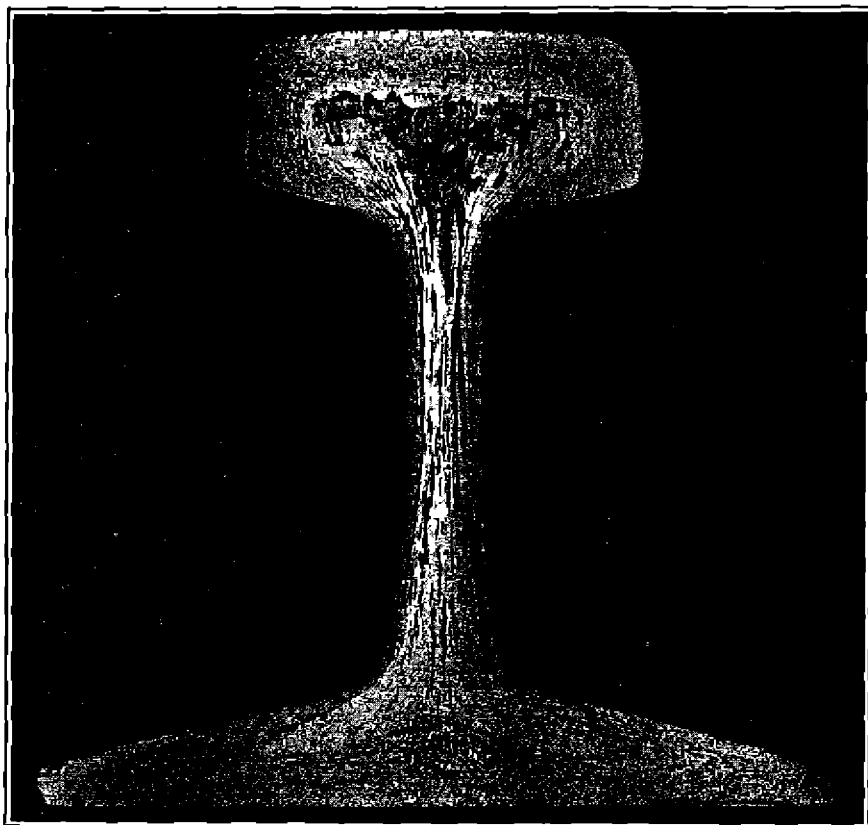
FIG 22—Etched cross section of a rail, rolled from an ingot which was laid on its side to cool, head side of rail up. Reproduced cut from earlier rail tests.

The ingot from which the rail, shown by figure 22, was rolled, was laid upon its side to cool after stripping, with the side up which formed the head of the finished rail, while the ingot from which the section shown by figure 23 was rolled was laid down with the side up which formed the web of the rail. The orientation of the markings was accordingly modified as witnessed in the cuts

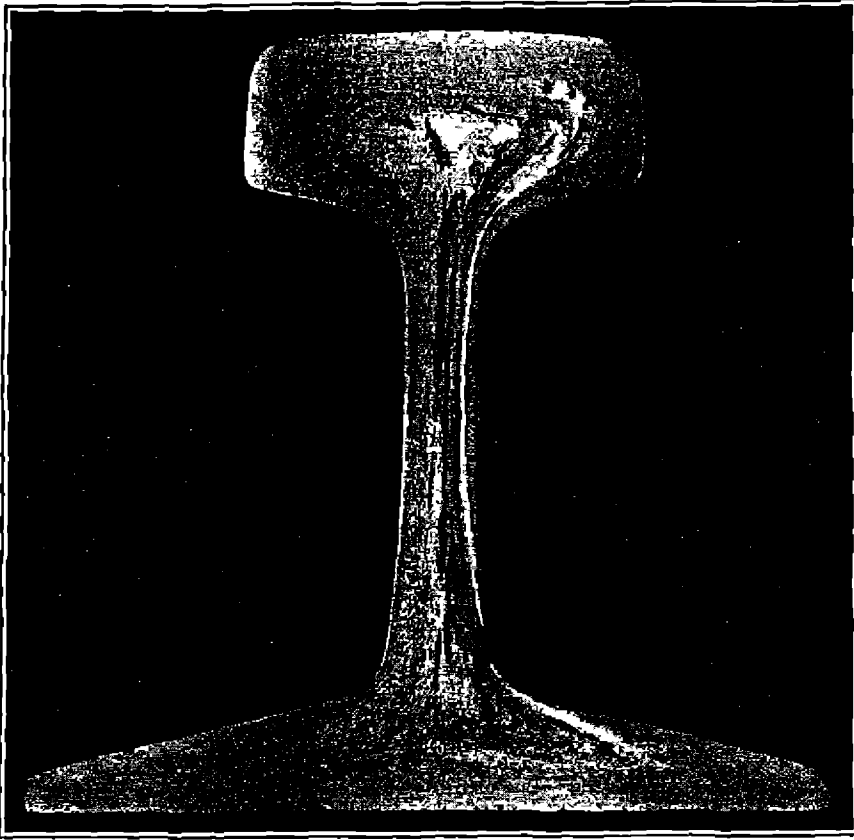
FIG 23—Etched cross section of a rail rolled from an ingot which was laid on its side to cool web side of rail up. Reproduced cut from earlier rail tests

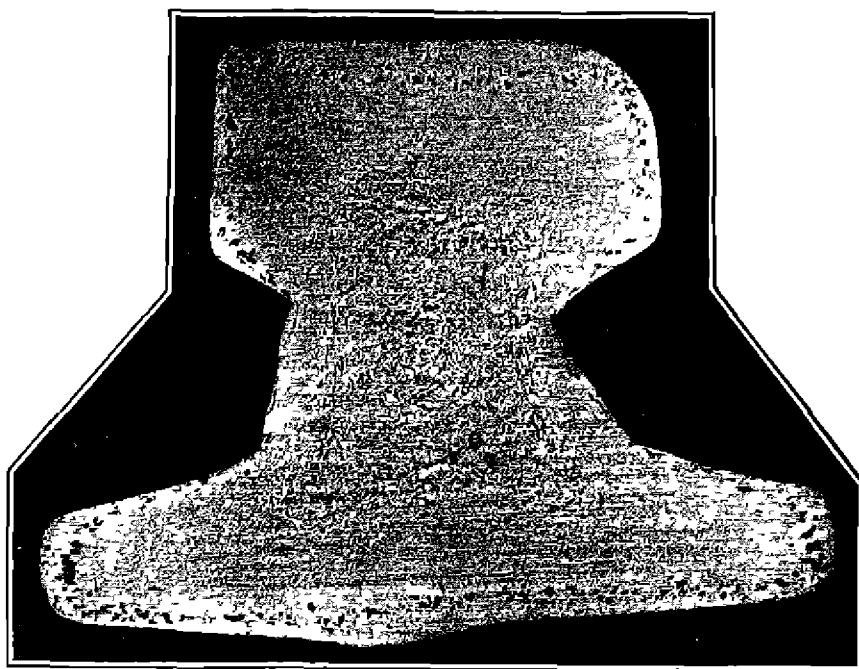
Figure 24 shows the section of an open-hearth steel rail ingot after the seventh roughing pass. This section was taken near the middle of the height of the ingot, or 52 per cent from the top. The markings are in kind not unlike those which are witnessed on the cross sections of finished rails.

FIG 24 —Etched cross section of shape after the seventh roughing pass. Open hearth rail steel. Reproduced cut from earlier rail tests.
