INTERSTATE COMMERCE COMMISSION

REPORT OF THE DIRECTOR OF THE BUREAU OF SAFETY IN RE INVESTIGATION OF AN ACCIDENT WHICH OCCURRED ON THE LINE OF THE KEY SYSTEM TRANSIT COMPANY AT OAKLAND, CALIF., DECEMBER 4, 1924

JANUARY 12, 1925

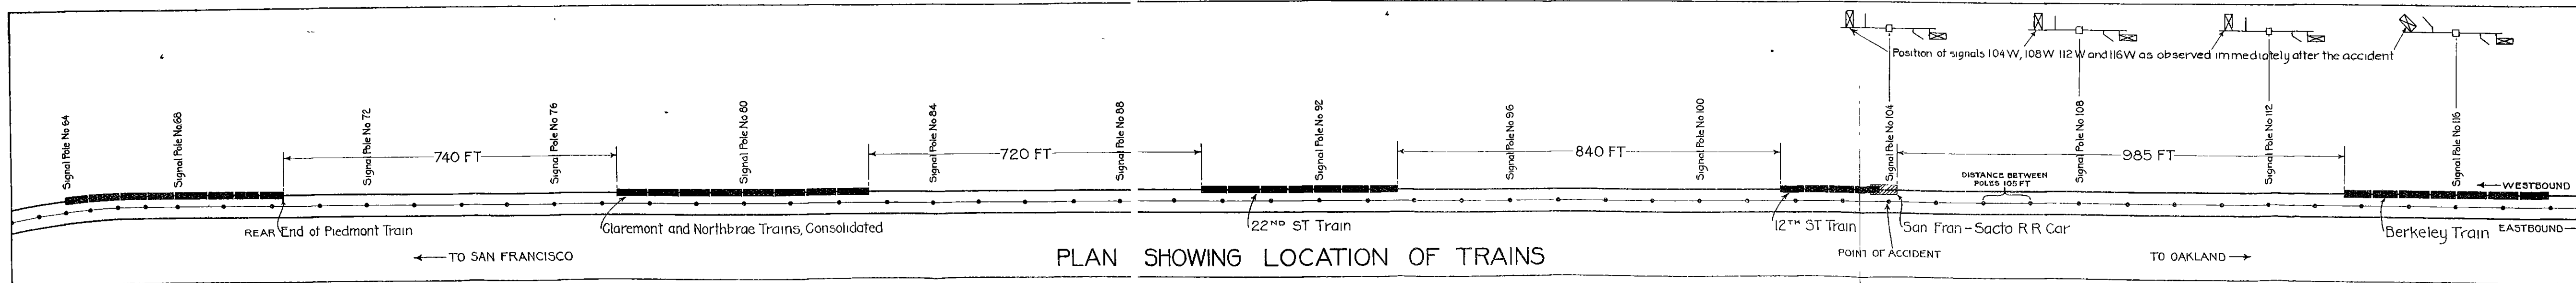
Signal 104 is located 11,321 feet west of signal 46 at tower No. 2. Approaching the point of accident from signal 46 the track is tan-

gent for a distance of 6,197 feet, then there is a 30' curve to the right 633 72 feet in length, followed by 4,491 feet of tangent to signal 104, the tangent extending a considerable distance beyond that signal. The accident occurred practically opposite signal 104, located at a point about 1½ miles east of the Pier Terminal, at about 7 54 a. m.
