INTERSTATE COMMERCE COMMISSION

REPORT OF THE DIRECTOR OF THE BUREAU OF SAFETY IN RE INVESTIGATION OF AN ACCIDENT WHICH OCCURRED ON THE ST LOUIS-SAN FRANCISCO RAILWAY NEAR VICTORIA, MISS, ON OCTOBER 27, 1925¹

JUNE 16 1927

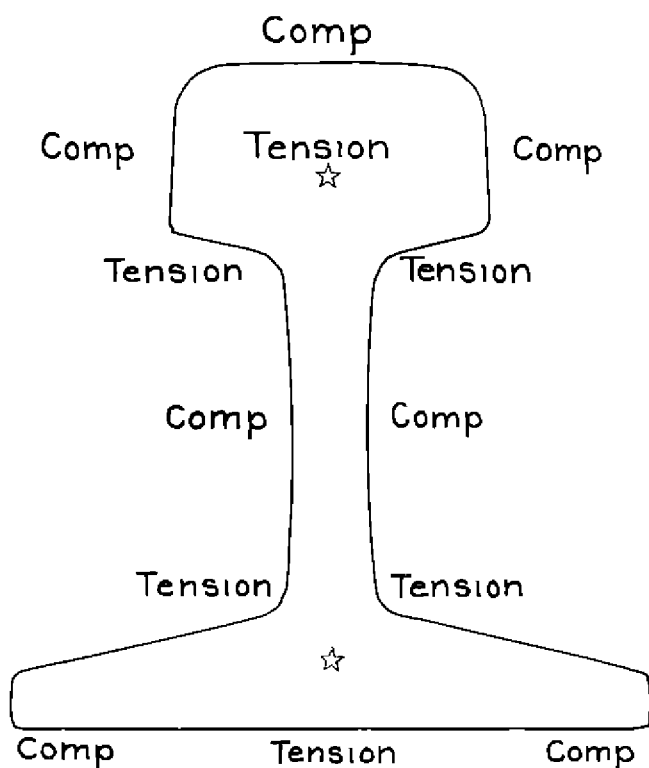
Placed within the outlines of the rail as shown by Figure No. 15, are stars indicating the location of zones where shrinkage cracks occur. At some period during the operation of cooling, internal strains of tension are set up, which occasionally are of sufficient magnitude to cause interior cracks in the rail at these two zones. It

FIG. 15 --Locations of strains of compression and tension in rails of normal cooling. Stars indicate zones where shrinkage cracks occur.

has been found that these shrinkage cracks do not extend to the hot sawed ends of the rails. They cease at approximately the same distance from the hot sawed end as the distance in laterally from the periphery to the shattered zone. This evidence fixes the period of their formation subsequent to the hot sawing operation. The character of the cracks leads to the belief they form while the central core is at a fairly high temperature, when the interior metal has but little tensile strength but is in a plastic state.

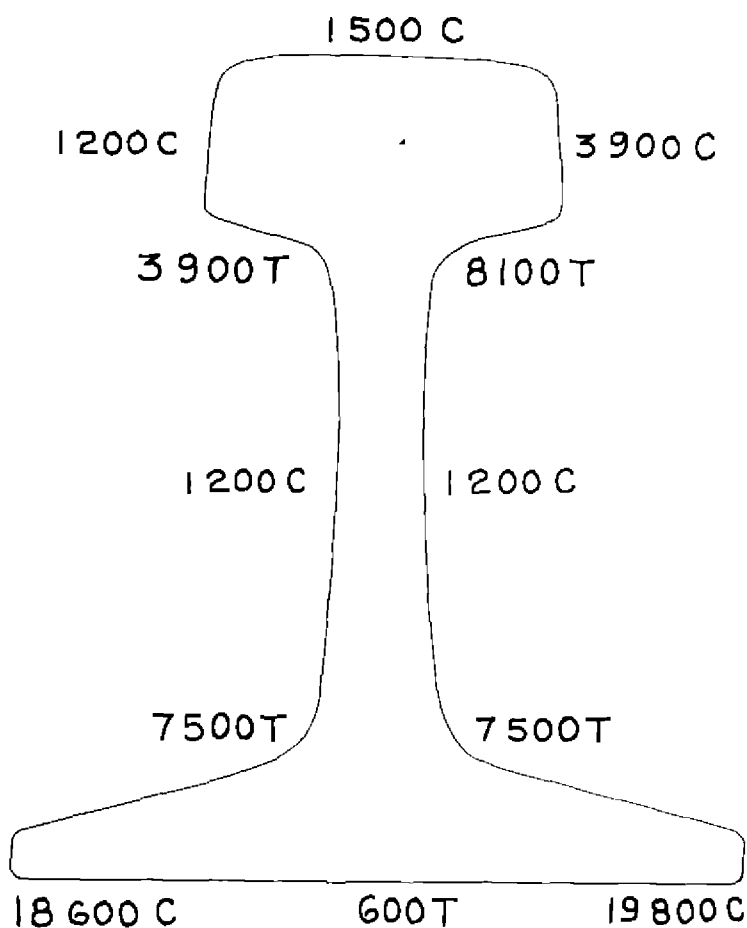
Numerical values, stresses pounds per square inch, representing the cooling strains of fabrication are illustrated by figure No. 16 for a rail cooled normally in air. The stresses here given were present in a 127-pound medium manganese steel rail. The manganese content was 1.67, carbon 0.68. Compression stresses of moderate degree prevailed in the periphery of the head. Tensile stresses not measured in the central core of the head, required to balance the external stresses, were necessarily of moderate degree. Tensile stresses were displayed at each of the fillets of the web, the intermediate portion of the web being in a state of initial compression. Higher stresses of compression prevailed in the edges of the flanges than elsewhere.

FIG. 16—Stresses corresponding to the cooling strains of fabrication in a medium manganese steel rail. Weight of rail 127 pounds per yard. Manganese content 1.67 carbon 0.68.

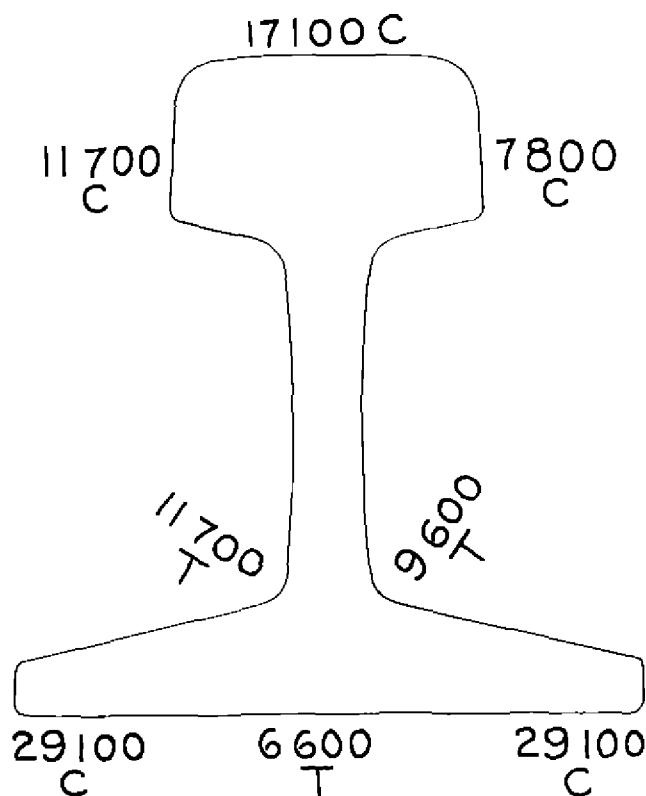
Figure No. 17 illustrates the stresses in a 100-pound rail of accelerated cooling. This rail was cooled by an air blast, directed upon the top of the head. It was cooled, from the finishing temperature of the rail mill, with an air blast of 10 pounds pressure of 4 minutes duration. The high values of the initial stresses will be noted, a maximum of 29,100 pounds compression, 11,700 pounds tension making a total range of 40,800 pounds per square inch. To balance these peripheral stresses the internal stresses must have been correspondingly high. A favorable opportunity is presented to develop internal shrinkage cracks by accelerated cooling.

FIG. 17.—Initial stresses in a 100 pound rail cooled by an air blast directed on the head 10 pounds pressure of 4 minutes duration

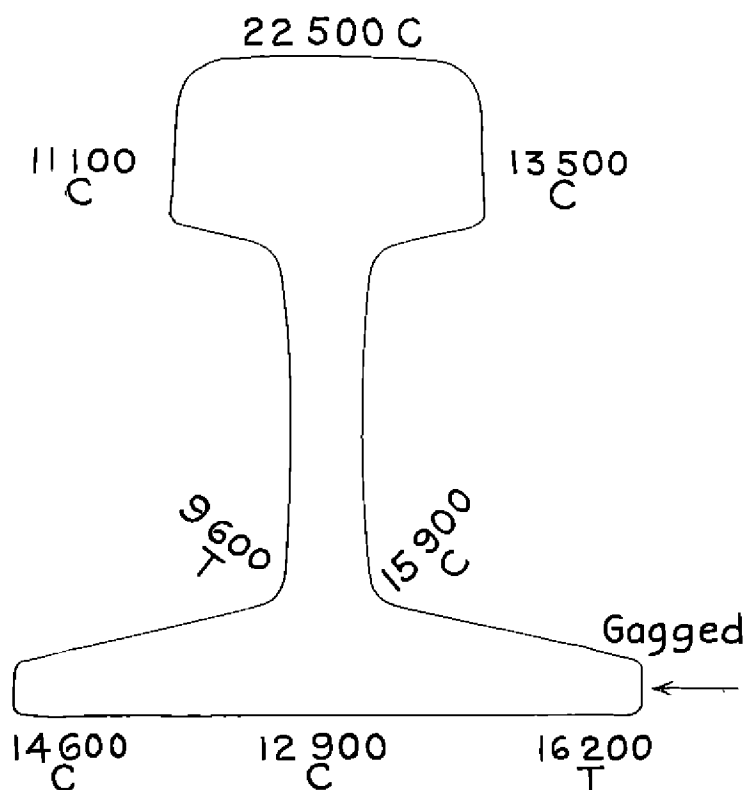
Figure No. 18 illustrates the stresses in a rail which was gagged on one flange. This was a 100-pound rail, air cooled in the same way as the rail last illustrated and described. It will be noted that internal stresses in the flange which received the gagging blow were reversed from the normal state of compression to that of tension. Also that a corresponding reversal of stresses occurred at the fillet of the web and the base on the side struck by the gag. Furthermore that the usual state of tension along the middle of the width of the base was changed to compression. An abrupt transition is shown by the stresses in the opposite fillets of the web and base, 15,900 pounds compression on one side against 9,600 pounds tension on the other. This made a range of stresses at the fillets of 25,500 pounds per square inch, while in the opposite flanges of the base there was a range of 30,800 pounds per square inch.

FIG. 18—Initial stresses in a 100 pound rail reversed from compression to tension by the operation of gagging. An cooled rail same as Figure 17

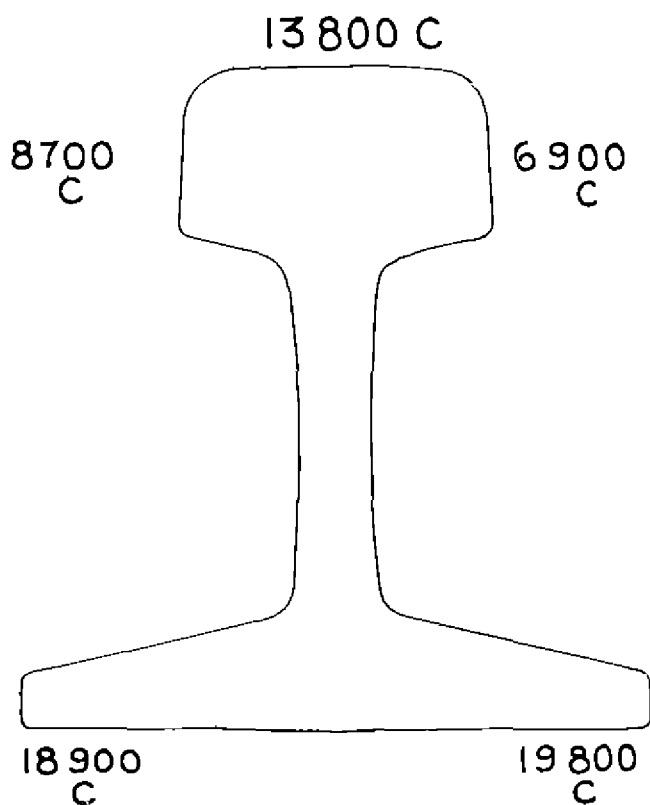
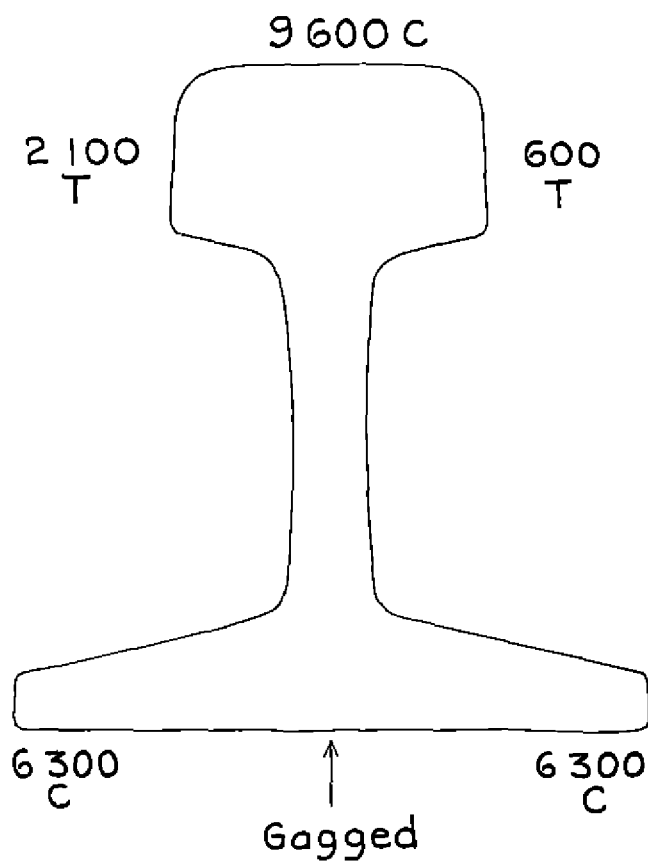
Figures Nos. 19 and 20 represent two 100-pound rails of accelerated rate of cooling, each cooled from $1,100^{\circ}$ F. with an air blast of 10 to 12 pounds pressure, of 6 minutes duration. One rail was gagged on the base. The initial stresses of compression of the base were lowered in values two-thirds. The initial stresses in the sides of the head were reversed from compression to a state of tension. Reversal to a state of tension in the flanges would no doubt have been accomplished if the gagging had been carried further.

FIG. 19.—Initial stresses in a 100 pound rail cooled from temperature of 1 100 F by an air blast directed on the head, 10 to 12 pounds pressure of 6 minutes duration

FIG. 20.—Initial stresses in a 100 pound rail after gaging on the base. An cooled rail same is Figure 19

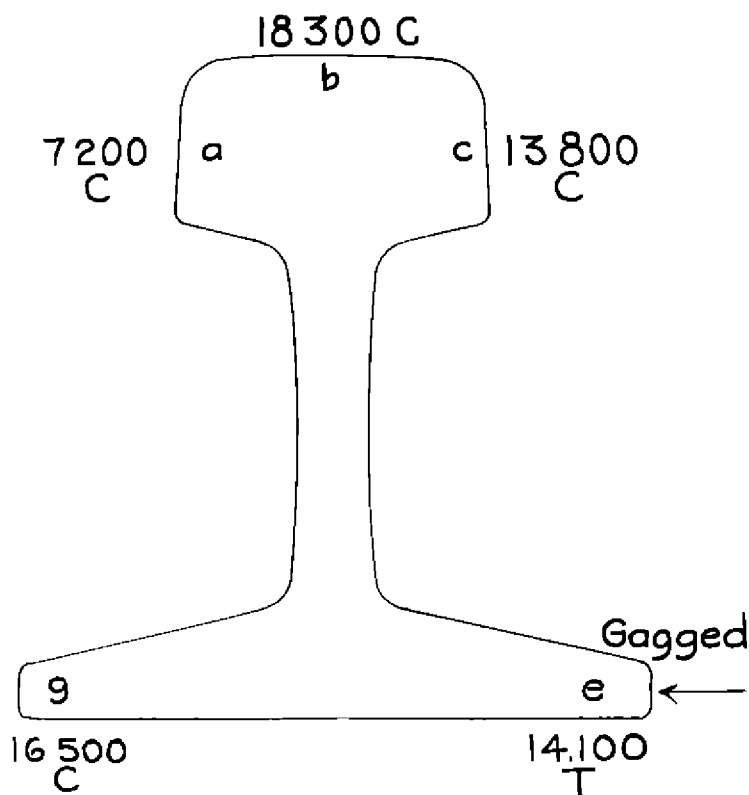
Figure No. 21 illustrates the initial stresses in a 100-pound rail, air cooled from the finishing temperature at the rail mill, with an blast of 6 pounds pressure of four minutes duration after which

FIG. 21.—Initial stresses in a 100 pound rail in cooled gagged on a flange
Strip from head and base annealed

the rail was gagged on the flange designated by the letter c. The flange which directly received the gagging blow was left in a state of tension, the opposite flange in a state of compression.

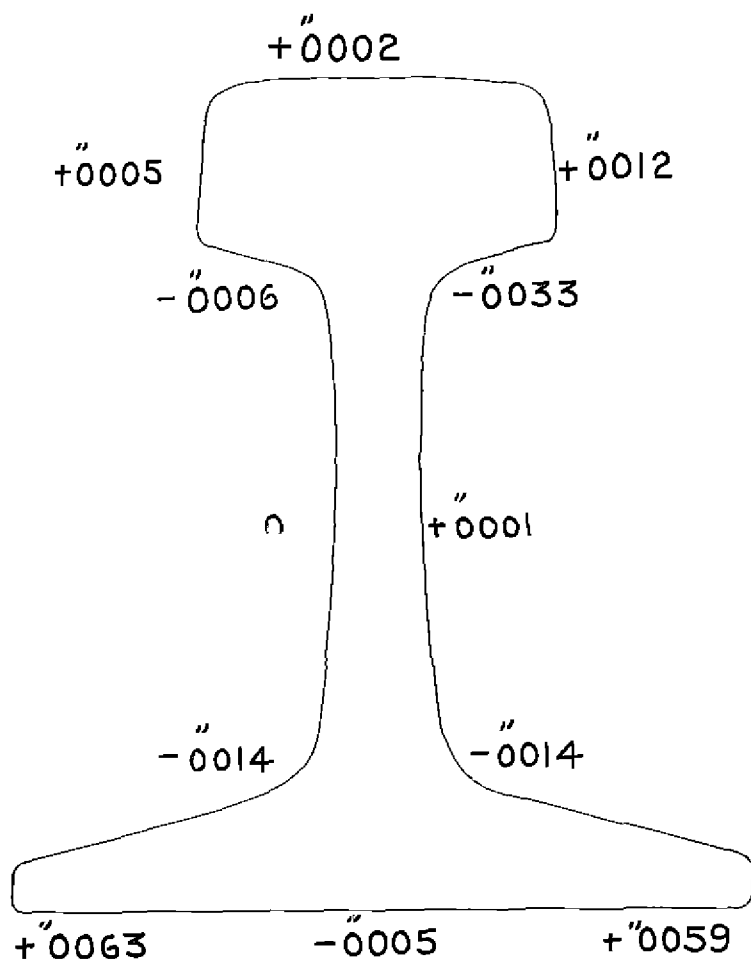
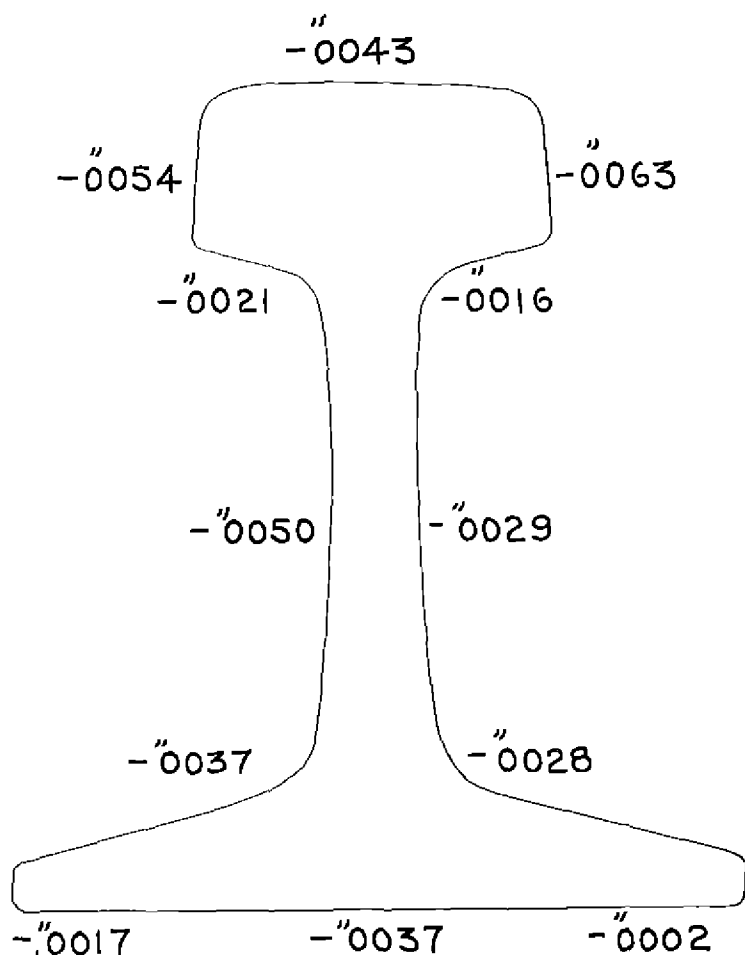
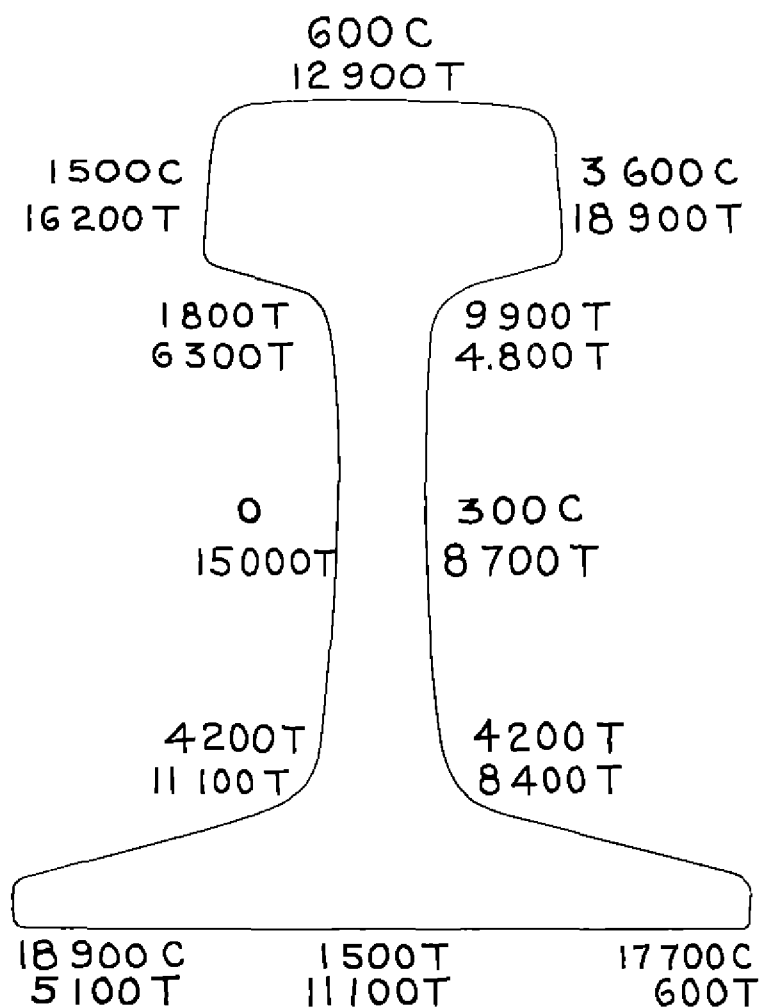
A group of three figures Nos 22, 23, and 24, present results obtained with a medium manganese steel rail of 127 pounds weight per yard, the manganese content being 1.67, carbon 0.68. Figure No 22 shows the measured cooling strains on 12 gauged lengths displayed when strips from the intact rail were removed. The strains ranged from 0.0033 to 0.0063 in., representing stresses of 9,900 pounds per square inch tension to 18,900 pounds compression.

The detached strips were twice annealed in lime, on each occasion at 1,450° F., resulting in the contraction in length of each of the several strips. The total contractions of the detached strips resulting from the two annealings are shown by Figure No 23. The corresponding values of these strains, expressed in pounds per square inch, are shown by Figure No 24.

Results deduced from the results shown by Figures Nos 22 and 23 are given on Figure No 24. The upper set of values refer to the stresses which existed in the rail, as normally cooled in air. The lower sets of values represent stresses corresponding to the measured decrements of length of the detached strips after they had been annealed. A large number of figures placed on a single diagram are apt to be bewildering, but at this time, for comparison of results, it becomes necessary to present them in juxtaposition.

FIG. 22.—Measured strains in strips attached from medium manganese steel and 127 pounds weight per yard. Normally cooled.

Fig 23—Changes in lengths of strips detached from medium manganese steel rail Figure 22 unweled

FIG. 24.—Stresses corresponding to the strains shown by Figures 22 and 23

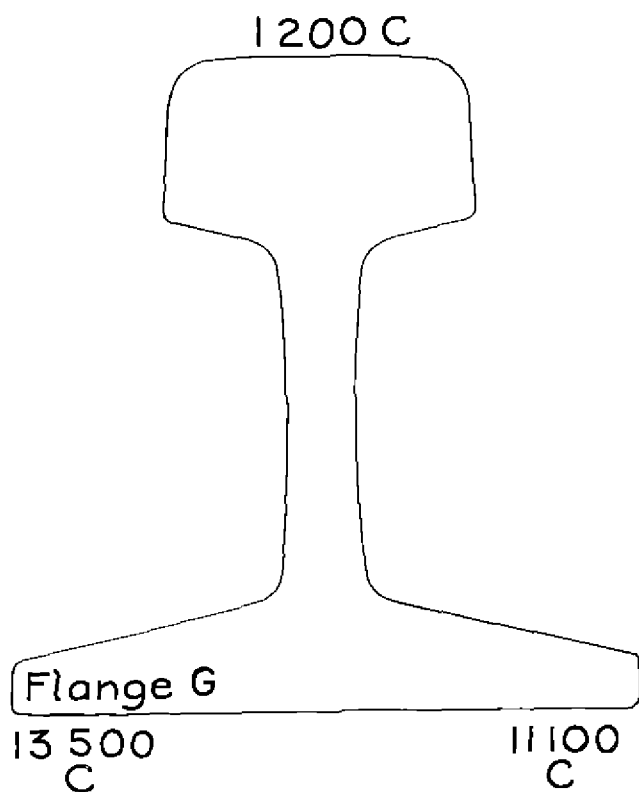
Tests were made with a strip detached from a flange of a 100-pound rail, illustrating first a successive shortening in length after which it was successively lengthened, each by heat treatment. The strip was taken from a 100-pound rail cooled normally in the air. Figure No. 25 illustrates the internal cooling stresses of fabrication, measured on three elements—at the top of the head and on each flange of the base. The strip detached from flange *g* was successively shortened by heating followed by slow cooling, after which it was successively lengthened by heating followed by rapid cooling.

FIG. 25—Straps from flange G 100 pound rail normally cooled.
Heated strap shortened by slow cooling, lengthened by rapid cooling.

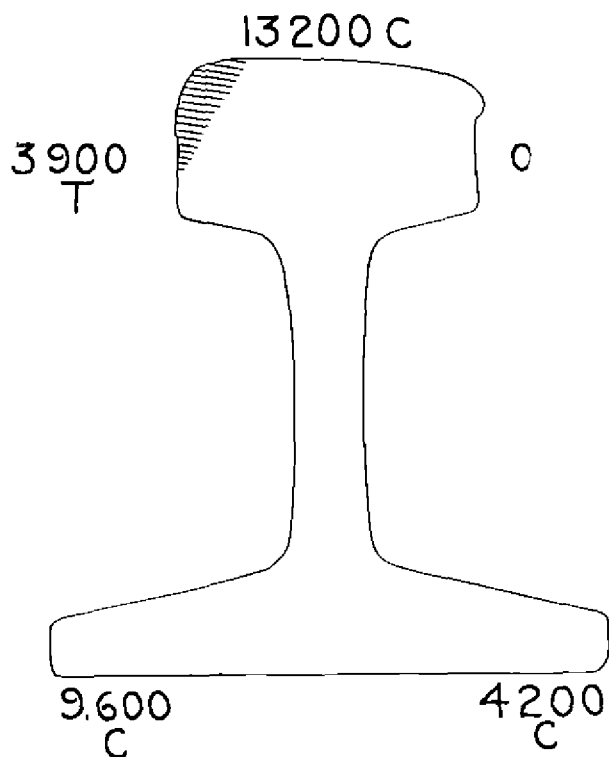
Figure No. 26 illustrates the stresses which were present in a 90-pound rail, after service in the track. Those of the head were modified by reason of a bond wire having been brazed to the outside, upper edge. The structural state was disturbed by the effects of the torch, indicated by the shaded portion of the sketch. A cross section of the rail was smooth polished, and the zone of affected metal brought into view by etching with ammonium persulphate.

Heating with the torch, for brazing overcompressed the metal for the time being which reversed the internal strains to a state of tension when the rail cooled. This brazing which was done near the end of the rail, on the outside of the head was the safest place such heating could be applied without menace to the integrity of the metal. The use of the torch on the web or the base of the rail would endanger its safety, leading to its rupture. The formation of cracks has been witnessed on the tread of a chilled iron wheel. Experimentally a small area of the tread was heated with an oxy-acetylene torch raising the temperature of the metal to a dull red heat. During the period of cooling a small network of cracks was formed on the surface of the tread, representing the relief of internal strains of tension.

FIG. 26—Internal stresses in a 90 pound rail modified by brazing a bond wire on side of head

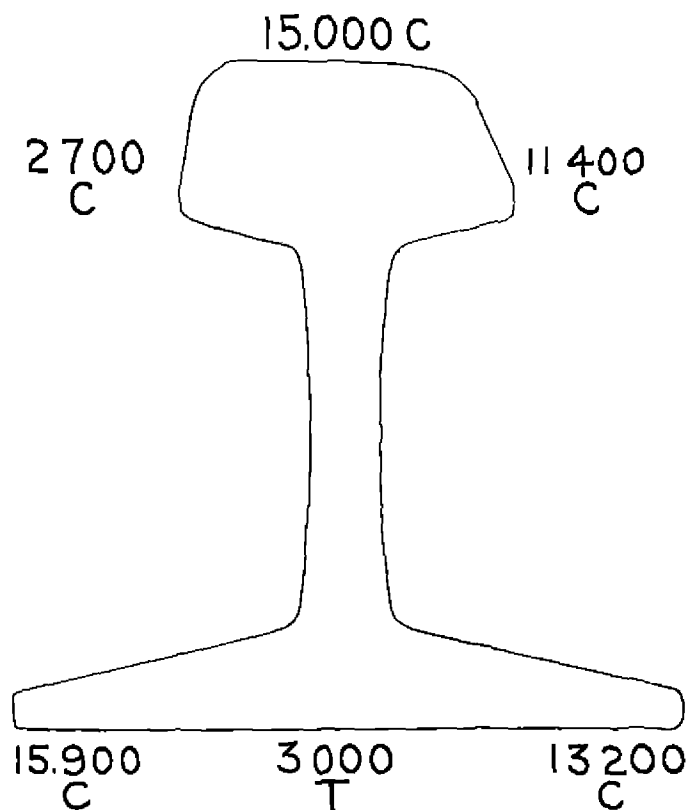
Figure No. 27 illustrates the internal stresses of a 100-pound rail from the tracks of the Interborough Rapid Transit Railroad of New York City. Its composition was C 0.81, Mn 0.86, P 0.029, S 0.042, Si 0.10. The total tonnage carried by this rail was 300,839.315 tons. The wheel loads were fairly light, understood to have been in the vicinity of 15,000 pounds on the motor end of the car. Notwithstanding the moderate wheel loads, rails in the tracks of this company have not been immune from the display of transverse fissures.

FIG 27 —Internal stresses in a 100 pound rail from the tracks of the Interborough Rapid Transit Railroad, New York City

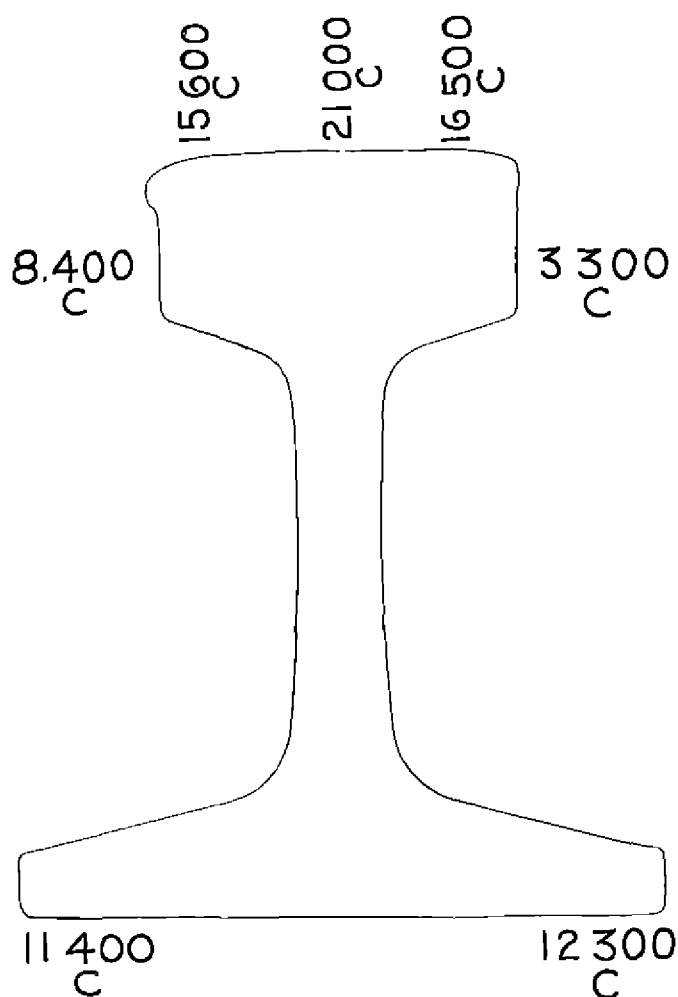
Figure No. 28 represents a low rail of a $3^{\circ} 40' 10''$ curve; its weight was 130 pounds per yard. The average composition of the rails to which this belonged was C 0.682, Mn 0.64, P 0.021, S 0.058, Si 0.077, Ni 0.59, Cu 0.24. The internal strains were measured after the rail had been in the track 16 months. The middle element along the top of the head had acquired strains equivalent to 21,000 pounds per square inch compression. These are cold rolling strains which come from the impinging pressures of the wheels. It is unlikely that the cooling strains of fabrication exert a material influence on the strains later acquired from the impinging action of the wheels; that is, in rails cooled normally on the hot bed.

FIG 28—Internal stresses in a 130 pound rail, low rail of a
8 40' 10" curve after 16 months in service

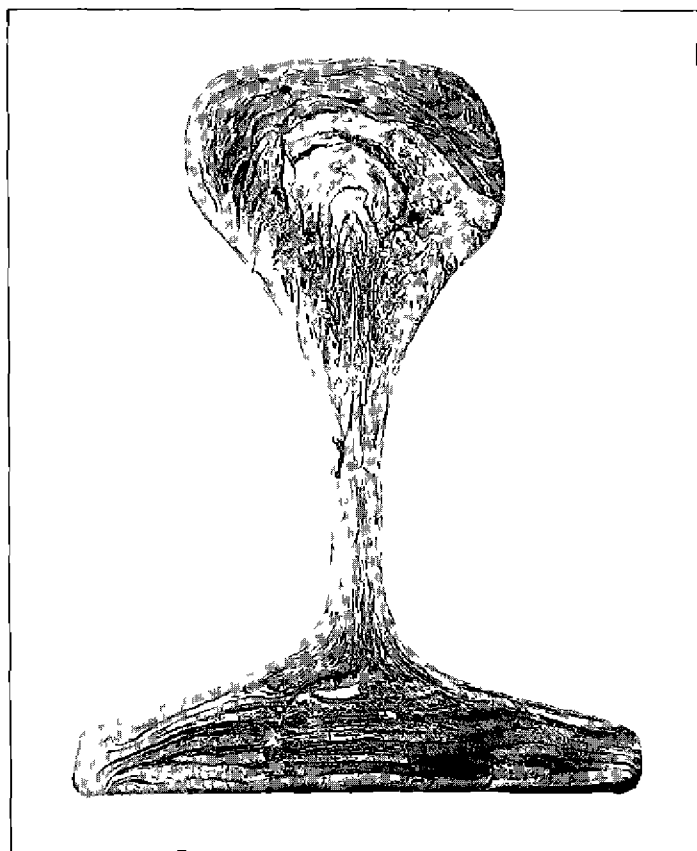
Figure No. 29 illustrates the appearance, in cross section, of an early, puddled, non-rail, of about 40 pounds weight per yard, after etching with tincture of iodine. Internal strains in the top of the head were equivalent to 24,920 pounds per square inch compression.

The detached strip on which these strains were measured assumed a pronounced convex shape, with the running surface uppermost, indicating the internal strains were of variable degree in magnitude, greatest adjacent to the running surface.

FIG 29 —Cross section of an early wrought iron rail etched with tincture of iodine. Internal stress in top of head 24,920 pounds per square inch compression.

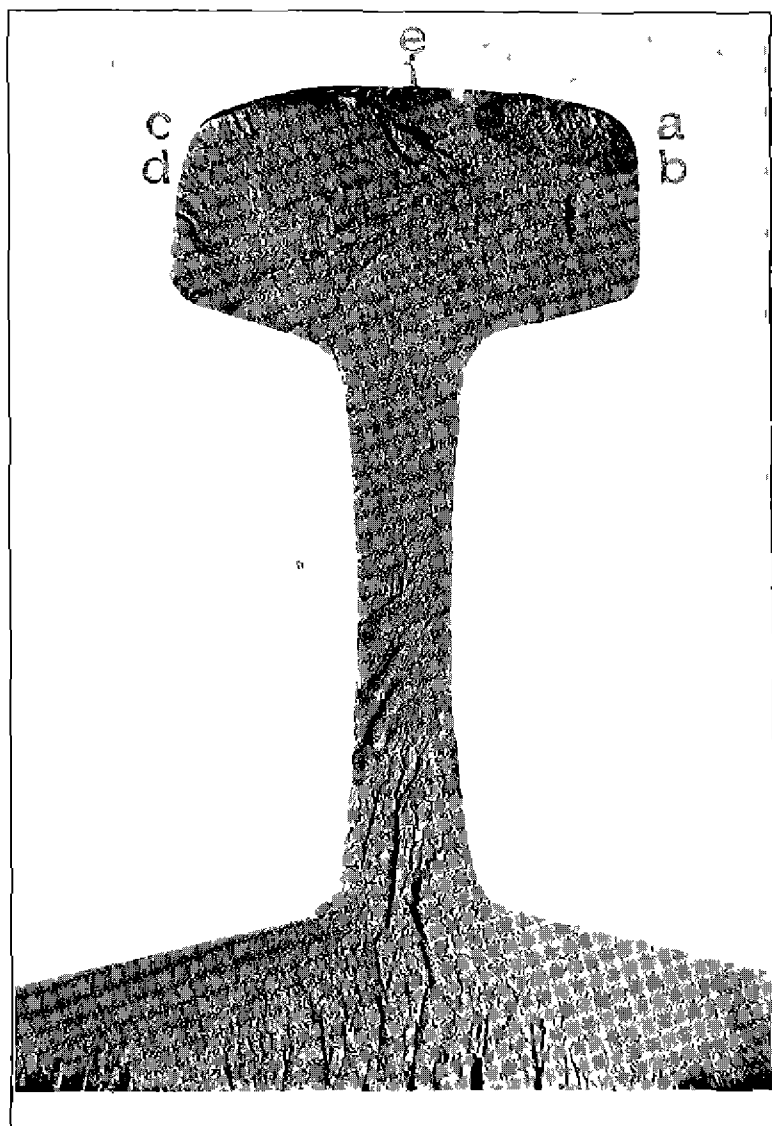
Fig 36—Head checked rail Weight 100 pounds per yard Microstructure shown by Figures No 36 a, b, c, d e, and f

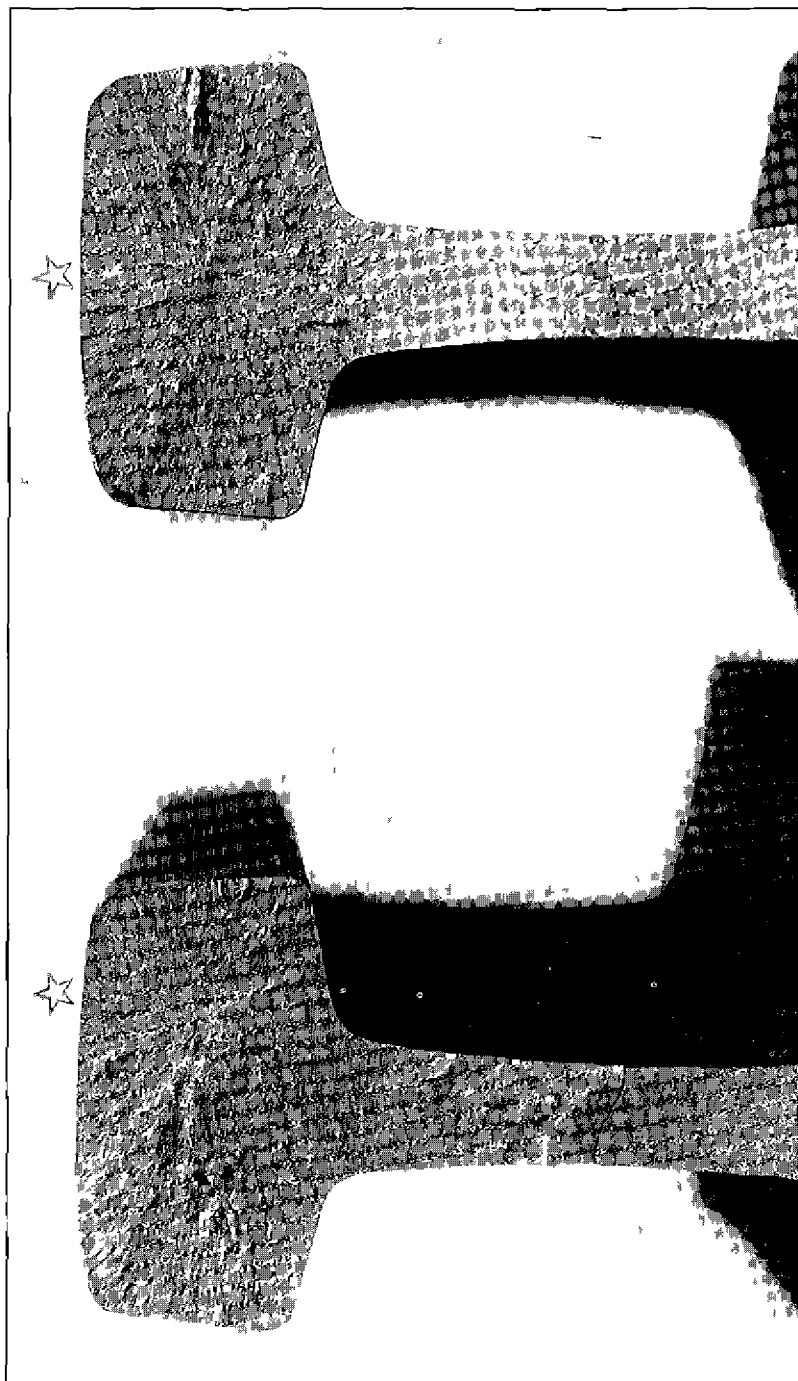
Figures Nos 41 and 42 show the location of fractures of some rails which were broken under the drop. Stars placed on the cuts above or below the origins of the fractures indicate the locations of the incipient points of rupture. The starting effects in the heads of two rails are illustrated by Figure No 41, one of which is eccentric, the other at the center of the head. Transverse fissures might, in the course of time, start at each of such places. It would be erroneous, however, to designate these as incipient fissures. A silvery crescent or silvery oval identifies a transverse fissure. The initial separation of the metal at a transverse fissure presents the same appearance as the initial point of separation of a tensile test piece. At their periods of inception tensile test pieces and transverse fissures are necessarily alike, each being a tensile fracture. Shrinkage cracks are also tensile fractures.

FIG 41 —Starring effects in the heads of two rails

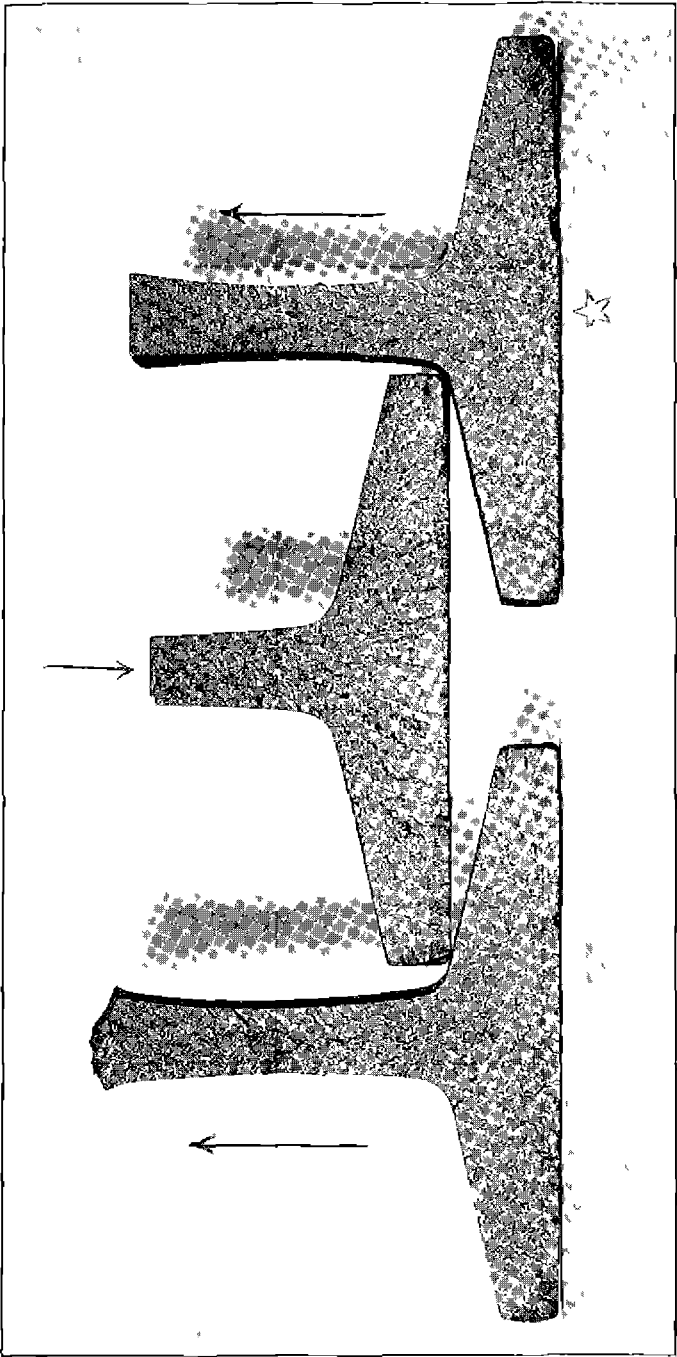
Figure No 41 illustrates starting effects in the bases of two rails, and a portion of the surface of a third rail the fracture of which originated under the head. One of the base fractures was eccentric with reference to the web, and at the middle of the depth of the flange at that place. The other base fracture originated at the middle of the width of the base, at its lower surface.

Arrows indicate the directions in which the several fractures traversed the cross sections of the rails. The cuts do not clearly show the characteristics of the fractured surfaces which on the rails themselves were very pronounced.

FIG 42.—Starling effects in the bases of two rails. Fracture of third section originated under the head. Arrows indicate the directions the lines of rupture followed.
