**REPORT OF THE CHIEF OF THE BUREAU OF SAFETY COVERING  
THE INVESTIGATION OF AN ACCIDENT WHICH OCCURRED ON  
THE UNION PACIFIC RAILROAD NEAR BELOIT, KANS, ON  
JANUARY 15, 1918.**

SEPTEMBER 16, 1918

On January 15, 1918, there was a derailment of a passenger train on the Union Pacific Railroad near Beloit, Kans, which resulted in the death of 4 passengers and the injury of 22 passengers and 3 employees. After investigation, I beg to submit the following report.

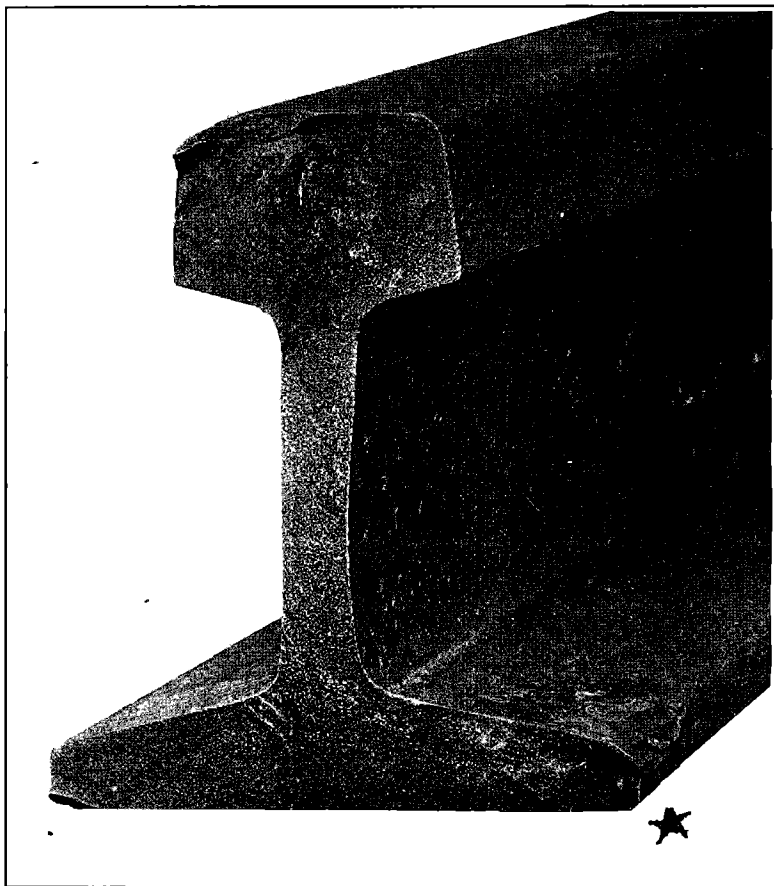
Examples of rails which have failed by reason of injuries received at the edges of their flanges are met from time to time. Figure No 9 illustrates a square break, one of a number which occurred in some 90-pound rails of more recent fabrication than those involved in the present derailment. The star marked on the cut indicates the initial point of rupture. The bolt holes shown in the web were drilled for attaching splice bars for temporary repairs to the track.

FIG 9 —Fracture of a 90-pound Bessemer rail Illustrating a fracture caused by injured flange
