**APPLICATION OF ACOUSTIC, STRAIN, AND OPTICAL  
SENSORS TO NDE OF STEEL HIGHWAY BRIDGES**

**By David W. Prine**

**Technical Report #12**

Originally presented at Sensors Expo Conference in Boston, MA May 16-18, 1995

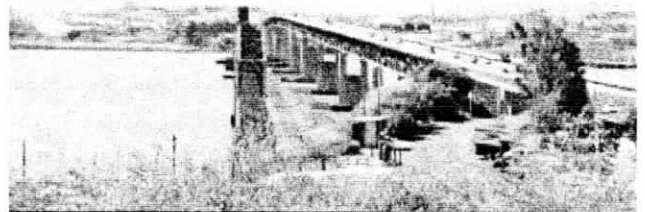
Figure 2 The I-680 Bridge

California Department of Transportation structure B-28-153 carries Interstate Highway 680 traffic across the Sacramento River at the east end of Carquinez Strait thirty miles northeast of San Francisco, California. This 1.2 mile long, high-level structure consists of ten steel deck-truss spans ranging in length from 330 to 528 feet. The bridge was designed by CALTRANS in the late 1950's and has been in continuous service since it was opened in 1963. An overall view of the structure is shown in Figure 2.
