TECHNICAL REPORT 0-6804-2
TXDOT PROJECT NUMBER 0-6804

Analysis of Lightweight Transparent Noise Barriers on IH-30 Elevated Structures in Dallas, Texas

Dr. Manuel Trevino

August 2018; Published June 2019

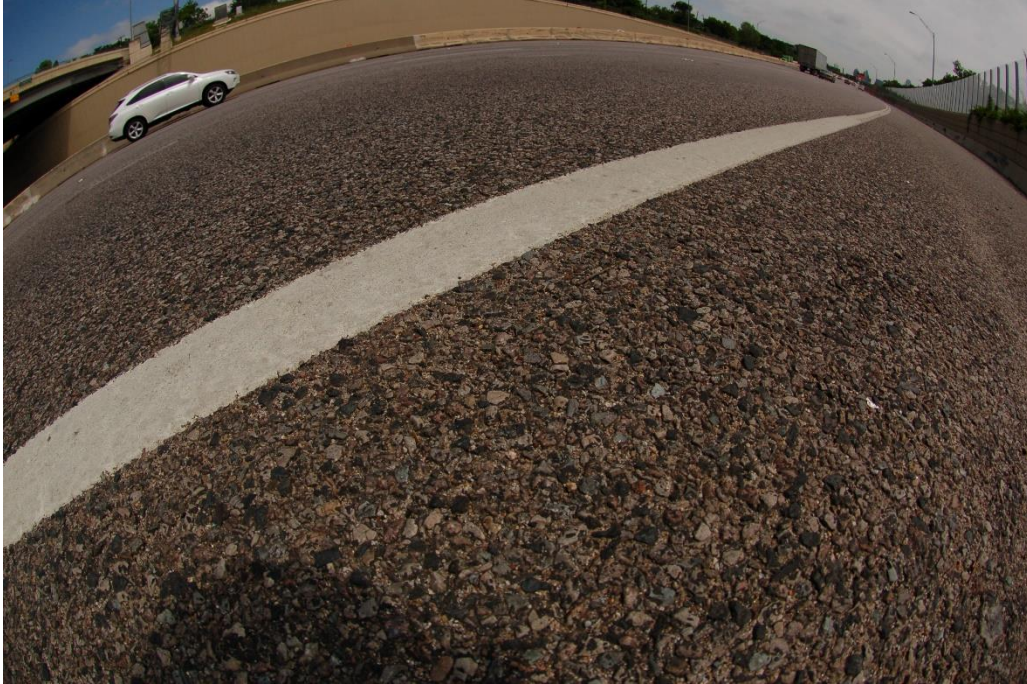
Figure 3.26: 2010 PFC in May 2016

Unfortunately, this type of pavement tends to lose its acoustic benefits over time, as its void content diminishes due to clogging and compaction. Clogging occurs when debris from the road fills the original pores that make these pavements quieter, while compaction under heavy traffic loading has a similar effect of reducing the voids over time. The degradation of the acoustical properties of PFC pavement surfaces over time is documented in the literature (Arambula 2013, Smit 2016). Figures 3.24 to 3.26 illustrate this

degradation of the PFCs, showing how the pavements look similar to dense-graded asphalt surfaces after clogging and compaction have decreased their void content.

More recent OBSI results, from 2016 (Figure 3.27), confirm that these overlays have gotten much louder, indicating that their acoustic benefits have substantially diminished over time; the 2006 PFC (PFC1 in the chart) is about 107 dBA, on average, while 2010 PFC (PFC2 in the chart) is almost 106 dBA, on average. Figure 3.28 compares two series of recent OBSI tests (the data from 2014 and 2016) indicating the trend that both PFCs are producing higher levels of noise.

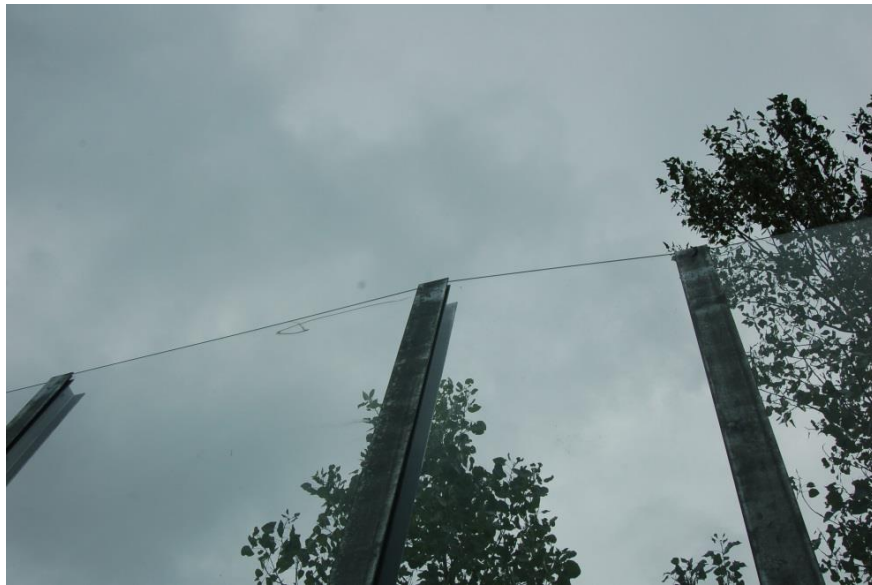
A few problems were noticed before the completion of the installation, such as some supports not being completely vertical (Figures 8.9 and 8.10), some apparently missing rubber gaskets between panels and the metal supports, some gaskets slightly out of place (Figure 8.11), as well as some gaps between gaskets and metal supports, both for vertical and horizontal gaskets (Figures 8.12 and 8.13).

Figure 8.10: Vertical support off-plumb

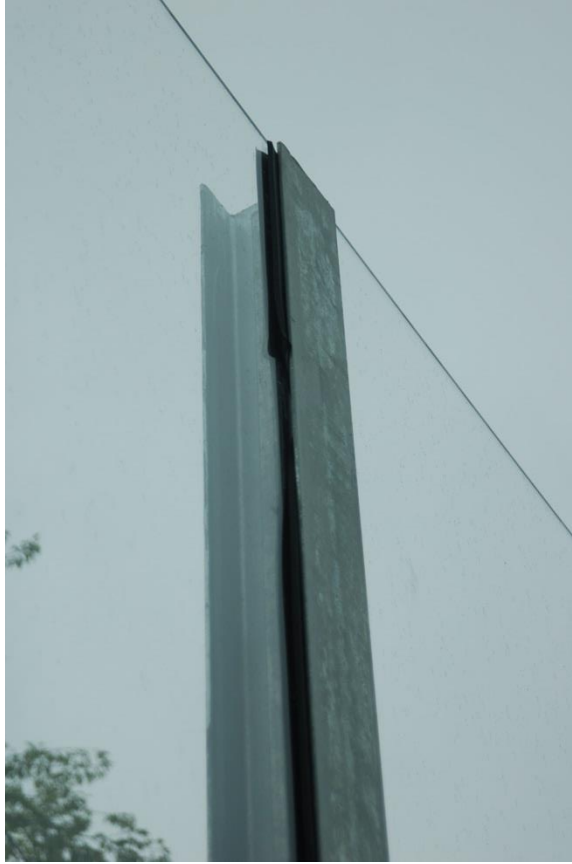
Figure 8.11: Gasket protruding from metal support

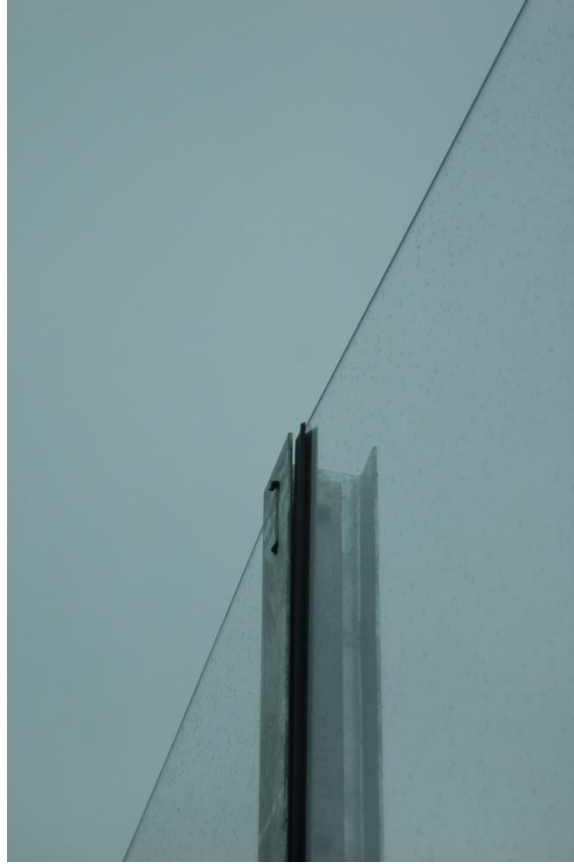
Figure 8.12: Gap between vertical gasket and metal support

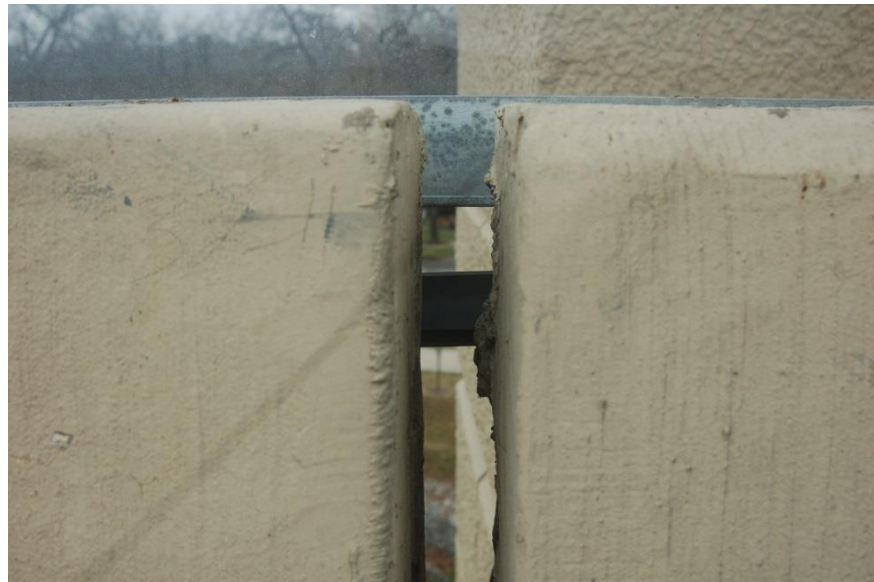
Additionally, some gaps were observed in the existing concrete wall at the expansion joints of the bridge (Figures 8.15 and 8.16), gaps that should be filled with some elastic joint sealing material allowing for the bridge's thermal expansion and contraction. Such material should prevent the sound from traveling from the highway to the neighborhood to further attenuate the noise at the receivers' locations and contribute to the wall's effectiveness. This would be TxDOT's responsibility, as it is not an issue of the transparent noise wall, but rather of the existing structure.

Figure 8.16: Gap in existing concrete wall at bridge expansion joint as seen from the highway side

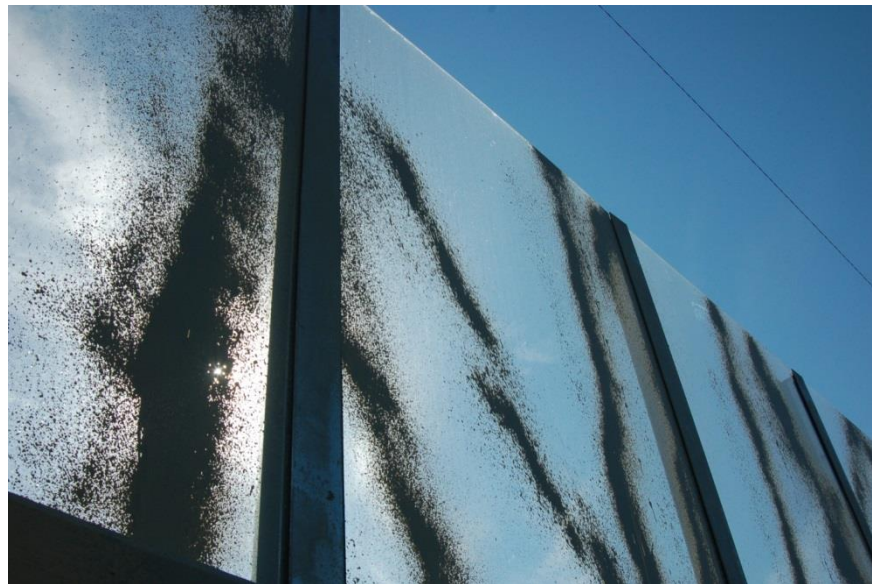
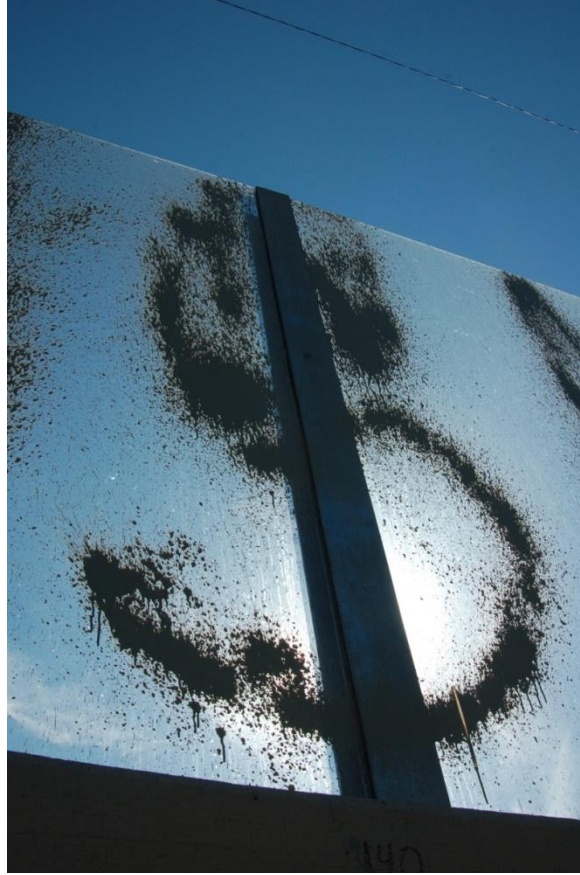
On November 11, 2013, while performing the wall inspection, it was noticed that some of the panels had been damaged by graffiti. Ten transparent panels, from spans # 135 to 144 (as marked by the contractor on the concrete wall during installation) were sprayed with paint. The concrete wall under span # 144 was also painted. From the distance, the damage was barely noticeable, and from some angles, it was not visible at all. However, when seen from the close proximity of the eastbound shoulder and at walking speed the paint was very

noticeable. The appearance of the sprayed material was that of some type of drywall mud or acoustic texture that is used in ceilings. Pictures of the graffiti are shown in Figures 8.17 to 8.23. The damage was reported immediately to TxDOT.

Figure 8.18: Graffiti as seen from the highway shoulder on November 11, 2013

Figure 8.21: Graffiti as seen from the highway shoulder on November 11, 2013

During the remaining part of November and December 2013, no work was performed to clean the sound wall. By January 28, 2014, the panels had been cleaned. The following cost information for the cleaning operations was kindly provided by Mr. Frank Jett, with the Dallas District, Heavy Equipment Maintenance:

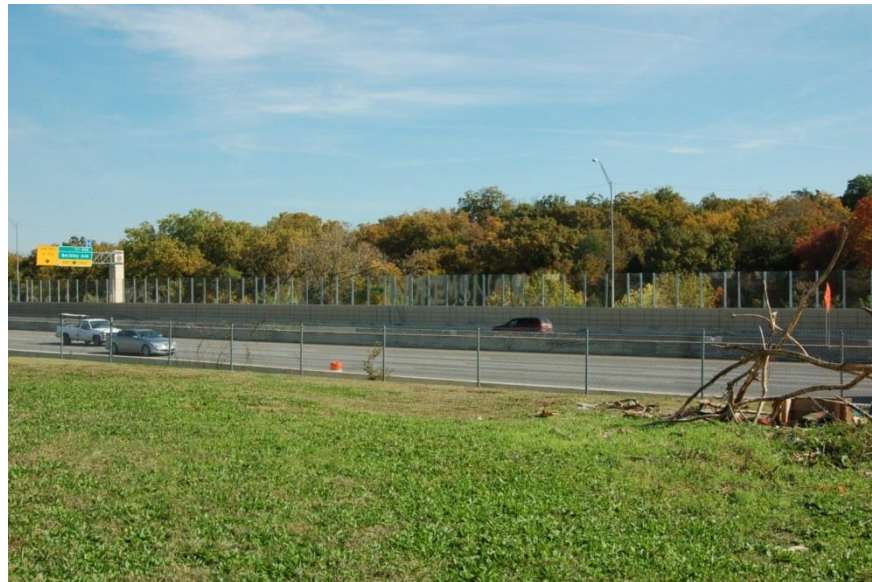
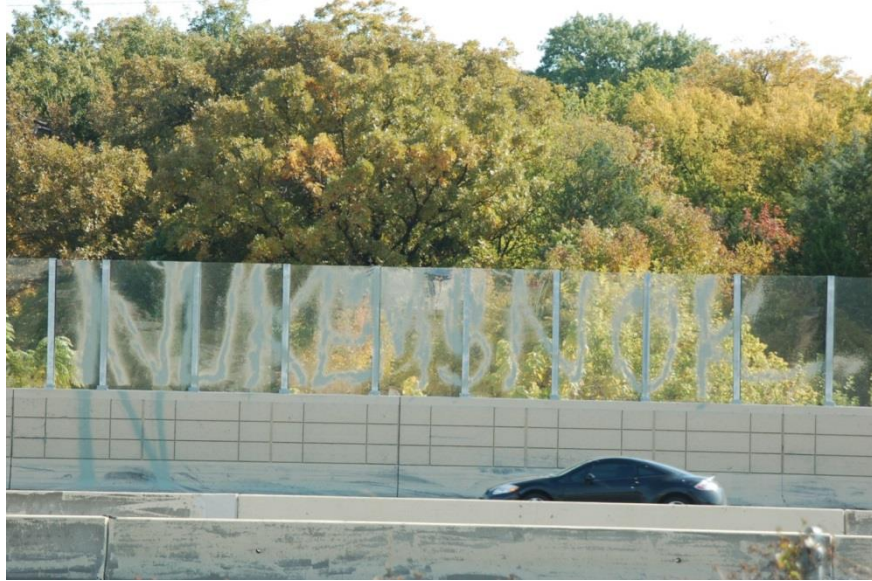
Figure 8.22: Graffiti seen from the north side of IH 30

Figure 8.23: Graffiti seen from the north side of IH 30

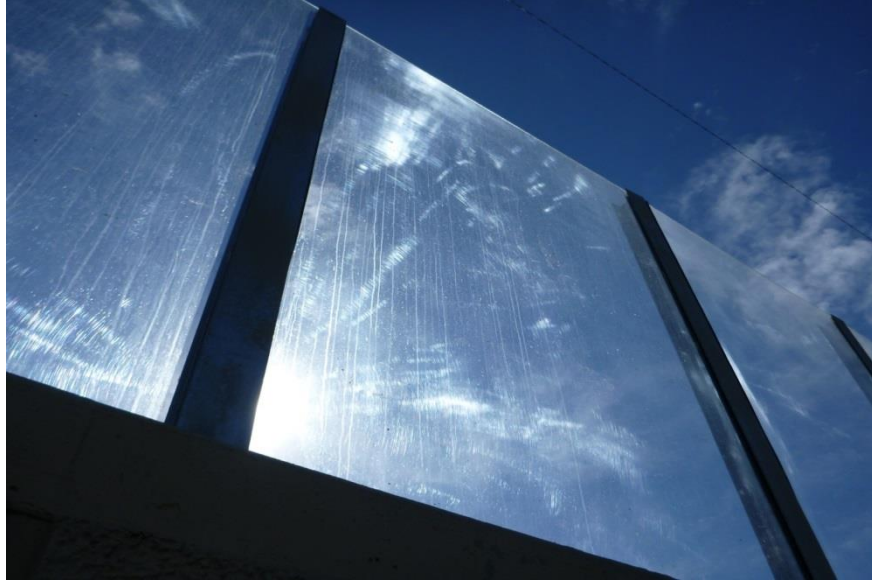
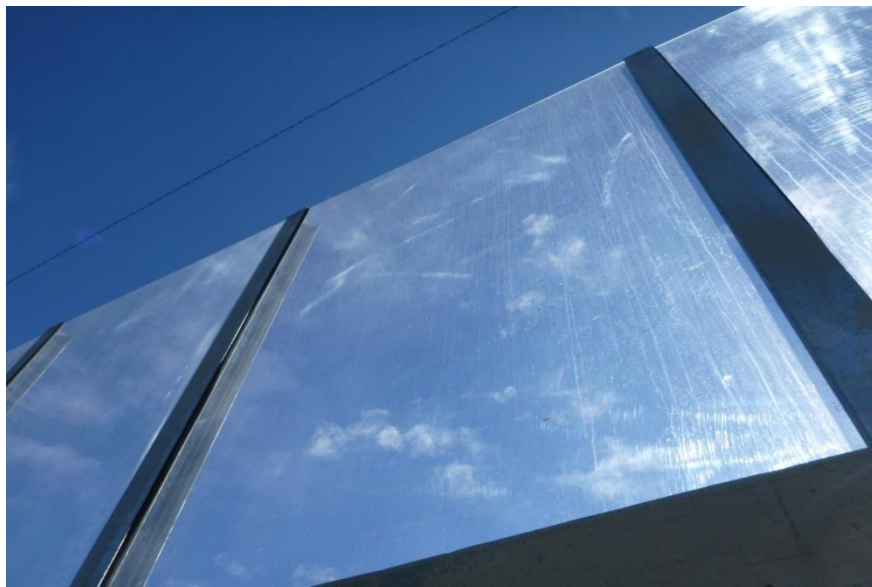
Figure 8.24: Cleaned panel showing traces of the cleaning operation

Figure 8.25: Cleaned panel showing traces of the cleaning operation

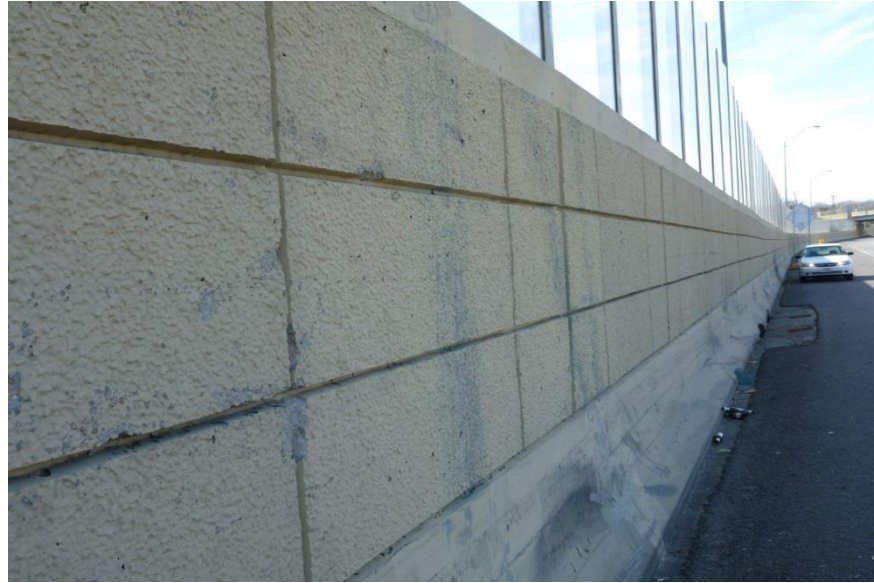
Figure 8.26 shows that the graffiti that extended to the concrete wall could not be entirely removed, and Figure 8.27 shows a photograph taken from afar after the panels had been cleaned.

Figure 8.26: Remnants of the graffiti on the concrete wall below the panels

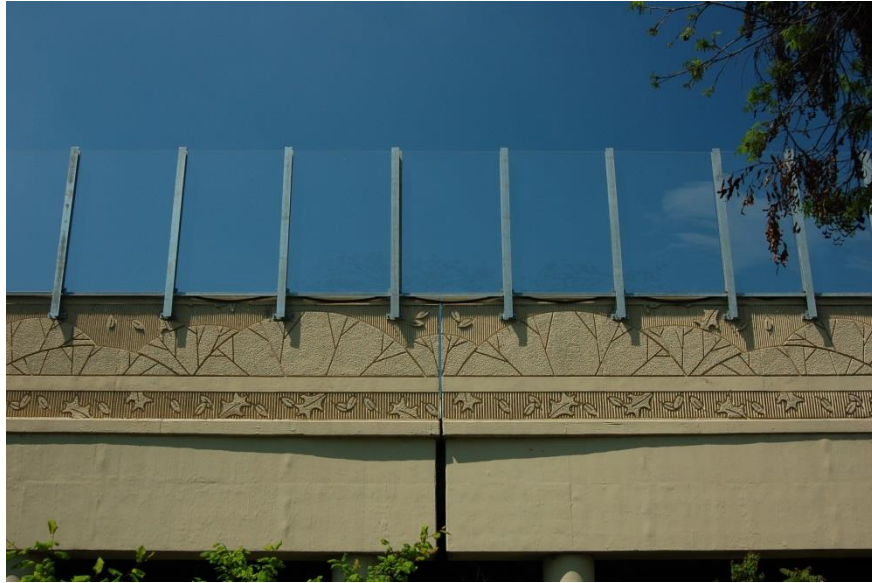
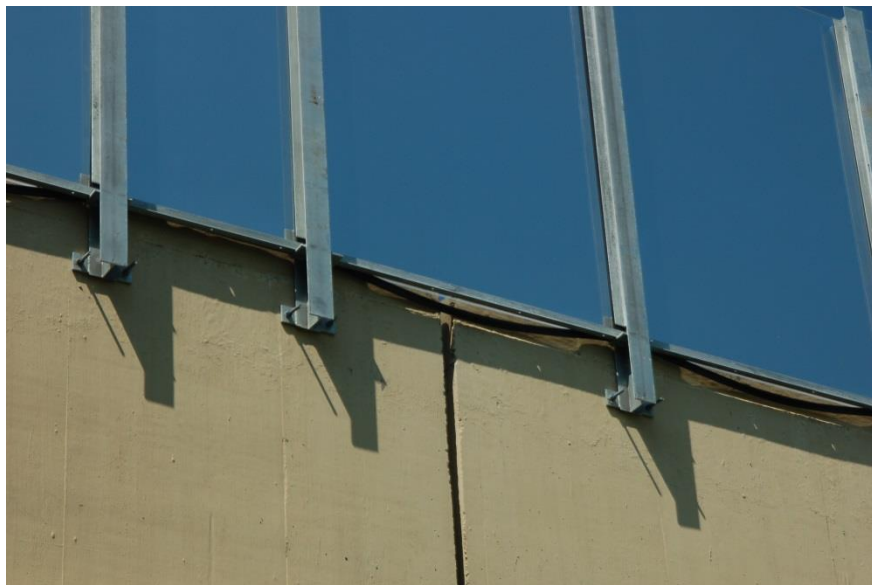
Besides the graffiti, which was successfully removed, the main problem with the wall was the deteriorating condition of the rubber gaskets that are supposed to seal the spaces between panels and the metal supports and the existing concrete walls. This problem was reported shortly after the wall was installed, as it was detected in the inspections during the installation, as mentioned before in this chapter. In the subsequent months, the condition of such gaskets appeared to worsen. Many of the gaskets were not properly placed from the time the wall was installed, and then, perhaps due to the weather, some of them fell out of

place, sagging and even breaking, leaving open gaps through which the noise travels from the highway to the neighborhood. Making an analogy with architectural acoustics, this is similar to leaving an opening (e.g., an open window or a gap under a door) in a room, in which case, the acoustic energy goes through the opening, and the transmission loss of the walls is undermined by the area of the opening, significantly reducing the wall's effectiveness. The problem with the gaskets occurred in both the vertical and horizontal gaskets, but the worst cases correspond to the horizontal gaskets that seal the bottom of the acrylic panels with the concrete wall. The sagging of the horizontal gaskets can be seen in Figures 8.28 through 8.31.

Figure 8.29: Sagging of horizontal rubber gaskets

Figure 8.30: Sagging of horizontal rubber gaskets

It was estimated that about 80% of the horizontal gaskets were in poor condition (broken, sagging, or out of place), which significantly hinders the acoustic performance of the barrier. In May 2014, CTR learned that the contractor had offered to fix the problems with the gaskets at no cost to TxDOT. In the following months, it was noticed that the sagging and broken gaskets had been removed, eliminating the negative visual impression of disrepair; however, those gaskets were not replaced with new ones, leaving the openings

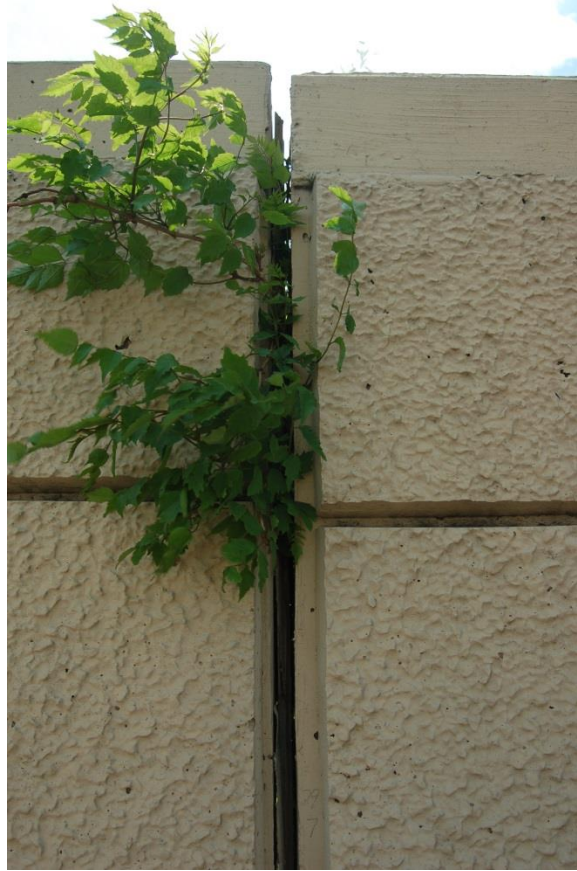
Another problem not directly related to the acrylic wall, but one that minimizes its effectiveness, is the high number of open joints in the existing concrete wall. This was mentioned before in this chapter, as it was noticed shortly after installation of the wall had been completed. These gaps are as wide as 3 or 4 in. (Figure 8.37); the joint sealants are old and have disintegrated with time and weather (Figure 8.38), and in some cases cannot be seen at all (Figure 8.39), allowing the acoustic energy to travel to the neighborhood. The vegetation is also growing through these gaps, as can be seen Figure 8.40. If these can be sealed and the gaskets can be repaired, the wall could be much more effective in mitigating the noise.

Figure 8.40: Vegetation from the creek side growing through the openings in the concrete structure

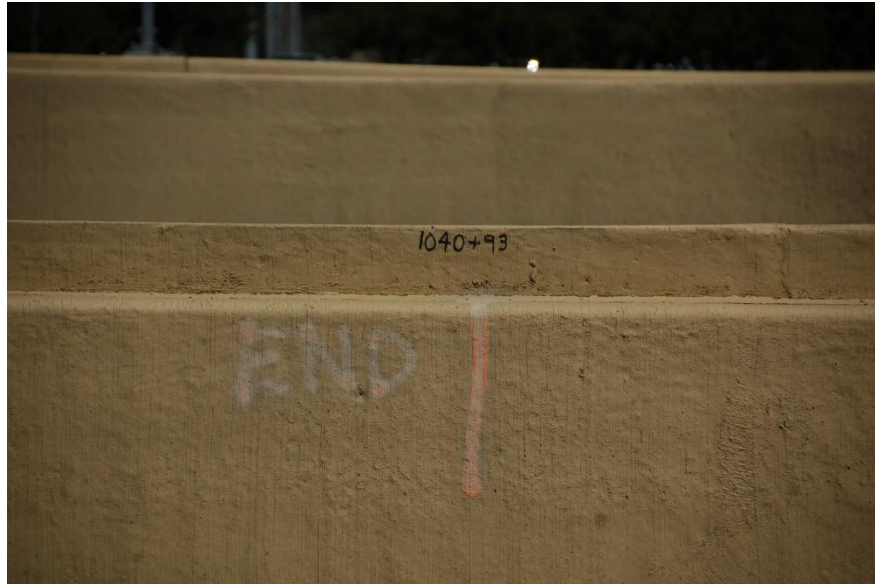
The easternmost end of the wall (Segment 3) was initially supposed to be at station 1040+93 (Figure 9.16), about 200 ft. to the east of where it actually ends, close to station 1039 (Figure 9.17). The stations are painted on the outside of the CTB, for Segment 3. There is also a paint mark at the spot where the wall is supposed to end, at station 1040 + 93. The reason for shortening the wall length was due to the difficulty of installing vertical posts beyond the actual end, as there is no more room to anchor the posts where the concrete

Figure 9.16: Supposed easternmost end of the wall at Station 1040+93 (March 2018)

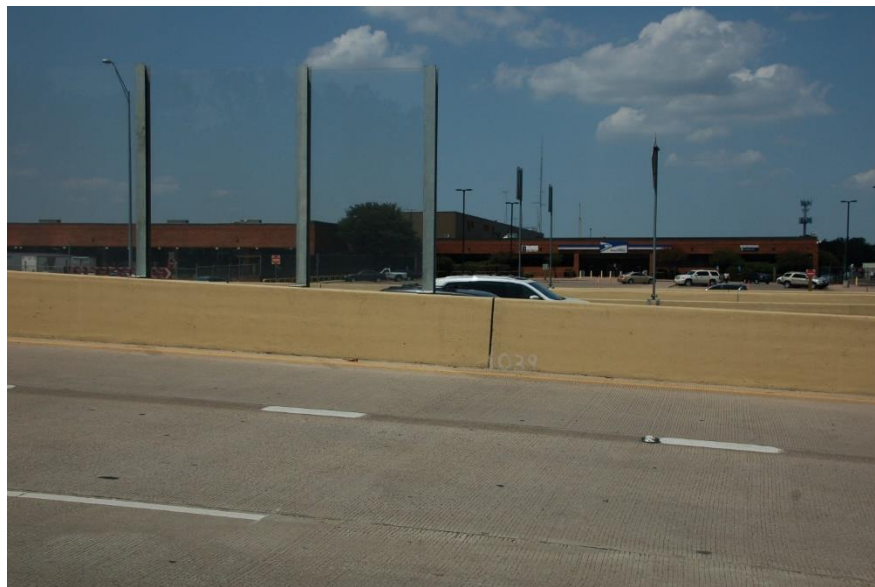
Figure 9.17: Actual easternmost end of the wall a few feet before Station 1039 (August 2018)

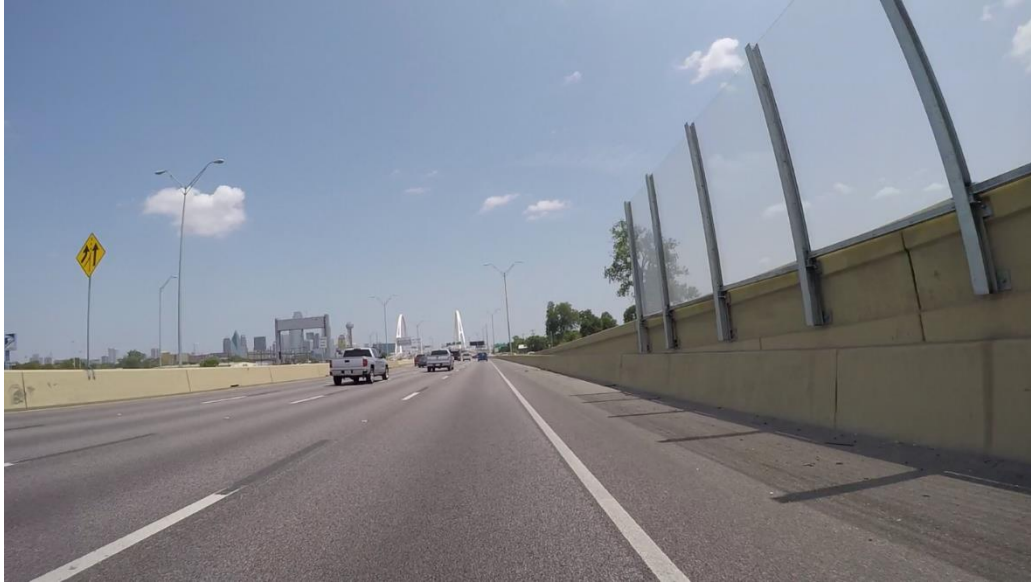
wall's height decreases. This can be seen in Figure 9.18, which shows the actual end of the wall as seen from the main lanes' side.

Figure 9.18: Actual easternmost end of the wall as seen from the main lanes (August 2018)

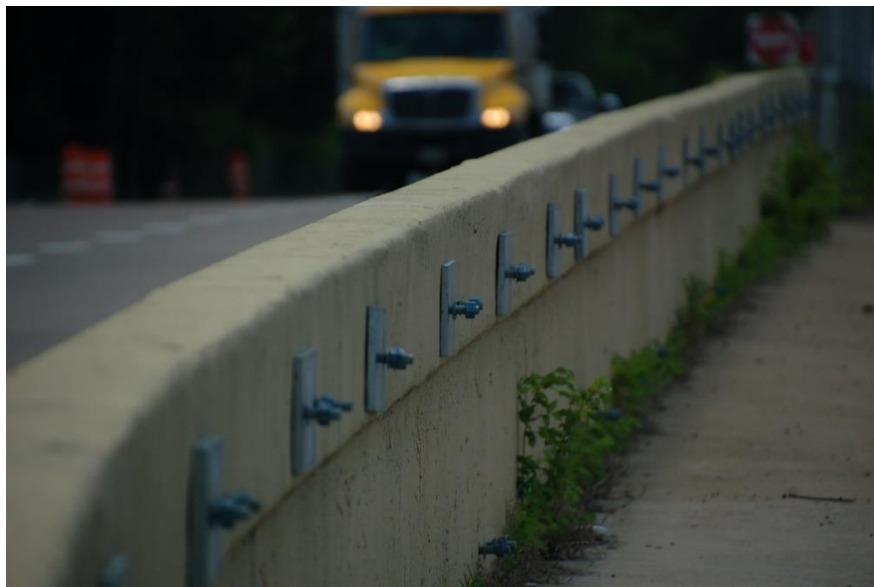
- In March, there were 85 vertical posts already installed for Segment 3, almost all the way to the end of the segment. There were panels already in place up to the 26th post. Some of the posts and panels had to be removed, as there was a design problem with the mounting of the posts to the existing concrete wall, as explained before in this chapter (Figures 9.19 and 9.20). Then the construction had to be interrupted to fix the problem. By the April 19th visit, the segment only had 15 posts and only 14 panels and only reached as far as approximately halfway between station 1033 and 1034. Once the design problem was resolved, construction resumed and the posts and panels were put back in place all the way to the end in August 2018.

Figure 9.20: Only plates and bolts remained after some posts were removed in April to fix design problem (May 2018)

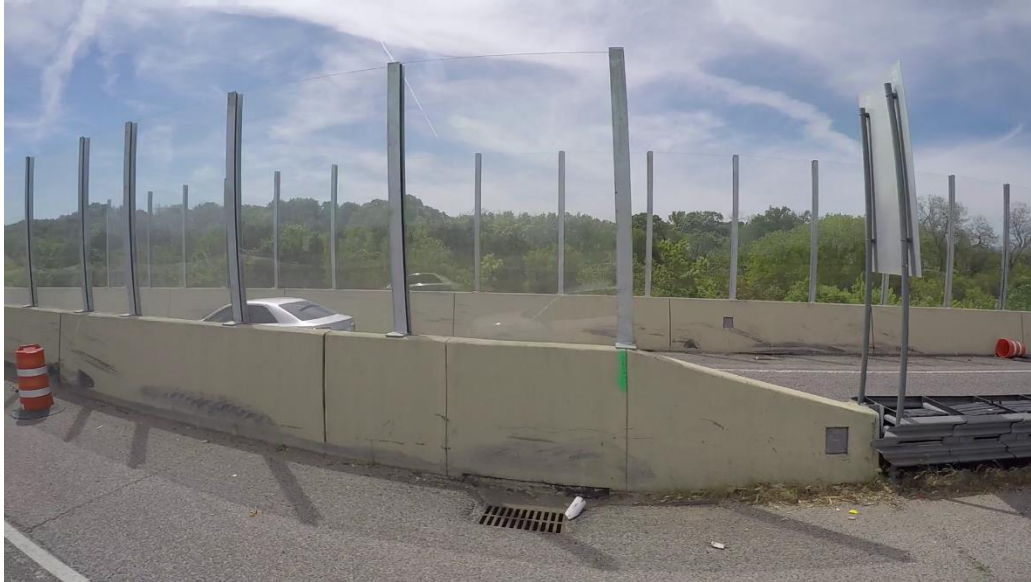
- Initially, only one of the two overlaps designed to reduce the noise traveling through the gaps between segments was installed; this was the overlap between the Segment 1 easternmost end and the Segment 2 westernmost end (Figure 9.21). Before August, there was no overlap between Segment 2 and Segment 3 (Figure 9.22). In fact, there was a small gap of about 5 ft. between segments (Figure 9.23). Once the installation work resumed in July 2018, the segment was extended to the east to include the overlap at the request of TxDOT (Figures 9.24 and 9.25). Notice the green paint marks on the CTB in Figures 9.23 (before) and 9.25 (after) that

Figure 9.21: Segment 1 and Segment 2 overlap, seen from the eastbound main lanes (April 2018)

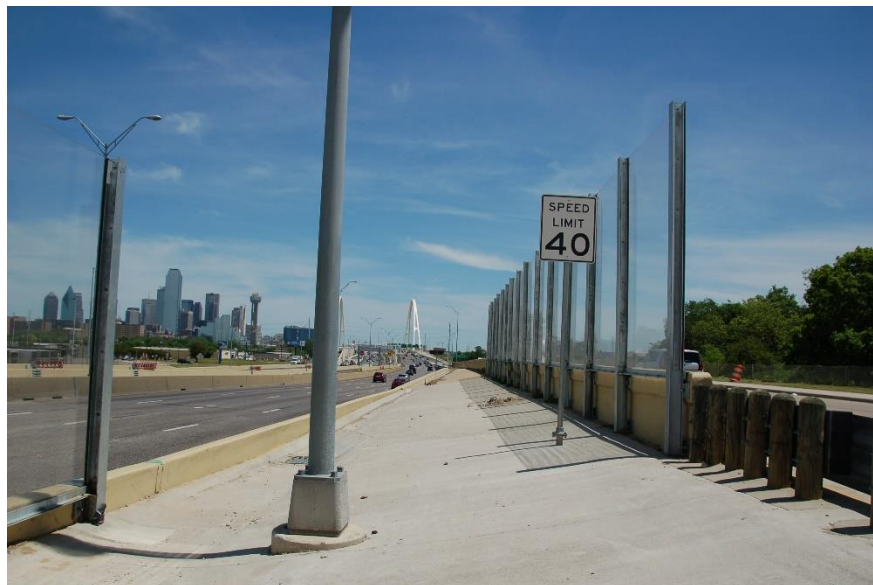
Figure 9.22: No overlap between Segment 2 and Segment 3 (April 2018)

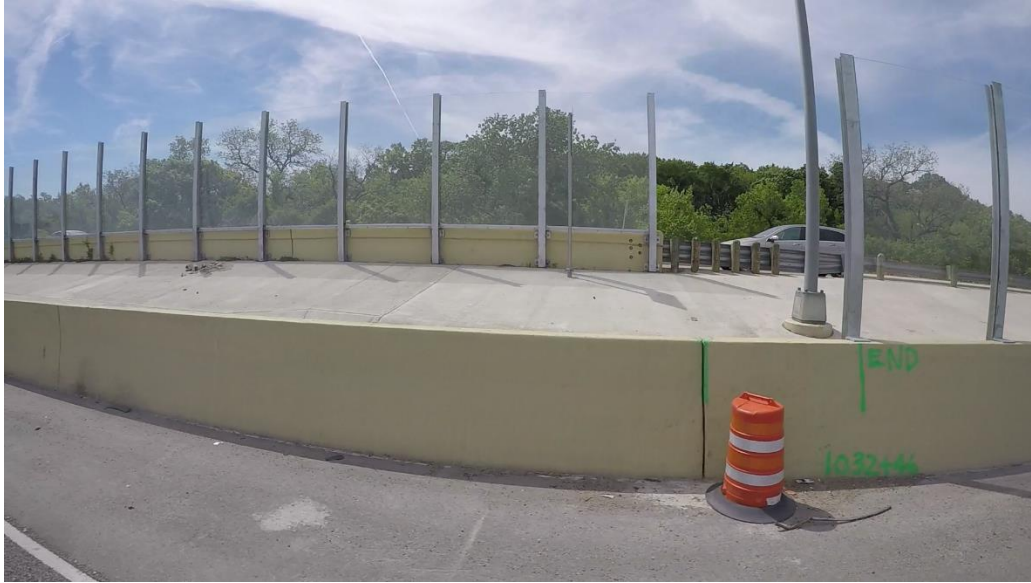
Figure 9.23: No overlap between Segment 2 and Segment 3, seen from the main lanes (April 2018)

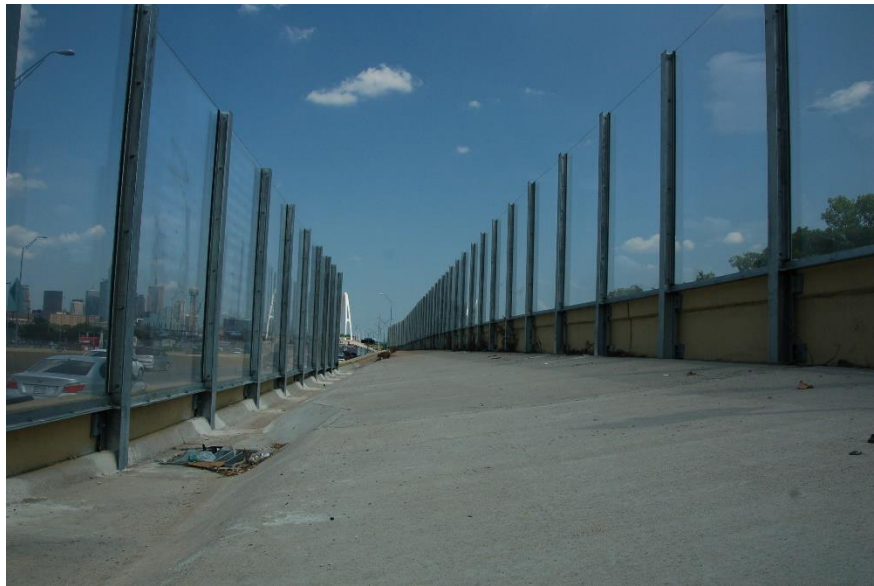
Figure 9.24: Segment 2 extended to the east to include overlap (August 2018)

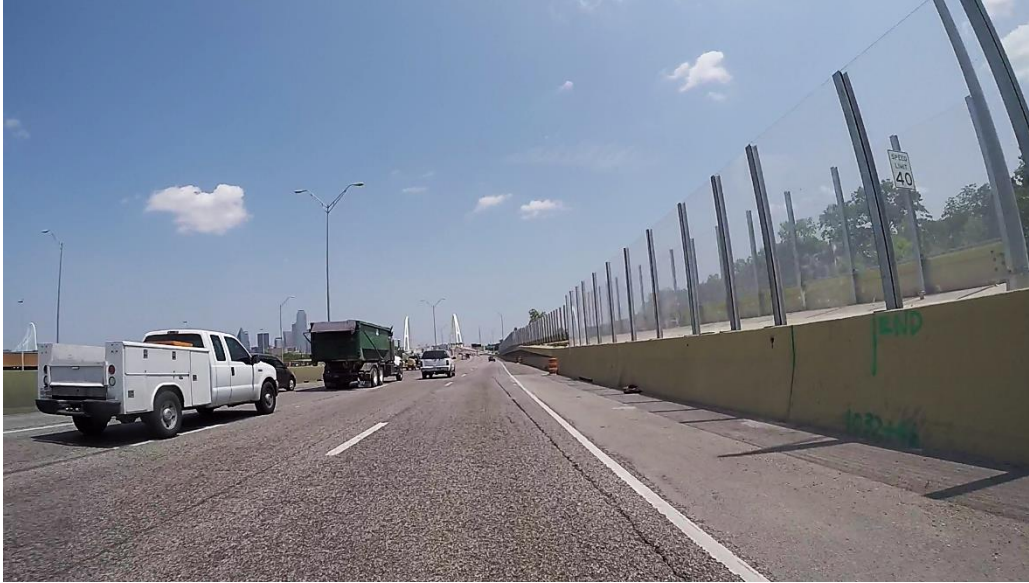
indicate the initial contractor's end of Segment 2, and the length of the overlap extended to the east in Figure 9.25 beyond the paint mark (11 panels added beyond the paint).

Figure 9.25: Segment 2 extended to the east to include overlap (August 2018)

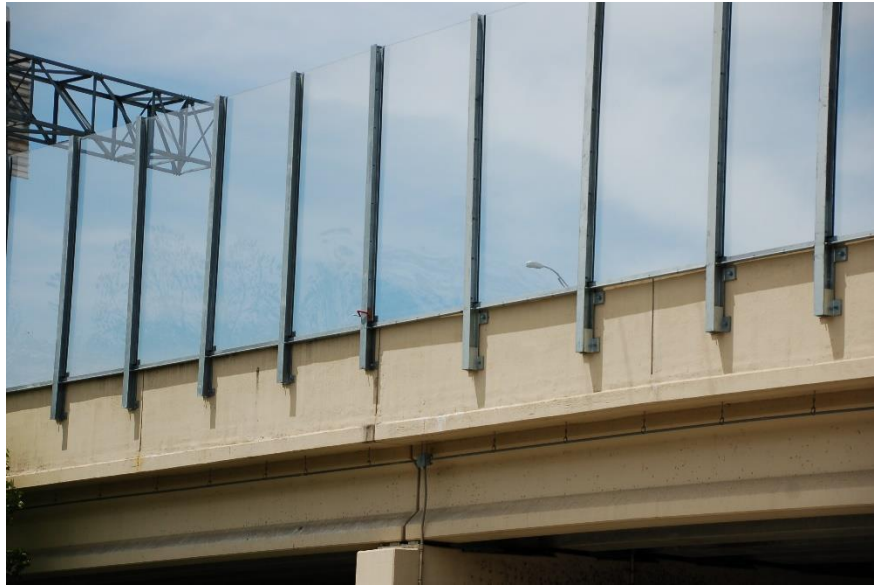
- The system that attaches the vertical supports to the concrete walls seems more robust than the one used for the Site 1 wall. There is also more length of the posts

that is bolted to the concrete (Figure 9.28). In this photograph, a red clamp is attached to the last post from the Site 1 wall.

Figure 9.28: Different anchoring for vertical posts at Site 1 wall (L) and Site 2 wall (R)

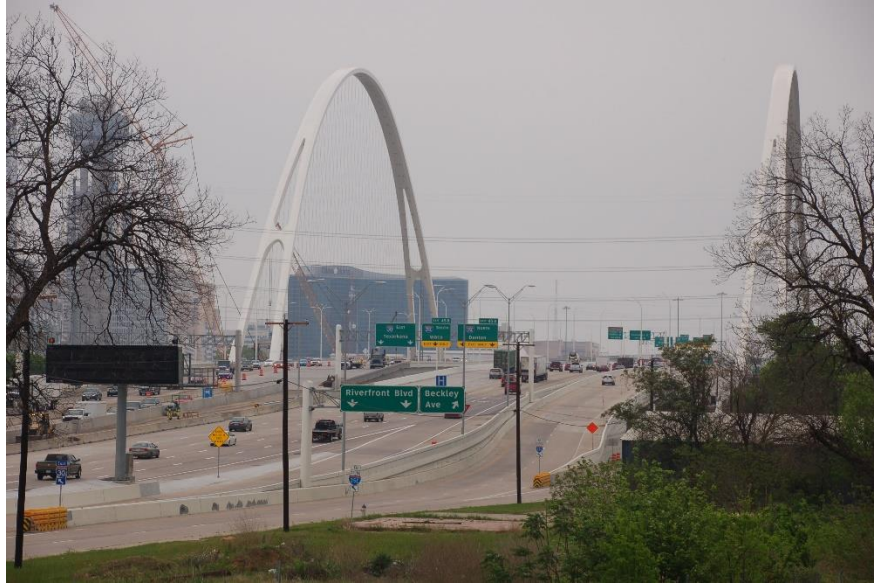
- An asphalt overlay has been placed on the main lanes CRCP approaching the McDermott Bridge, as can be seen in Figures 9.44 to 9.46, showing comparisons of photographs from March 2017 and April 2018.

Figure 9.44: CRCP on both the main lanes and frontage road (March 2017)

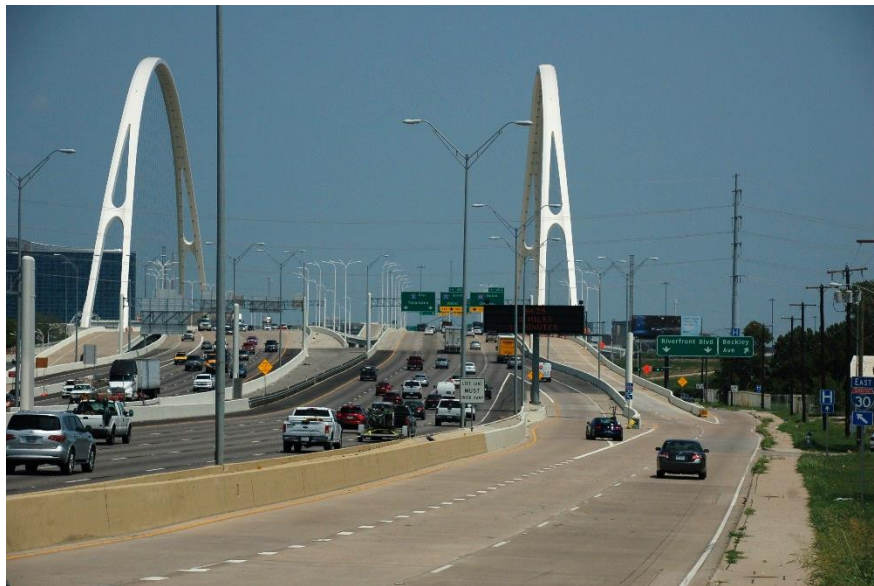
Figure 9.45: Asphalt overlay on main lanes (L), CRCP on frontage road (R) (April 2018)

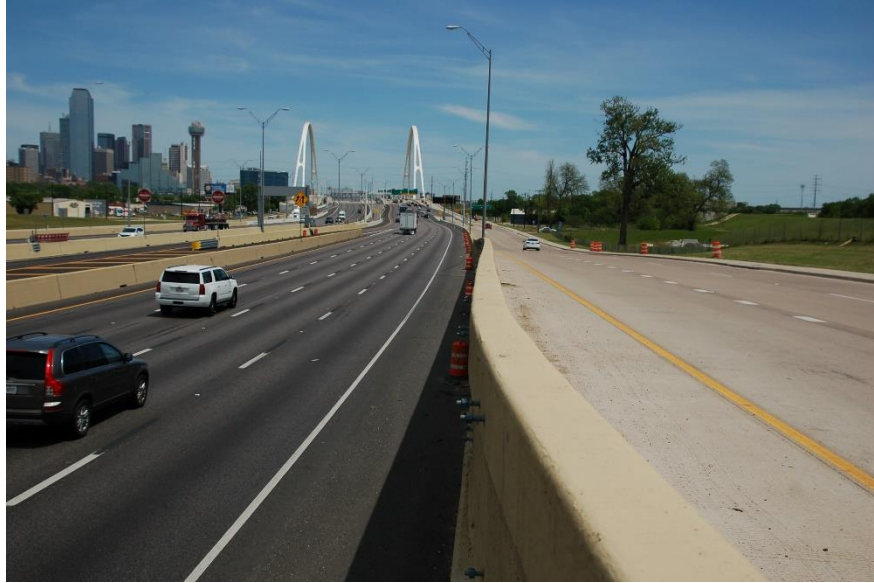
Figure 9.46: Asphalt overlay on main lanes (L), CRCP on frontage road (R) (April 2018)

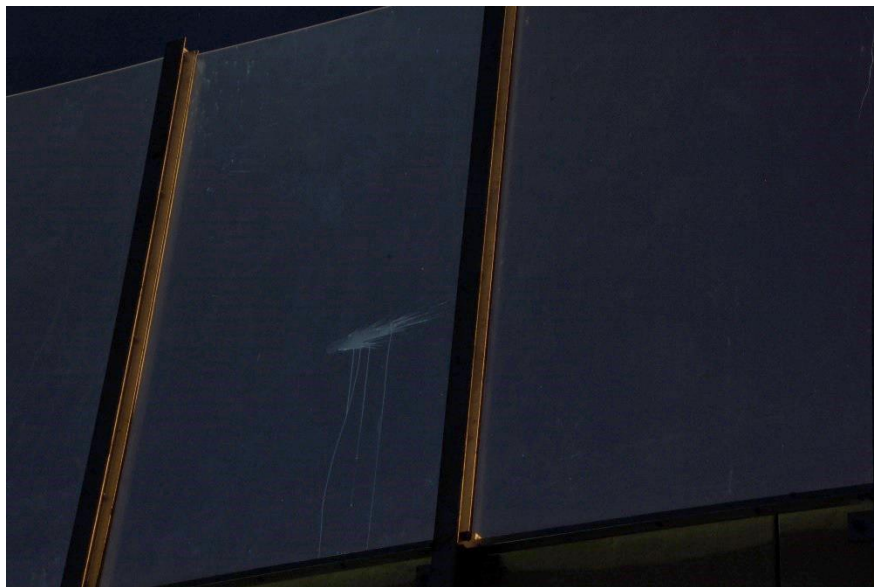
- There is already a bird-crash on one of the panels of Segment 1, east of Sylvan Ave., close to the easternmost end of the segment (Figure 9.47).

Figure 9.47: Bird-crash in one of the panels of Segment 1 (April 2018)

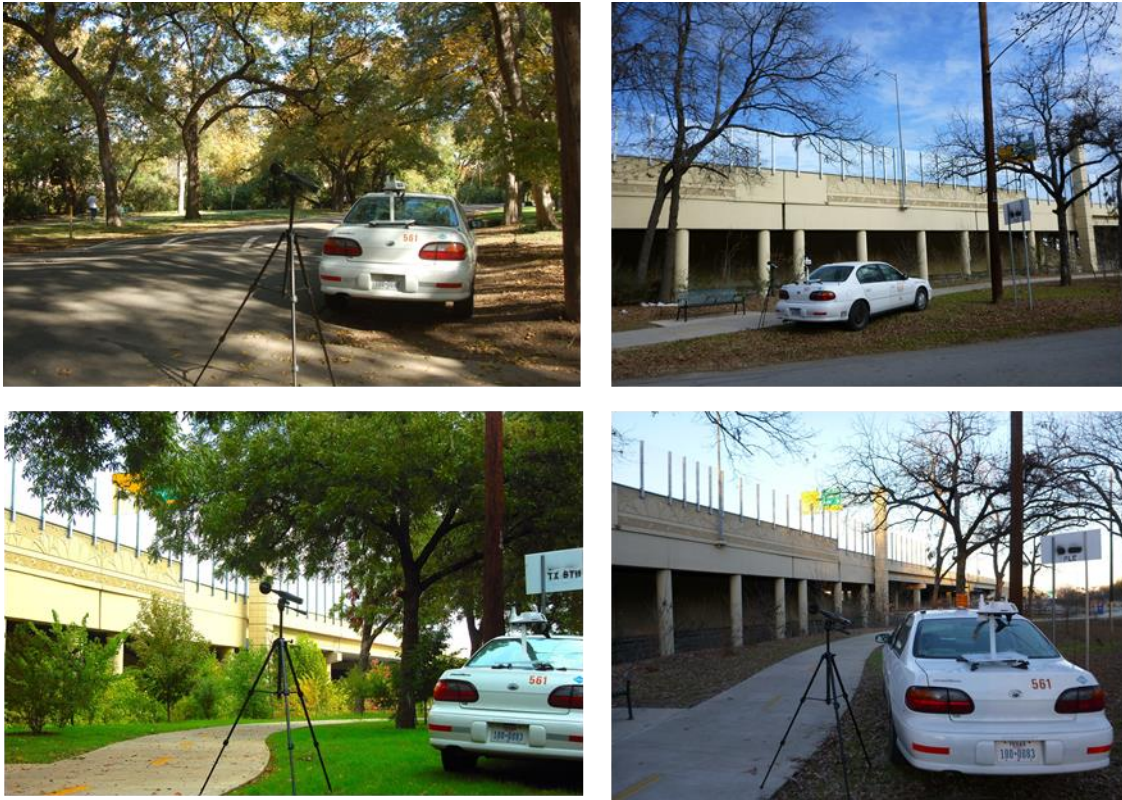
An aspect that has not been discussed in this report, but that has been observed throughout the measurement periods over the seasons, is the effect of the foliage on the way noise propagates at this location; the absence of foliage appears to result in higher noise propagation; therefore, foliage might have some influence on the noise levels. It diffracts and absorbs sound. There is a considerable difference in the aspect of the foliage between the hot and cold seasons in this area, as illustrated in Figure 10.1. Therefore, the hypothesis is that when the vegetation looks as barren as the pictures on the right side of Figure 10.1

show (late fall, winter, and early spring), the noise from the highway propagates without obstruction towards the receivers, whereas when the foliage obstructs the view of the highway from the receivers locations, it contributes to lowering the noise levels.

Figure 10.1: Foliage differences between warm (left) and cold (right) seasons in the proximity of the barrier
