# **INCREASED SPAN LENGTH FOR THE MGS LONG-SPAN GUARDRAIL SYSTEM PART II: FULL-SCALE CRASH TESTING**

MwRSF Research Report No. TRP-03-339-17

April 7, 2017

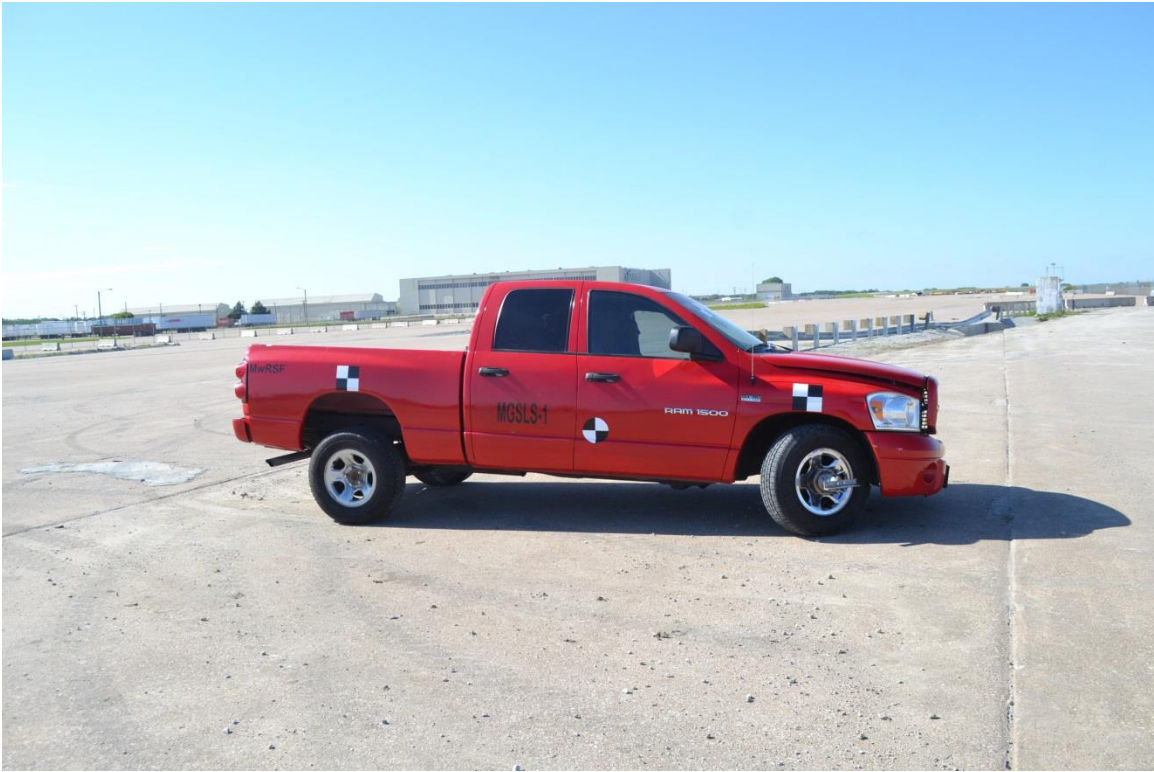
Figure 47. Vehicle Final Position and Trajectory Marks, Test No. MGSL-1

Initial vehicle impact was to occur at the centerline of post no. 11, as shown in Figure 46, which was selected using LS-DYNA analysis to evaluate the potential for vehicle instability by maximizing the interaction of the front wheel of the pickup truck with the wing wall of the culvert [3-4]. The actual point of impact was 1¾ in. (44 mm) downstream from post no. 11. A sequential description of the impact events is contained in Table 4. The vehicle came to rest 30 ft – 10 in. (9.4 m) behind the system and 177 ft – 6 in. (54.1 m) downstream from the point of impact. The vehicle trajectory and final position are shown in Figures 42 and 47.

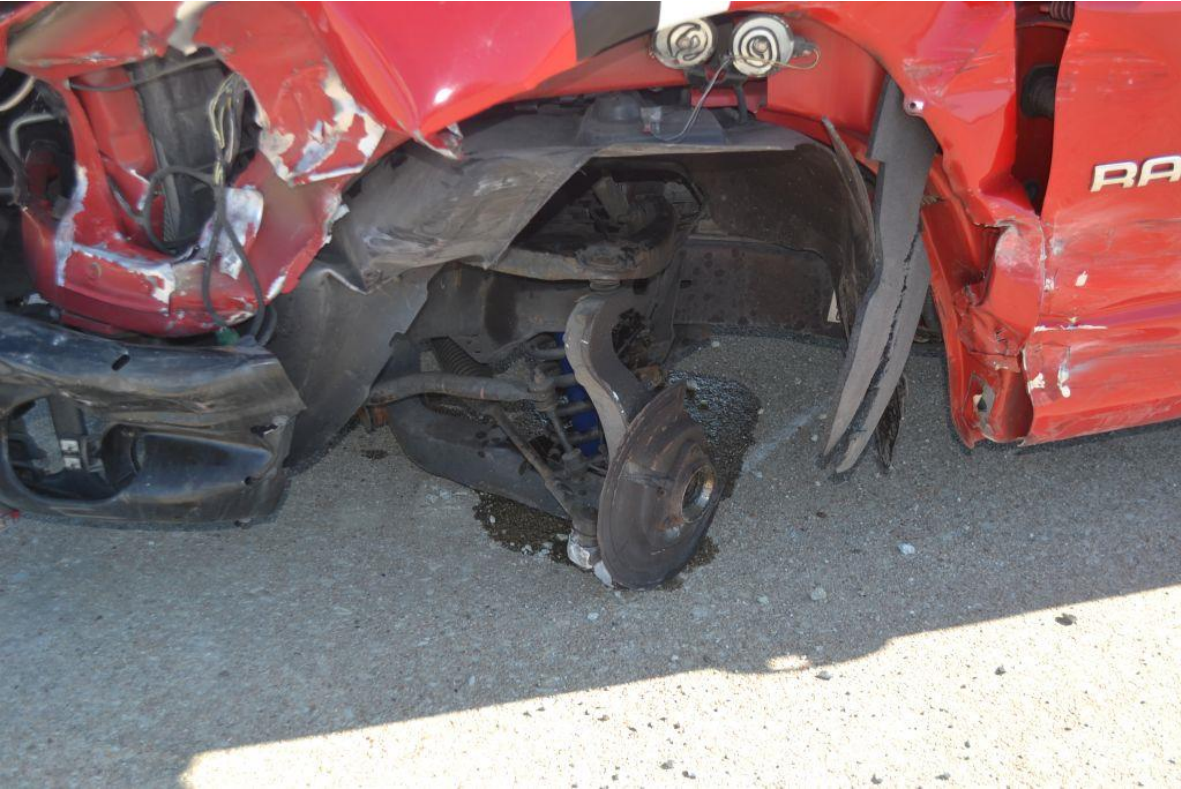
Figure 57. Vehicle Damage, Left Fender, Test No. MGSL-1

The damage to the vehicle was moderate, as shown in Figures 56 through 58. The maximum occupant compartment deformations are listed in Table 5 along with the deformation limits established in MASH for various areas of the occupant compartment. Note that none of the MASH-established deformation limits were violated. Complete occupant compartment and vehicle deformations and the corresponding locations are provided in Appendix D.

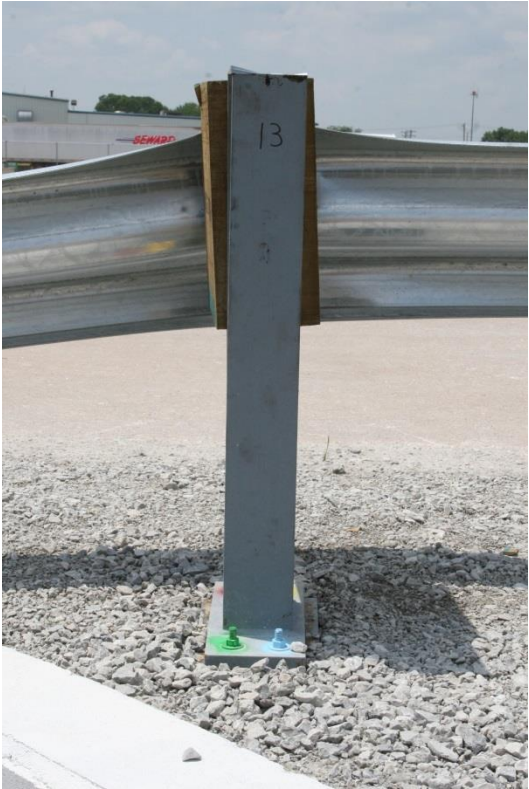
Figure 71. Damage at Post No. 13, Test No. MGSLS-2

Damage to the barrier system was severe, as shown in Figures 68 through 79. Barrier damage consisted of rail deformation and tearing, disengagement of W-beam rail away from posts, bending of steel posts, fracture of wood posts, and damage to the concrete culvert. The length of vehicle contact along the barrier was approximately 80 ft (24.4 m), which began 239<sup>7</sup>/<sub>8</sub> in. (6.1 m) upstream from post no. 13 and extended through the end of the barrier system.

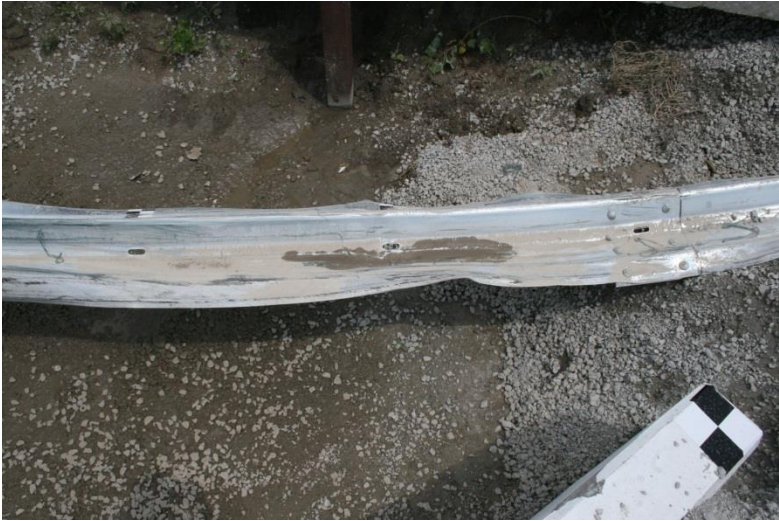
Figure 72. Damage Between Post Nos. 13 and 14, Test No. MGSL-2

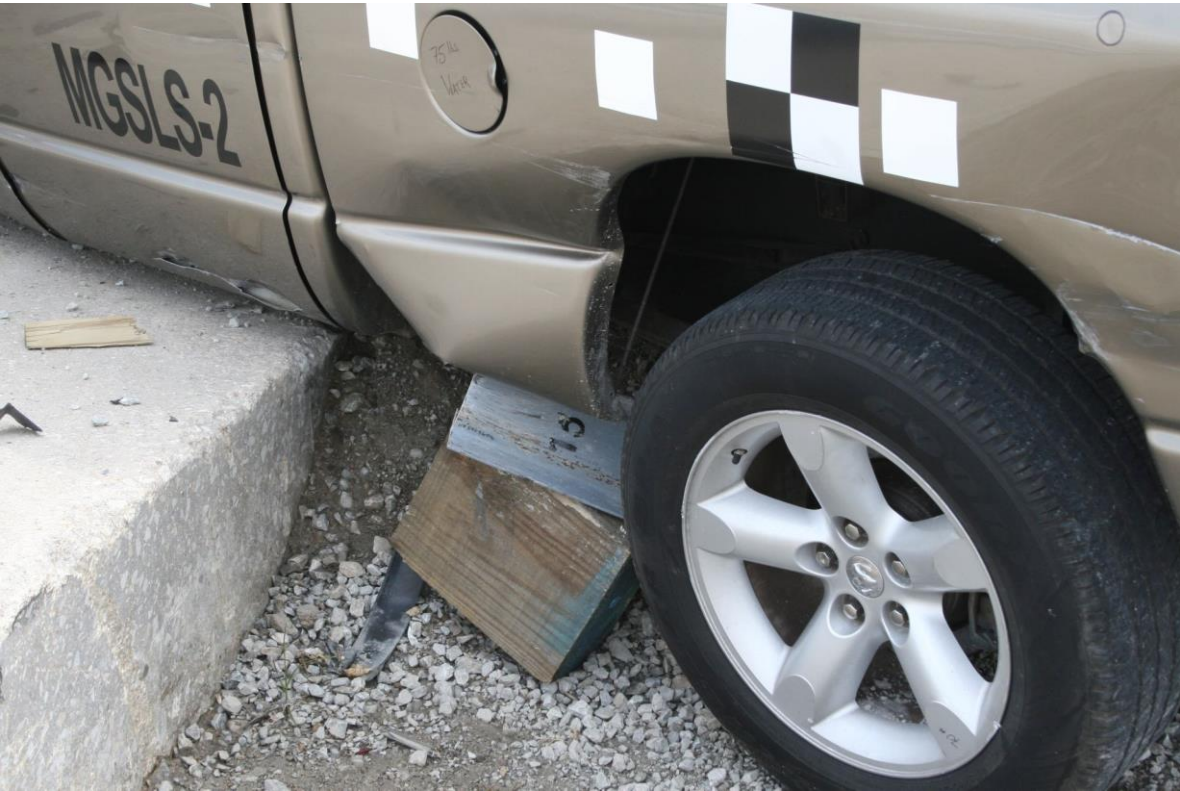
Figure 74. Damage at Post No. 15, Test No. MGSL-2

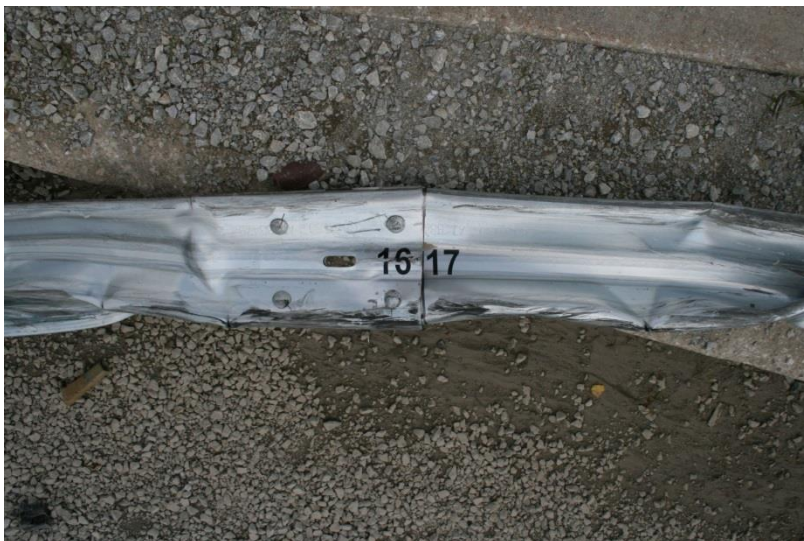
Figure 75. Damage at Post No. 16 and Splice 16-17, Test No. MGSLS-2

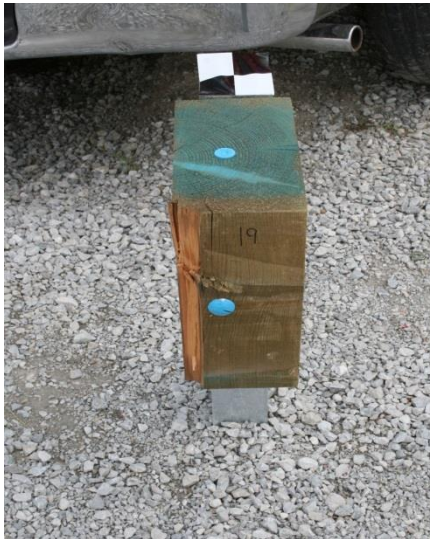
Figure 76. Damage to Post Nos. 17 through 19, Test No. MGSLS-2

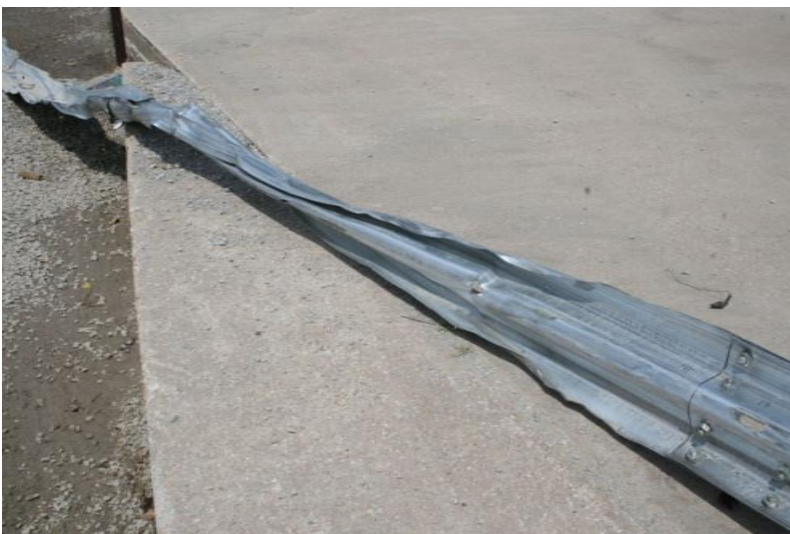
Figure 77. Damage to Rail Between Post Nos. 17 through 19, Test No. MGSLs-2
