**NCHRP REPORT 350 ASSESSMENT OF
EXISTING ROADSIDE SAFETY HARDWARE**

Contract No. DTFH61-97-C-00039
Project No. 404211-F

Sponsored by
**U.S. Department of Transportation
Federal Highway Administration**

**TEXAS TRANSPORTATION INSTITUTE
THE TEXAS A & M UNIVERSITY SYSTEM
COLLEGE STATION, TEXAS 77843**

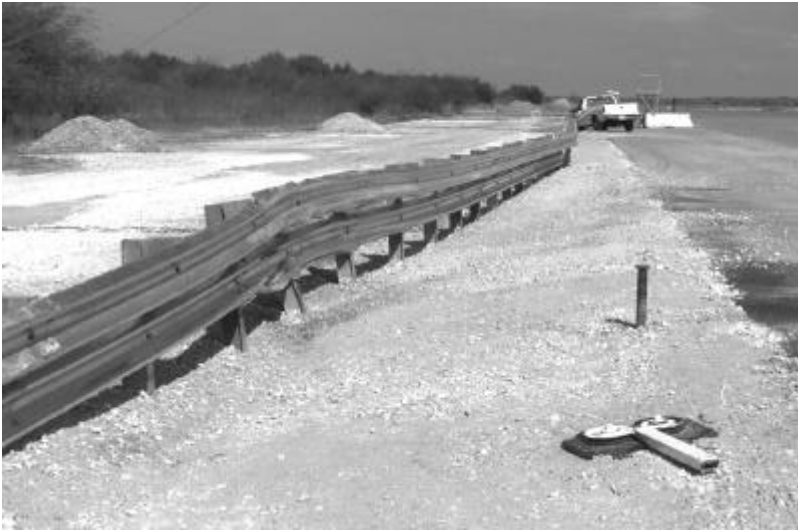
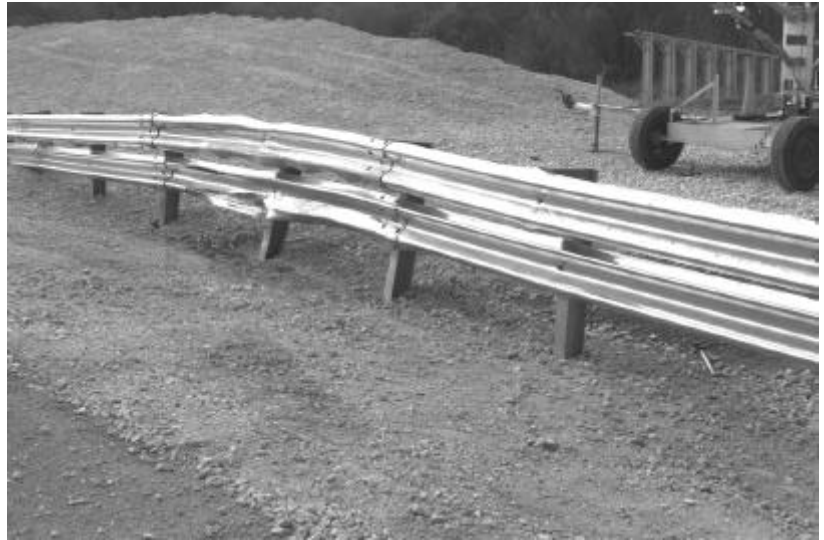
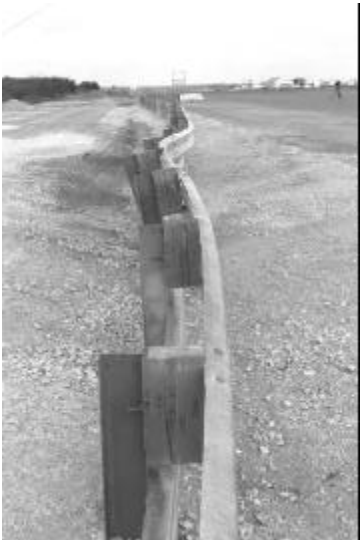
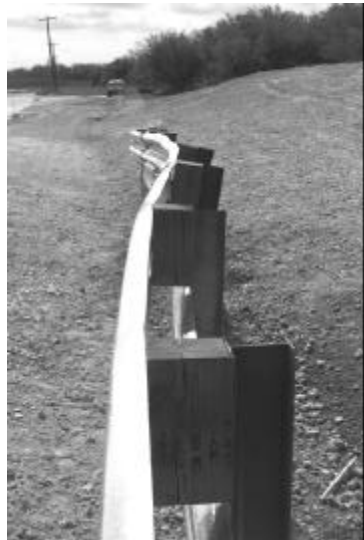
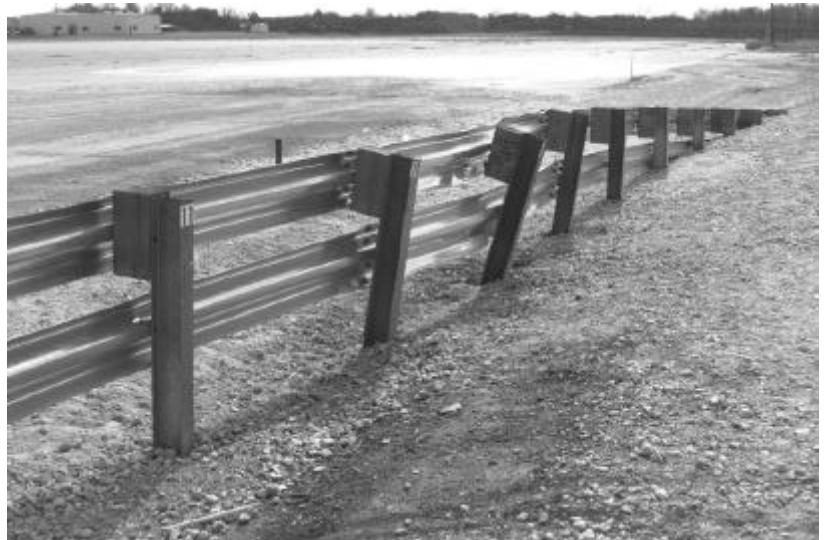
Figure 4. G4 W-beam guardrail buried-in-backslope terminal after test 404211-1.

Deformation to the upper and lower W-beams extended from between post 8 and 9 to past post 11, as shown in figure 4. The flange on the top of post 8 was deformed. Tire marks on the W-beam could be seen at a point 558 mm down from post 8. On post 9, the lower W-beam was deformed, the bolt on the upper W-beam was pulled completely through, the lower part of the flange was deformed and the wood on the lower section of the block was gouged out. Maximum dynamic deflection of the W-beam during the test was 0.67 m and the maximum residual deformation after the test was 0.41 m near post 11.

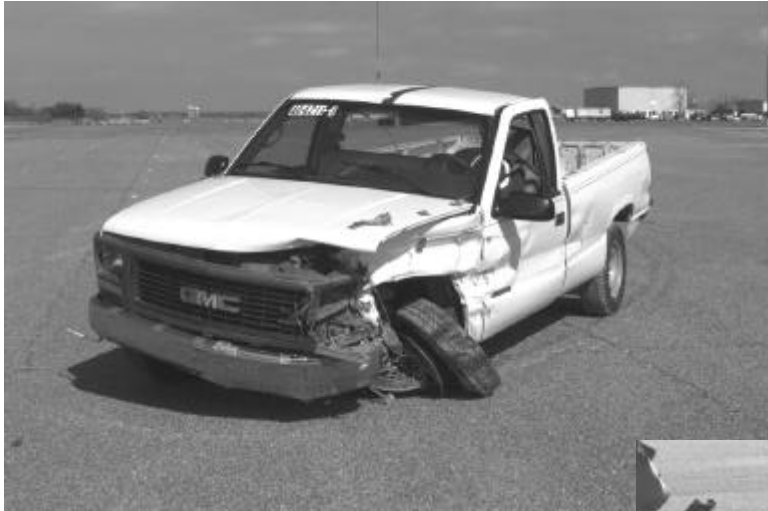
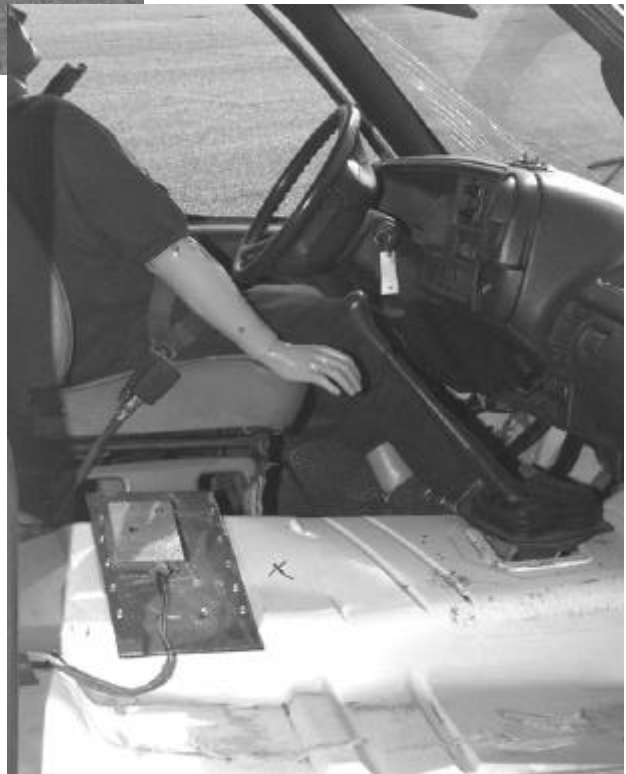
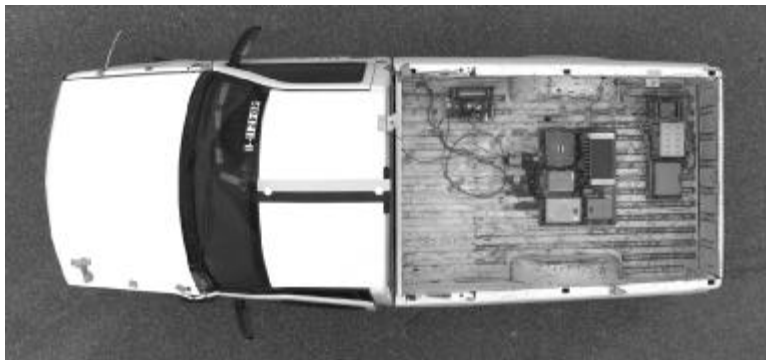
Figure 5. Vehicle after test 404211-1.

The vehicle sustained structural damages on the front left and left side. The left stabilizer bar, upper and lower A-arms, spindle and assembly, tire and wheel were all severely damaged. The front left portion of the bumper, hood, grill and frame were crushed as shown in figure 5. The windshield was cracked in the lower left corner and the left door was deformed to the point that it separated from the frame 90 mm at the top. The left rear quarter panel was dented and the bed shifted 20 mm to the right. The right door was jammed and the front right quarter panel was jammed into the door. The maximum crush to the front bumper was 430 mm on the front and 520 mm on the left side. The floor pan and the firewall were deformed. Maximum deformation of the occupant compartment was 45 mm in the center floor pan area. Exterior vehicle crush and occupant compartment deformation measurements are shown in appendix B, tables 25 and 26.

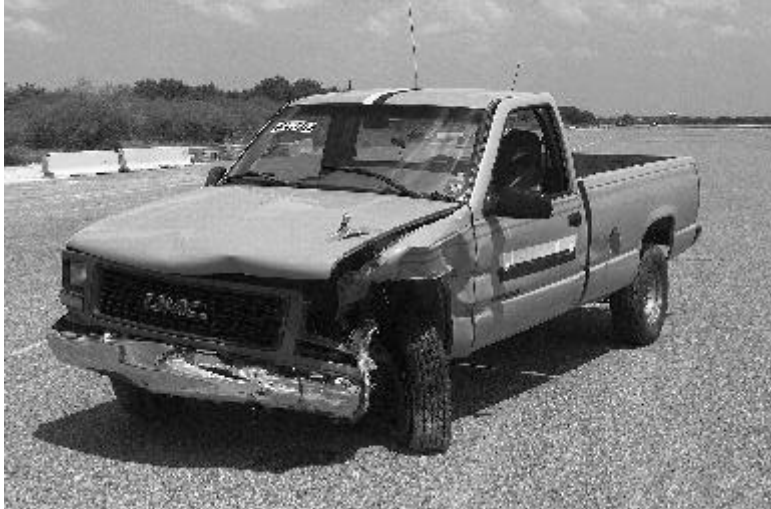
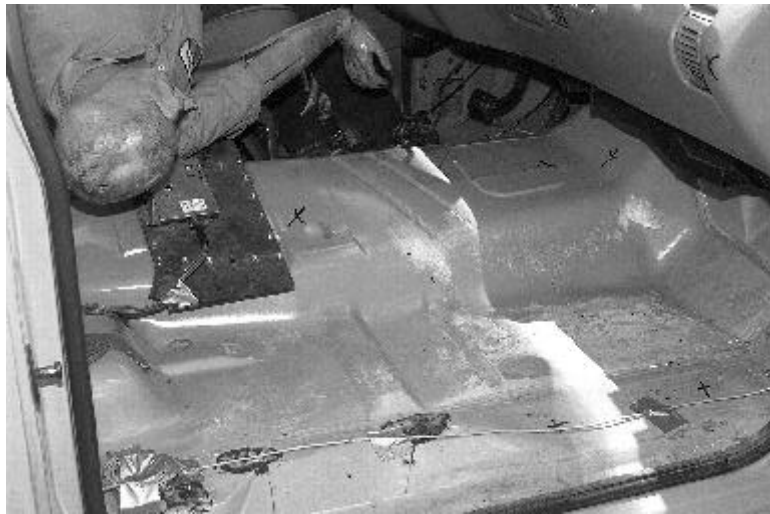
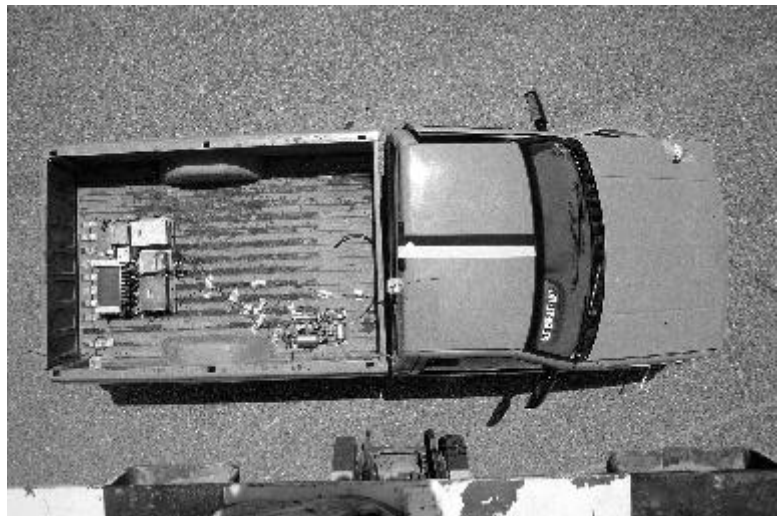
Figure 11. Vehicle after test 404211-13.

The pickup sustained moderate damage as shown in figure 11. Structural damage included deformed left front frame and left outer tie rod. Also damaged were the front bumper, hood, radiator, fan, left front tire and wheel, left front quarter panel, left door, and left rear of the bed. The windshield received stress cracks and the left door window glass was broken. Maximum exterior crush was 550 mm to the left front corner at bumper height. Maximum occupant compartment deformation was 125 mm in the center floor pan area. Exterior vehicle crush and occupant compartment measurements are shown in appendix B, tables 27 and 28.

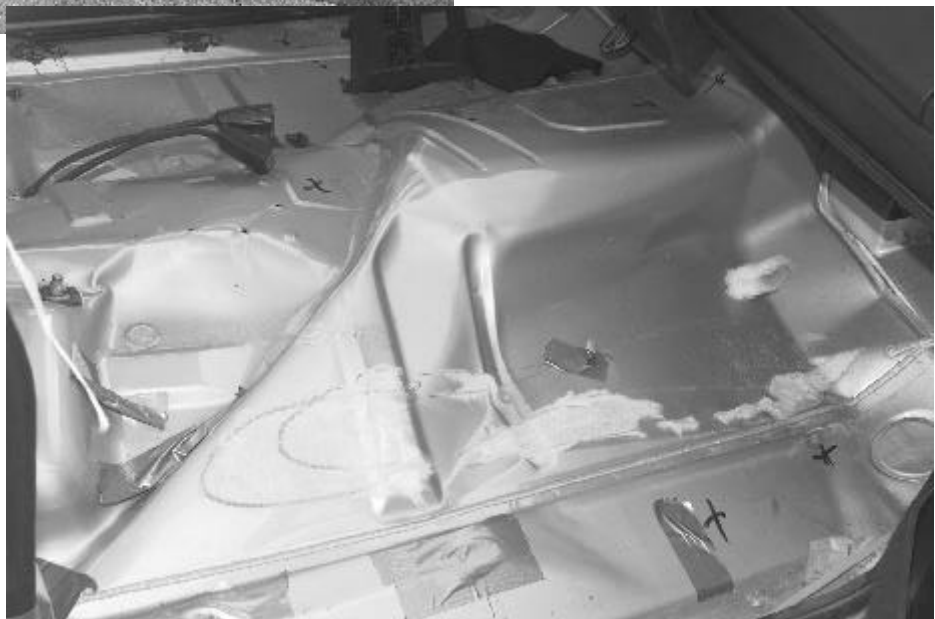
Figure 28. Vehicle after test 404211-12.

The vehicle sustained structural damage to the right side frame rail, right front upper and lower A-arms, and floor pan. The drive shaft was separated, the right rear U-bolts broke at the axle and the shock pulled out. As shown in figure 28, the front bumper, grill, radiator, fan, right front tire and rim, right front quarter panel, right door, right rear quarter panel, rear bumper, and right rear tire and rim were damaged. The windshield was shattered and the cab was pushed rearward into the bed. The front end of the vehicle was shifted to the left 140 mm. Maximum exterior crush to the vehicle was 500 mm at the right corner at bumper height. Maximum occupant compartment deformation was 80 mm in the lateral direction near the occupant's feet. Exterior vehicle crush and occupant compartment measurements are shown in appendix B, tables 33 and 34.

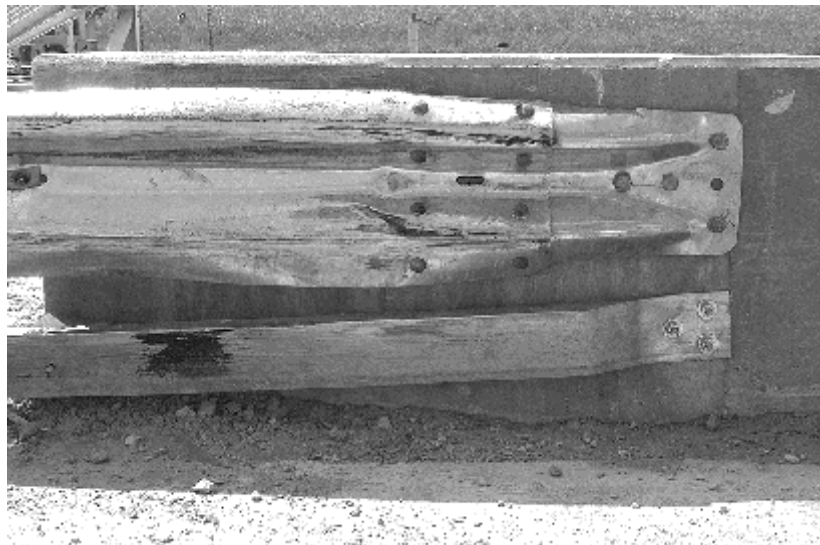
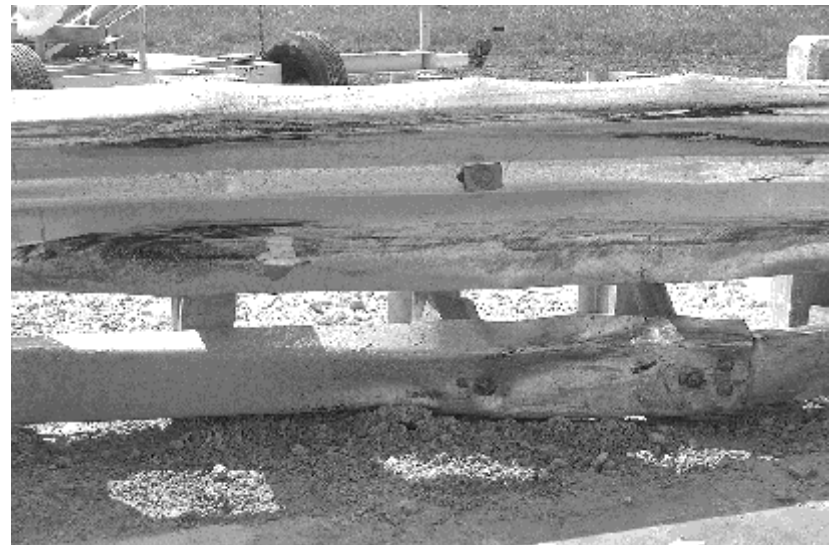
Figure 33. Installation after test 404211-4.

The vertical flared back transition received moderate damage as shown in figure 33. Deformation to the upper and lower W-beams extended from post 5 through post 1. The bolt was out of posts 1 and 2 at the bottom blockout. Also at post 2, the rub rail was deformed outward. At

post 3, the rub rail was twisted. The spacing between the metal pipe and blockout and the concrete parapet was 45 mm before the test and after the test the pipe was leaning against the parapet and the spacing was 15 mm. The concrete parapet was pushed back 25 mm. Total length of contact of the vehicle with the transition and concrete parapet was 3.91 m.

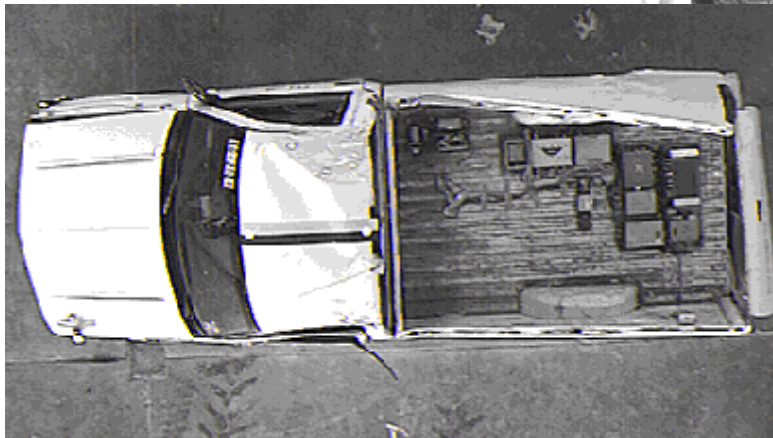
Figure 34. Vehicle after test 404211-4.

The vehicle sustained substantial damage as shown in figure 34. The upper and lower A-arms and frame rail were all severely damaged. Both left-side quarter panels were damaged and the left door had a gap (not measurable). The right door, front and rear rims, and the rear quarter panel sustained damage. Also damaged were the rear bumper and tailgate. The front bumper, grill, hood, radiator, fan, and cab were deformed. The windshield and the right, left, and rear glasses were shattered. Maximum exterior crush to the vehicle was 530 mm at the front bumper and 410 mm above the front bumper. Maximum deformation of the occupant compartment was 75 mm in the center floor pan area and 27 mm in the firewall area. Details can be found in appendix B, tables 35 and 36.

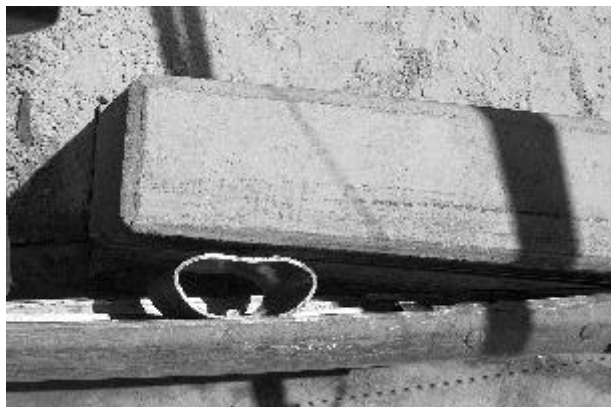
Figure 39. Installation after test 404211-3.

The Pennsylvania transition sustained minimal damage as shown in figure 39. Tire marks were on the face of the W-beam rail element and rub rail and both were deformed. The bolt on the rub rail at post 2 was bent and the bolt was pulled out of the rub rail at post 4. The spacer tube was crushed 28 mm. The space between the spacer tube and the concrete parapet was reduced 5 mm. No movement was noted in the end terminal. Maximum dynamic deflection of the W-beam rail element was 177 mm. Maximum permanent rail deformation of the W-beam rail element was 110 mm at post 1 and the rub rail was deformed 98 mm at post 2. The length of contact of the vehicle with the transition was 3.9 m. No apparent cracking was observed in the concrete parapet or slab.

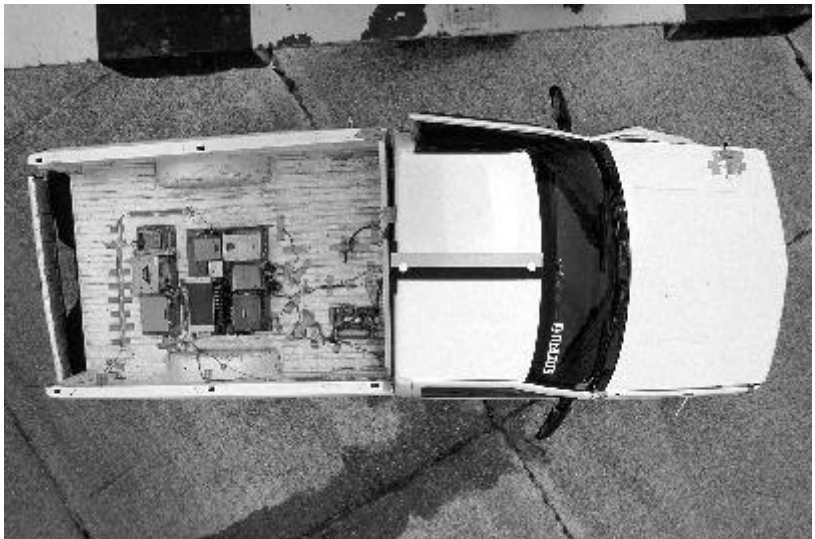
Figure 46. Vehicle after test 404211-7.

Moderate damage was imparted to the 2000P vehicle as shown in figure 46. The following vehicle components received structural damage: the frame at the left front, steering arm, stabilizer bar, left side rod ends, left upper and lower A-arms, and left front spindle, rotor and tire. Also damaged were the front bumper, fan, radiator, left front quarter-panel, left door, left side of the bed, and the left rear rim. The floor pan and firewall were deformed and the seam where the floor pan and firewall connect were separated. Maximum exterior crush to the left front corner was 400 mm. Maximum interior deformation was 129 mm at the left side floor pan area. Exterior vehicle crush and occupant compartment measurements are shown in appendix B, tables 39 and 40.

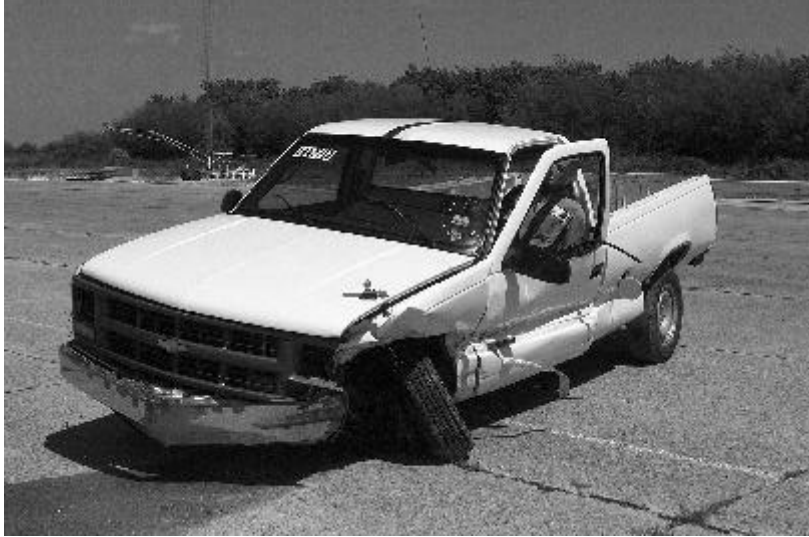
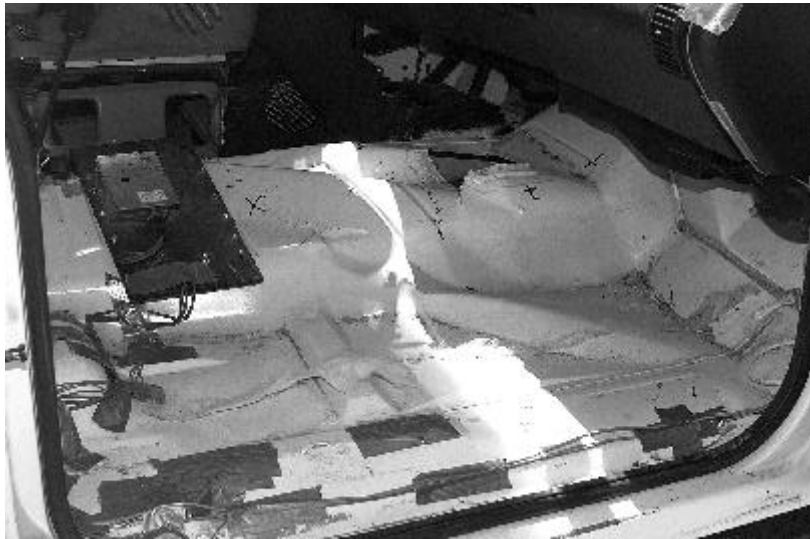
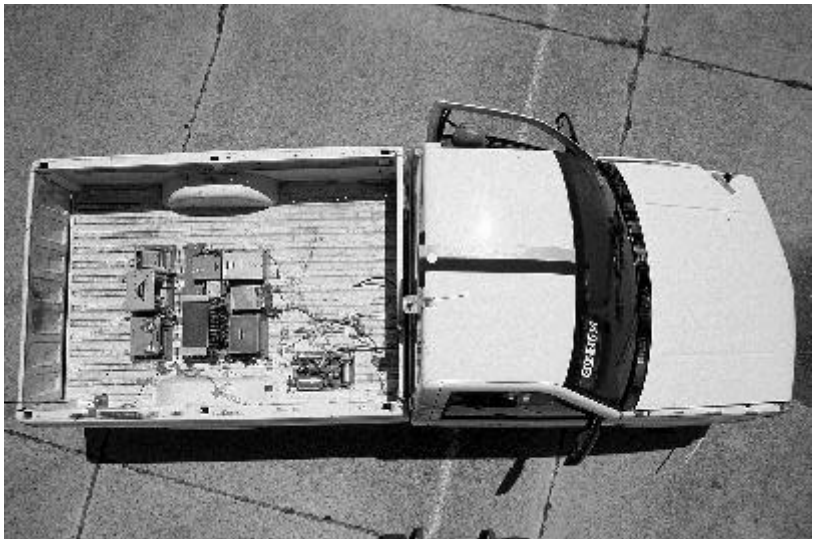
Figure 52. Vehicle after test 404211-9.

The vehicle sustained structural damage to the left front as shown in figure 52. Structural damage included the left front of the frame, left upper and lower A-arms, left inner and outer tie rods, steering arm, stabilizer bar, floor pan, and firewall. Also damaged were the front bumper, hood, grill, fan, radiator, left front quarter panel, left door, left rear quarter panel, and the left front tire and wheel rim. The windshield sustained stress cracks. Maximum exterior crush of the vehicle was 430 mm at the left front corner at bumper height. The maximum deformation of the occupant compartment was 130 mm in the center floor pan area and 124 mm in the center firewall area. Exterior vehicle crush and occupant compartment measurements are shown in appendix B, tables 41 and 42.

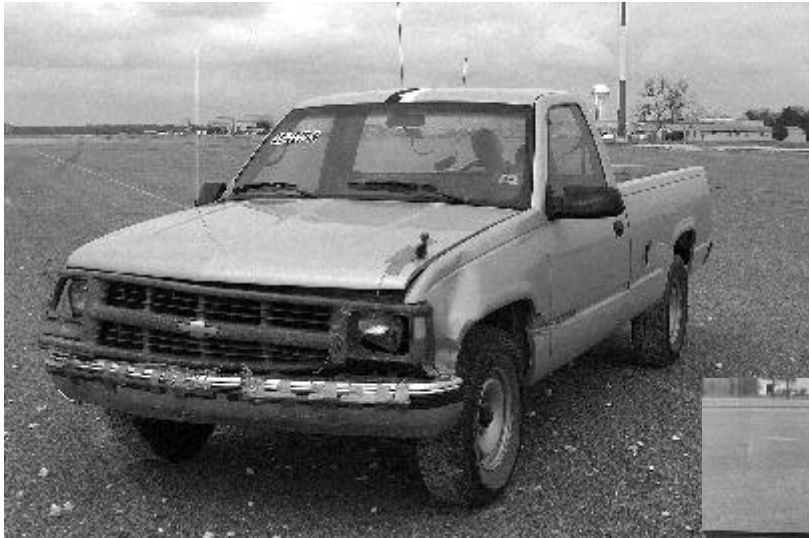
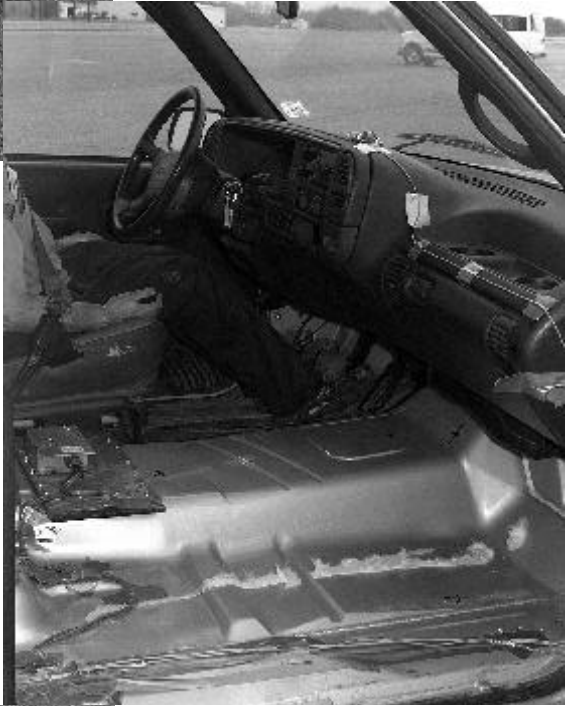
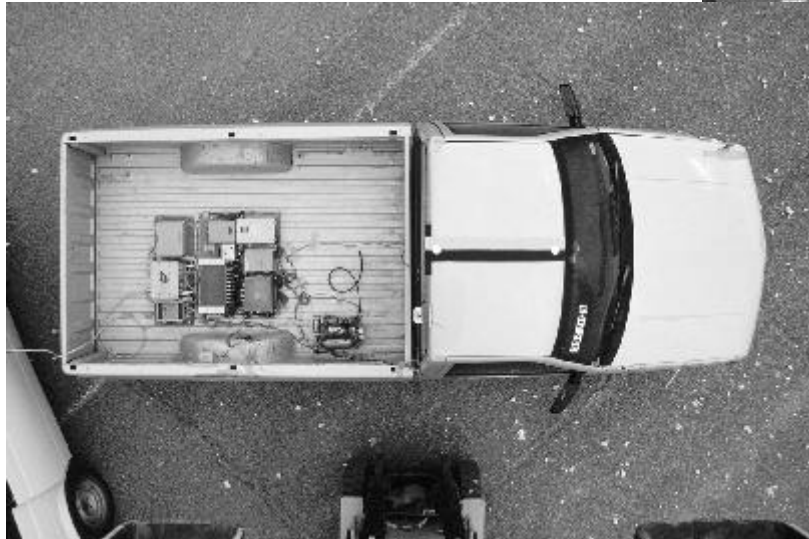
Figure 59. Vehicle after test 404211-8.

The vehicle sustained minor damage as shown in figure 59. There were scuff marks on the left front and rear quarter panels and left door. In addition, the left front and rear tires were cosmetically damaged. Maximum exterior crush to the vehicle was 320 mm above the front bumper at the left front corner. No deformation or intrusion into the occupant compartment occurred from the impact with the cable barrier. Exterior vehicle crush and occupant compartment measurements are shown in appendix B, tables 43 and 44.
