THREE BEAM TRANSITION CRASH TESTS

January 2005

**U.S. Department of Transportation
Federal Highway Administration**

1. Report No. FHWA-RD-04-115		2. Government Accession No.		3. Recipient's Catalog No.	
4. Title and Subtitle Thrie Beam Transition Crash Tests				5. Report Date January 2005

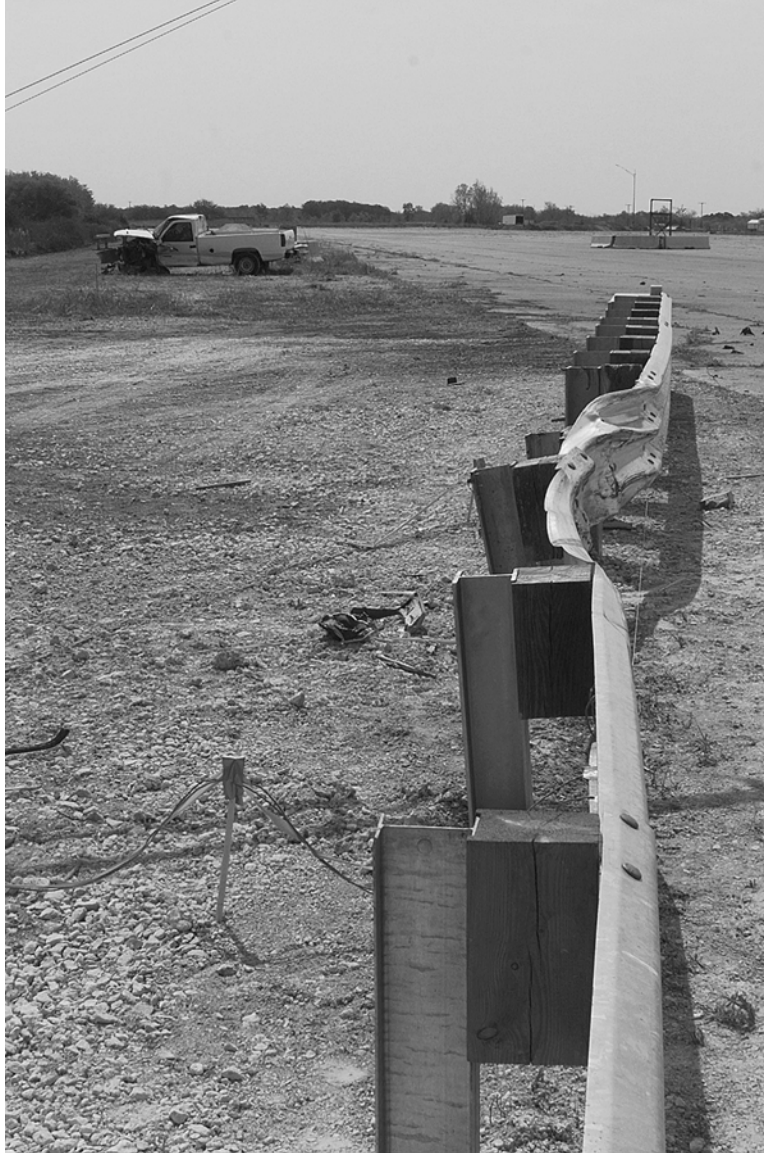
Figure 6. Vehicle trajectory path after test 401021-4.

The Ohio transition sustained moderate damage as shown in figures 6 and 7. Tire marks marred post 13 and the rail element was torn at the splice at post 13. The rail element was detached from post 14. Blockouts were chipped at posts 13 and 14. The blockout at post 15 was twisted and chipped. Posts 16 through 14 were pushed rearward 5 mm, 22 mm, and 80 mm, respectively. Posts 13 and 12 moved 170 mm and 53 mm rearward. Posts 11 to the end terminal were disturbed. Length of contact of the vehicle with the transition was 4.6 m. Maximum dynamic deflection of the rail element during the test was 439 mm and maximum permanent deformation was 190 mm to the rail element at post 13.

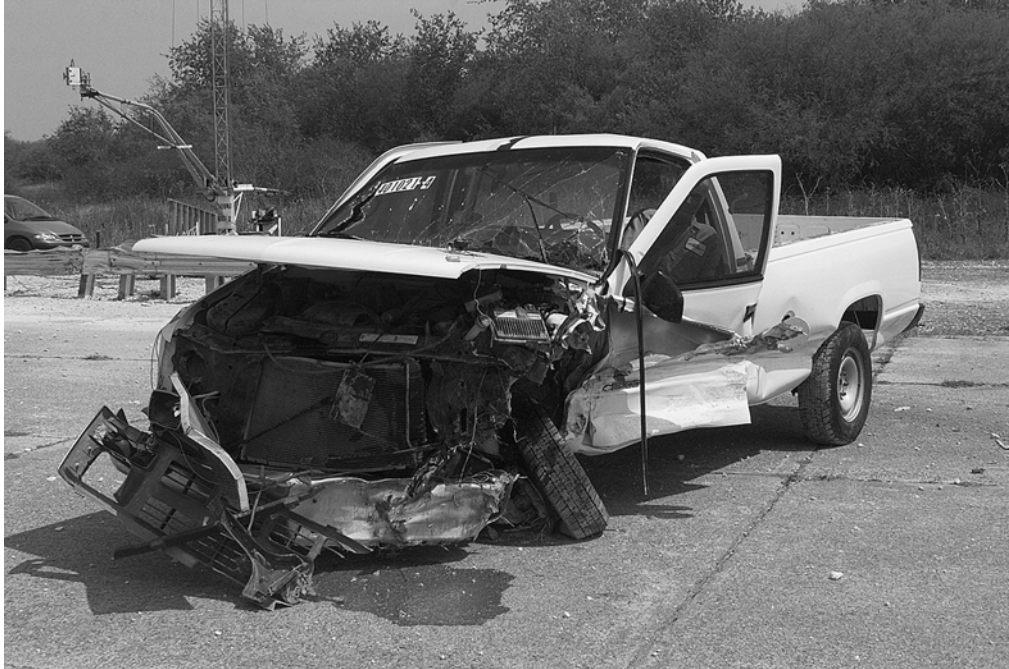
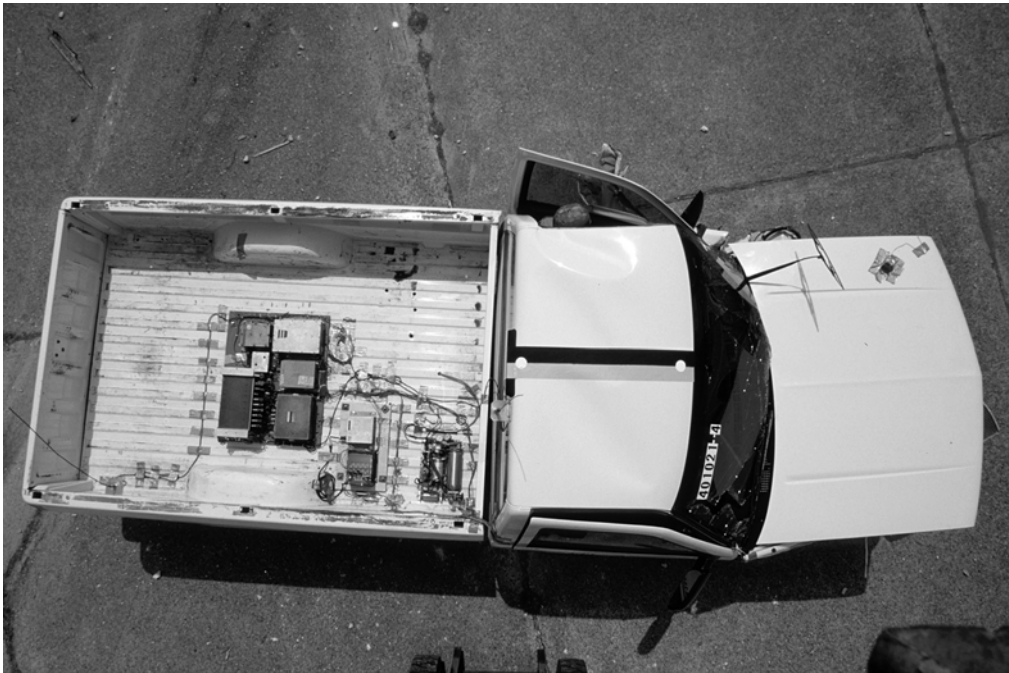
Figure 8. Vehicle after test 401021-4.

Damage imparted to the vehicle is shown in figure 8. The following vehicle components received structural damage: left upper and lower A-arms, right side A and B pillars, left side ball joint, rod ends, steering arm, stabilizer arm, and left front frame. Also damaged were the bumper, hood, radiator, fan, left front and rear quarter panels, left door, left front wheel and rim, right front quarter panel, and right door. The floor pan and roof of the vehicle were deformed. Maximum exterior crush to the front bumper was 740 mm. The interior of the vehicle is shown in figure 9. Maximum deformation of the occupant compartment was 175 mm at the lower kick panel in the driver's foot well area. Exterior vehicle crush and occupant compartment measurements are shown in appendix B, table 16 and figure 112.

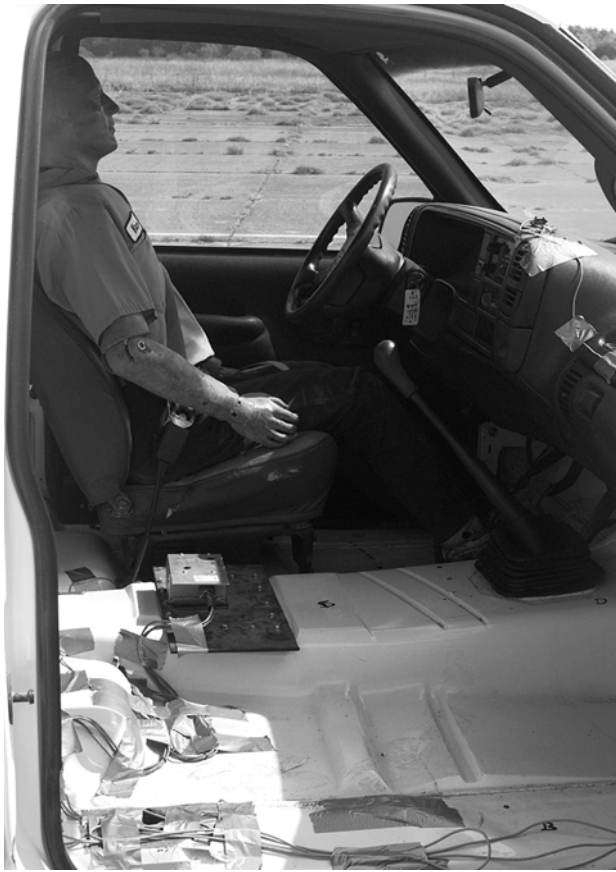
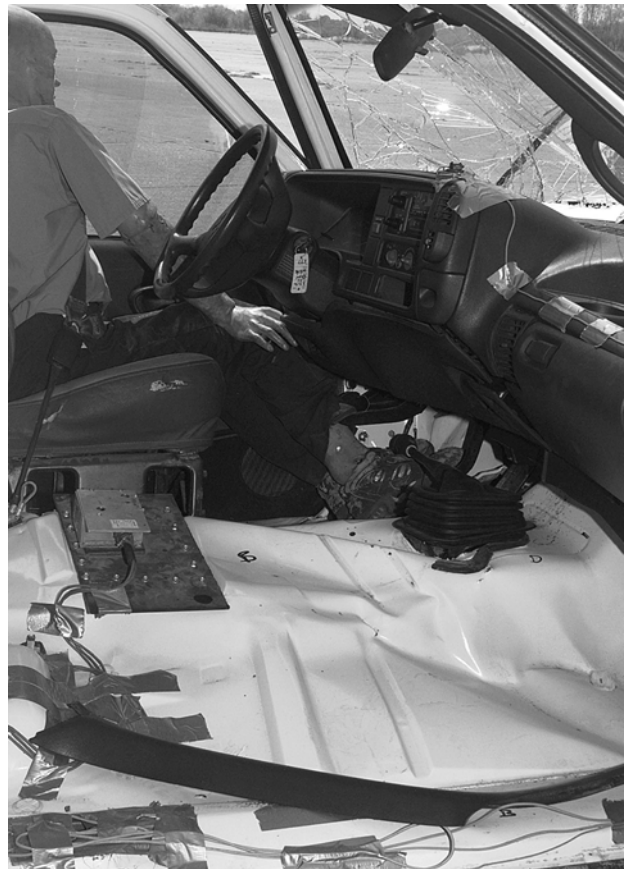
Figure 9. Interior of vehicle for test 401021-4.

Result: No detached elements, fragments, or other debris were present to penetrate or to show potential for penetrating the occupant compartment, nor to present undue hazard to others in the area. Maximum deformation of the occupant compartment was 175 mm to the center of the floor pan area. (FAIL)

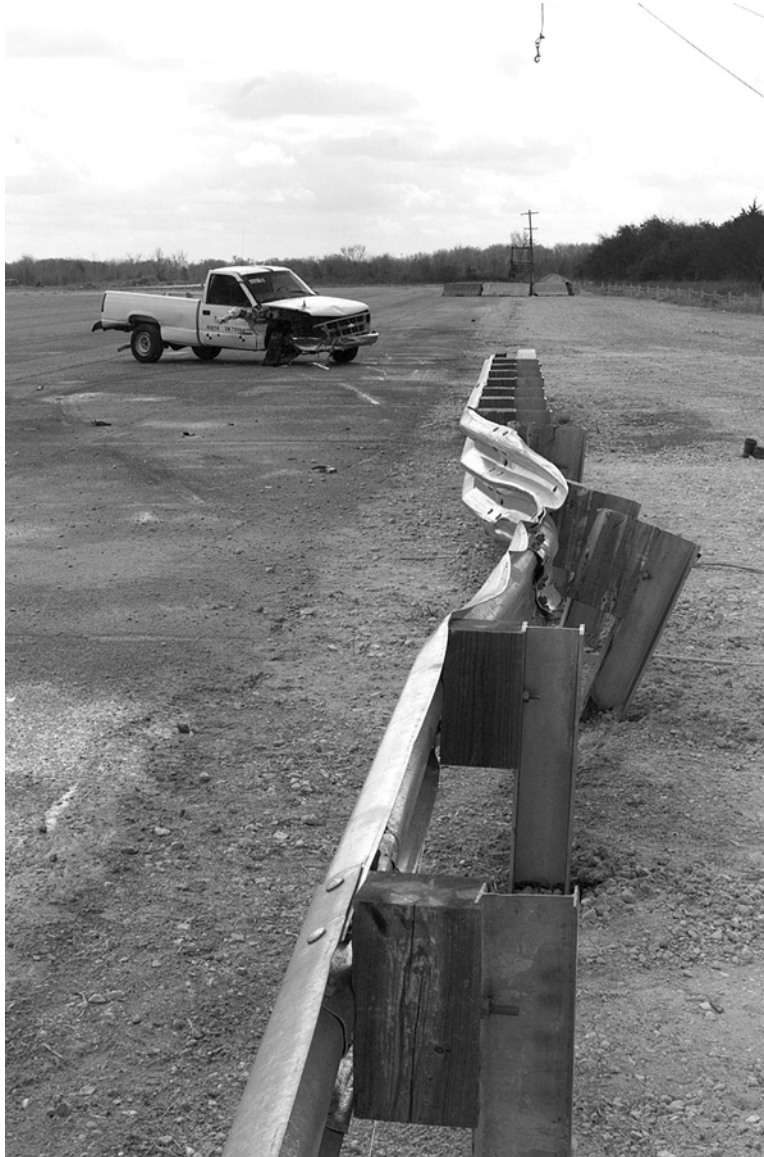
Figure 15. Vehicle trajectory path after test 401021-6.

Damage to the transition is shown in figures 15 and 16. Tire marks were on the impact edge of the flange and front faces of posts 11 and 12. The rail element was separated from the blockout at post 11; the rail element was torn around the lower right splice bolt. The upstream terminal was pulled longitudinally 25 mm. Maximum dynamic deflection of the rail during the test was 659 mm; maximum permanent deformation was 554 mm. The vehicle was in contact with the rail element for a distance of 6.67 m.

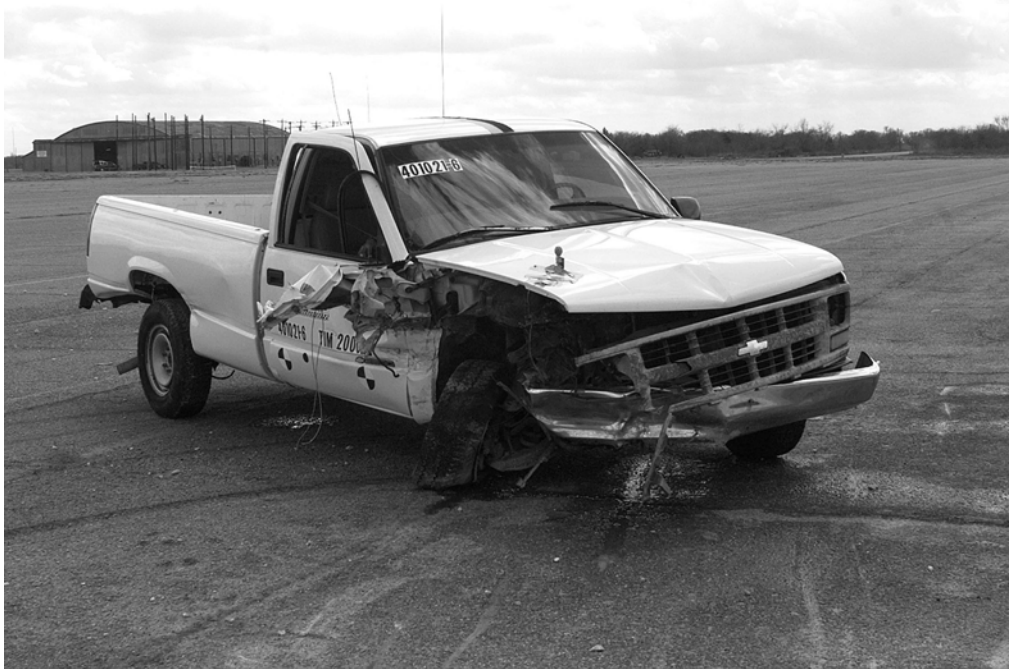
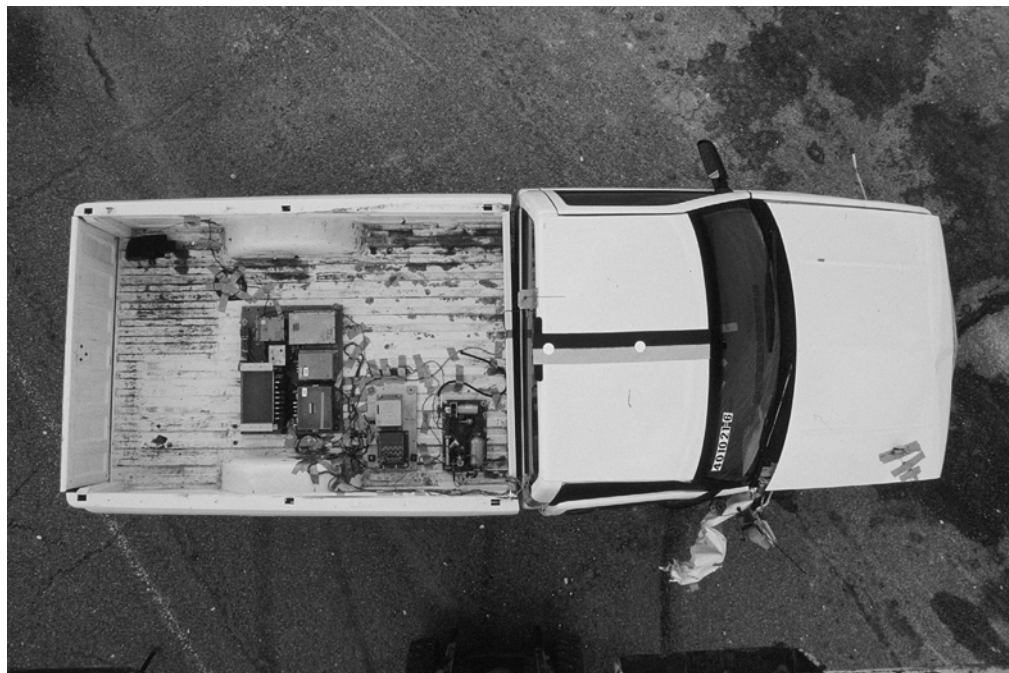
Figure 17. Vehicle after test 401021-6.

The right front quarter of the pickup truck was damaged, as shown in figure 17. Structural damage included deformed right front frame member, stabilizer bar, right upper and lower A-arms, right side tie rod ends and spindle, floor pan, and firewall. Also damaged were the front bumper, fan, radiator, right front quarter panel, right door and window glass, right rear bed, and the right front tire and wheel rim. The windshield sustained stress cracks. Maximum exterior crush to the vehicle in the frontal plane was 680 mm at the right front corner at bumper height, and in the side plane was 470 mm at the right front corner. Maximum occupant compartment deformation was 52 mm in the kickpanel area near the passenger's feet. Photographs of the interior of the vehicle are shown in figure 18. Exterior vehicle crush and occupant compartment measurements are shown in appendix B, table 17 and figure 114.

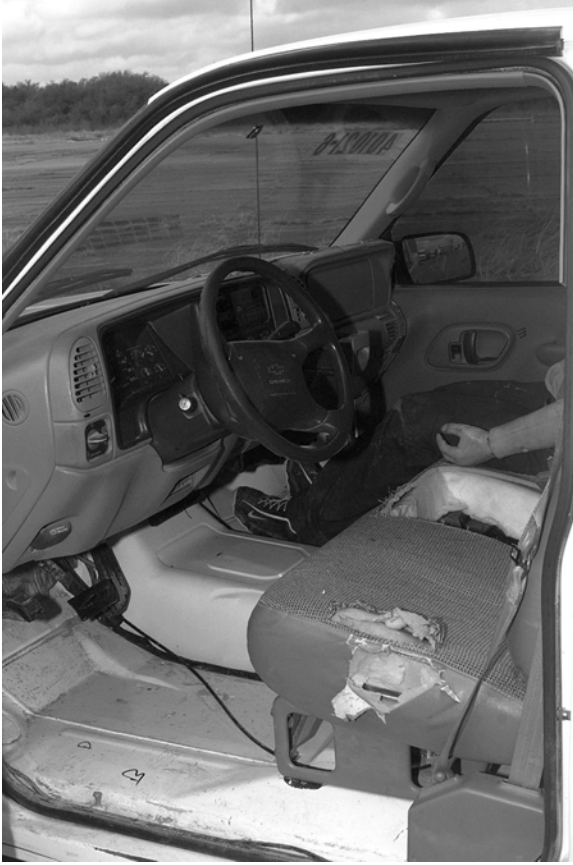
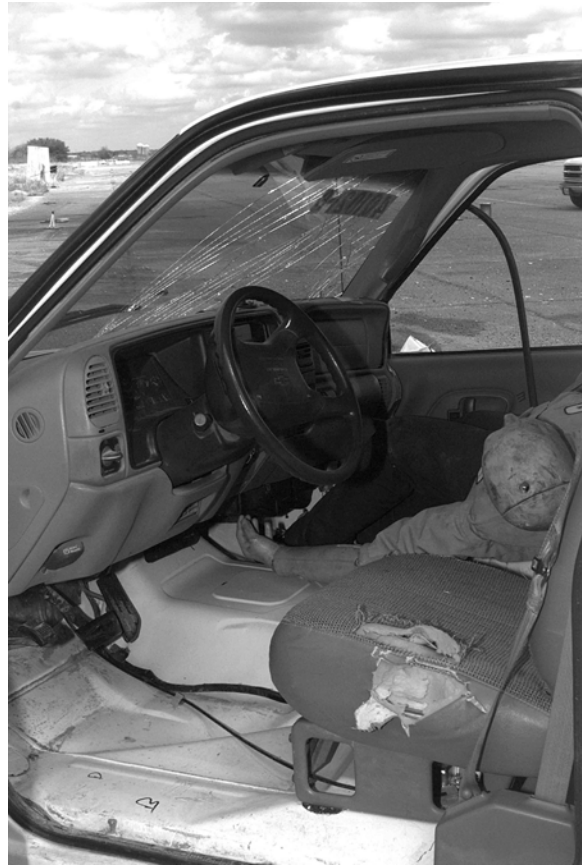
Figure 18. Interior of vehicle for test 401021-6.

Result: No detached elements, fragments, or other debris was present to penetrate or to show potential for penetrating the occupant compartment, or to present undue hazard to others in the area. Maximum occupant compartment deformation was 52 mm at the kickpanel near the passenger's feet. (PASS)

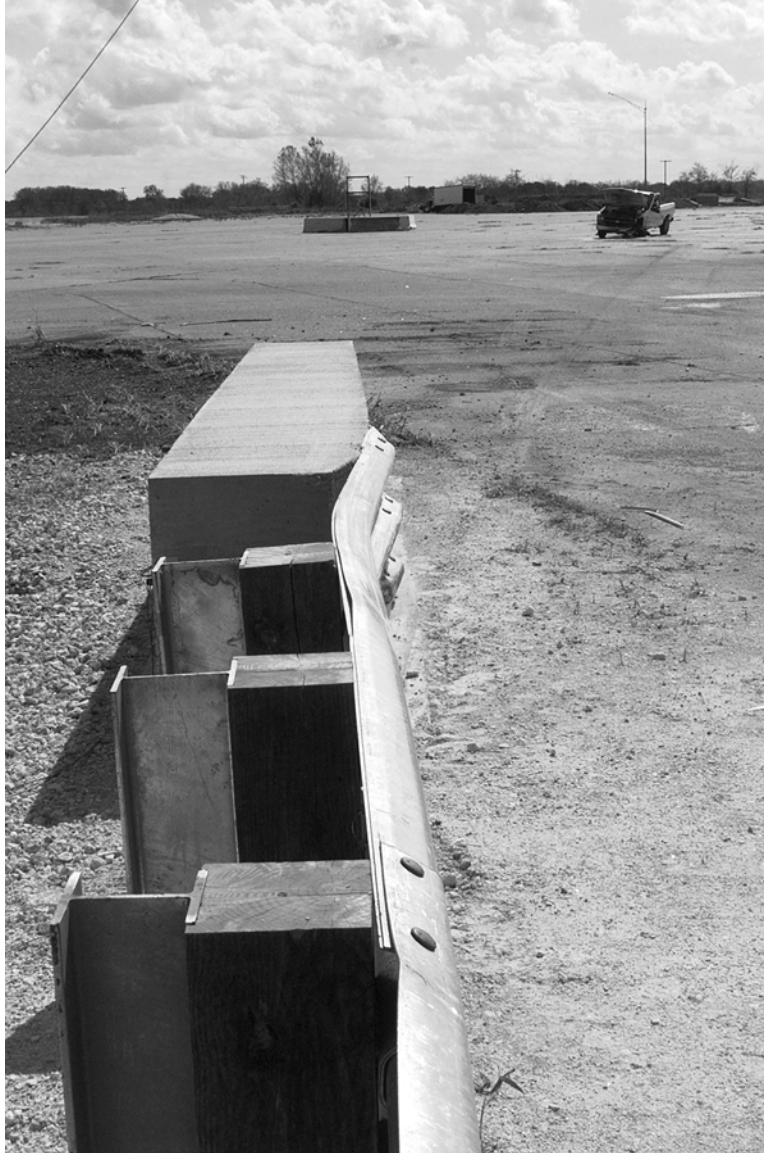
Figure 25. Vehicle trajectory path after test 401021-1.

The Ohio Type 1 Thrie Beam Transition to Concrete Parapet sustained minimal damage as shown in figures 25 and 26. Tire marks marred the rail at post 13 and the end of the concrete parapet (which was chipped). The rail element remained attached at all posts. Post 13 moved 60 mm toward the field side and the rail deformed 78 mm. Post 12 moved 28 mm toward the field side and the rail deformed 15 mm. Posts 11 to the end terminal showed no movement. Length of contact of the vehicle with the transition was 3.2 m. Maximum dynamic deflection of the rail element during the test was 163 mm and maximum permanent deformation was 146 mm to the rail element between post 13 and the end of the concrete parapet.

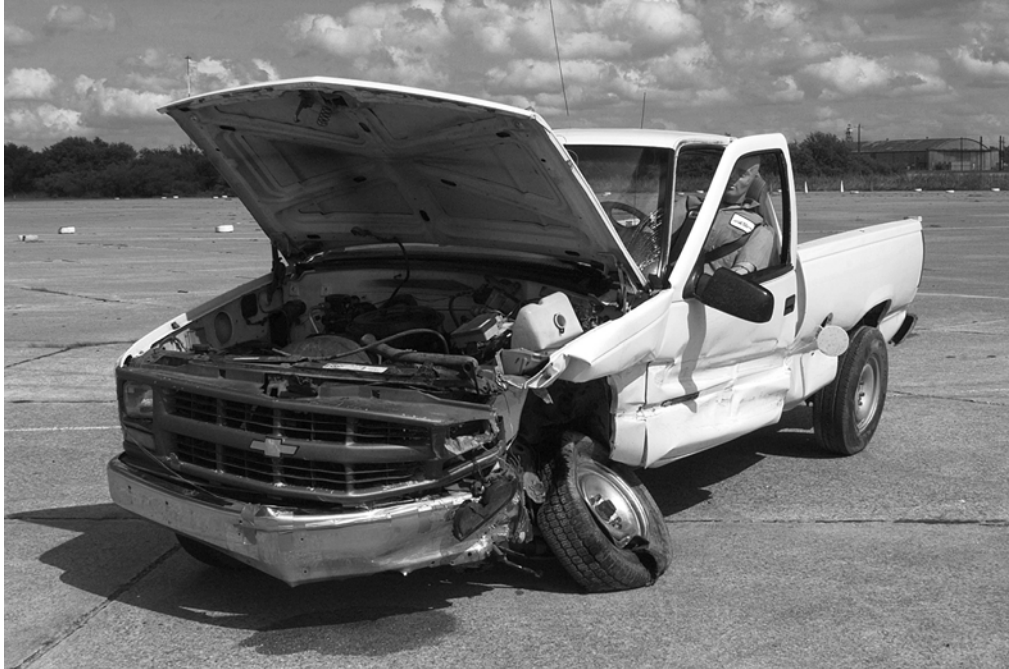
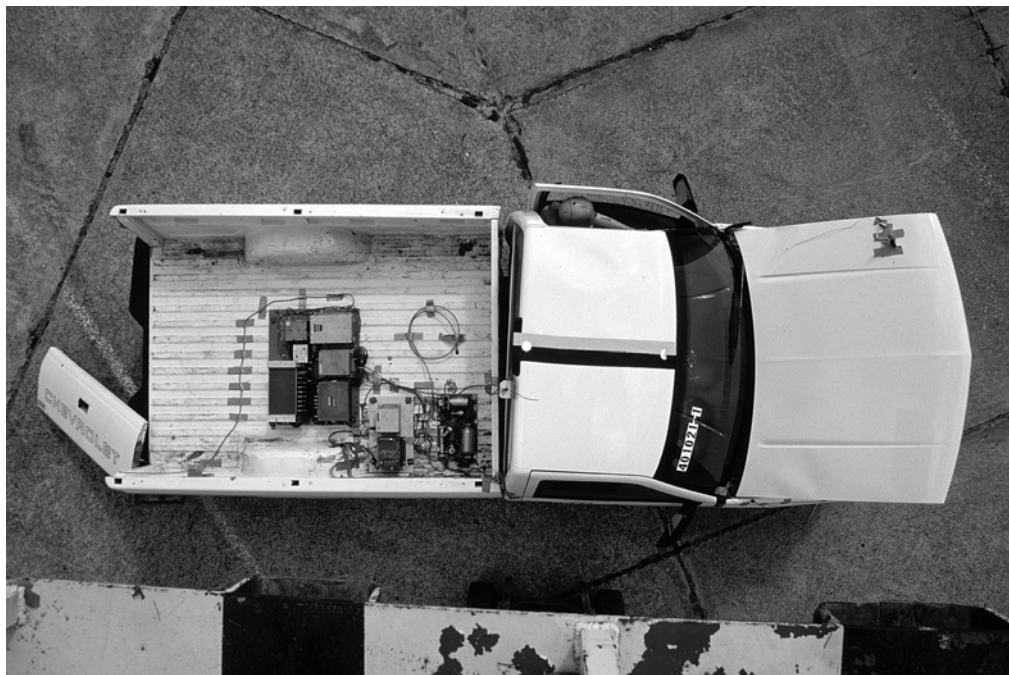
Figure 27. Vehicle after test 401021-1.

The 2000P vehicle sustained damage shown in figure 27. The following components received structural damage: left upper and lower A-arms, upper left side ball joint, left outer rod ends, and left side frame. Also damaged were the windshield (stress), front and rear bumpers, hood, grill, radiator, fan, left front and rear quarter panels, left door and glass, left rear wheel and rim, right front quarter panel, tailgate, and instrument panel. Maximum exterior crush to the front bumper was 550 mm. The interior is shown in figure 28. Maximum deformation of the occupant compartment was 140 mm at the center of the floor pan area and 129 mm in the kick panel area. The seam between the floor pan and fire wall opened. Exterior vehicle crush and occupant compartment measurements are shown in appendix B, table 18 and figure 116.

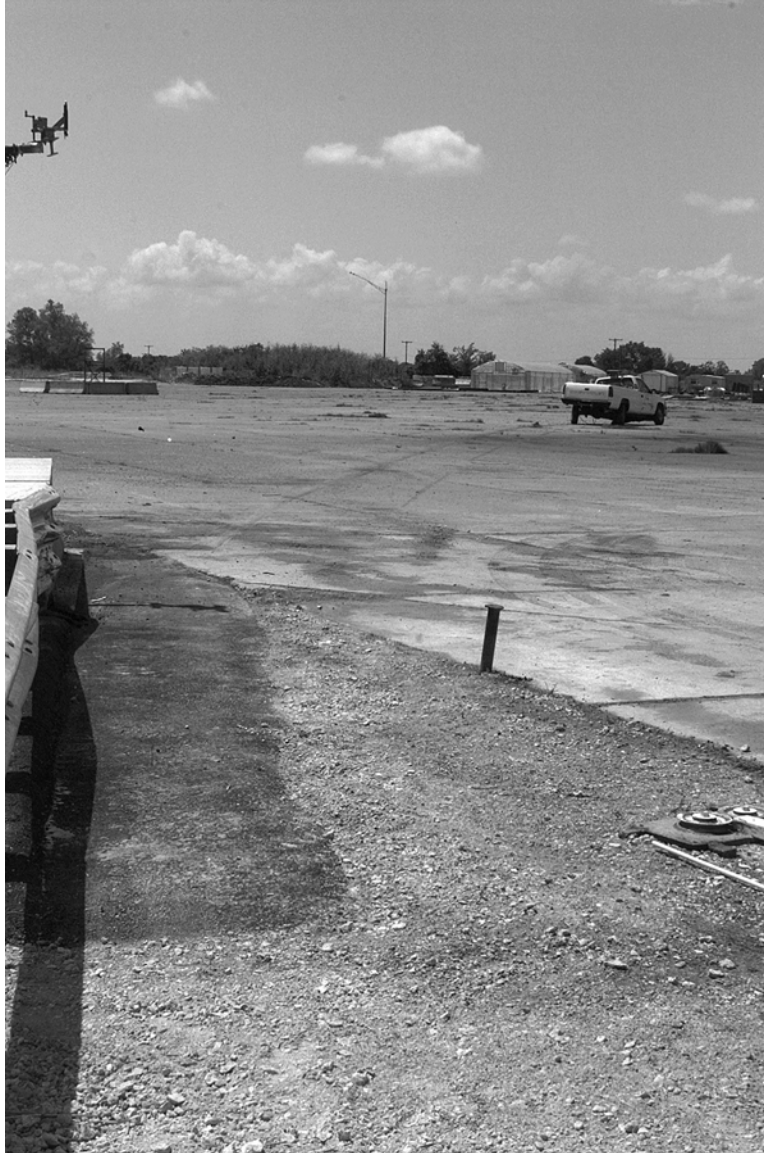
Figure 36. Vehicle trajectory path after test 401021-5.

The 2000-kg pickup truck impacted the Ohio Type 1 transition at 1.67 m upstream from the end of the concrete parapet, while traveling at 100.4 km/h and an impact angle of 25.8 degrees. Shortly after the pickup contacted the thrie beam, posts 12 and 13 moved; at 0.042 s the vehicle began to redirect. The dummy's head shattered the left door glass at 0.102 s. At 0.180 s the vehicle was traveling parallel with the transition installation at 75.9 km/h. The rear of the vehicle contacted the thrie beam at 0.194 s. At 0.385 s, the vehicle lost contact with the transition and was traveling at 72.4 km/h and an exit angle of 16.0 degrees. Brakes on the vehicle were applied at 2.1 s, and the vehicle came to rest 41.1 m downstream from impact and 10.7 m forward of the traffic face of the rail. Sequential photographs of the test period are shown in appendix C, figures 133 through 135.

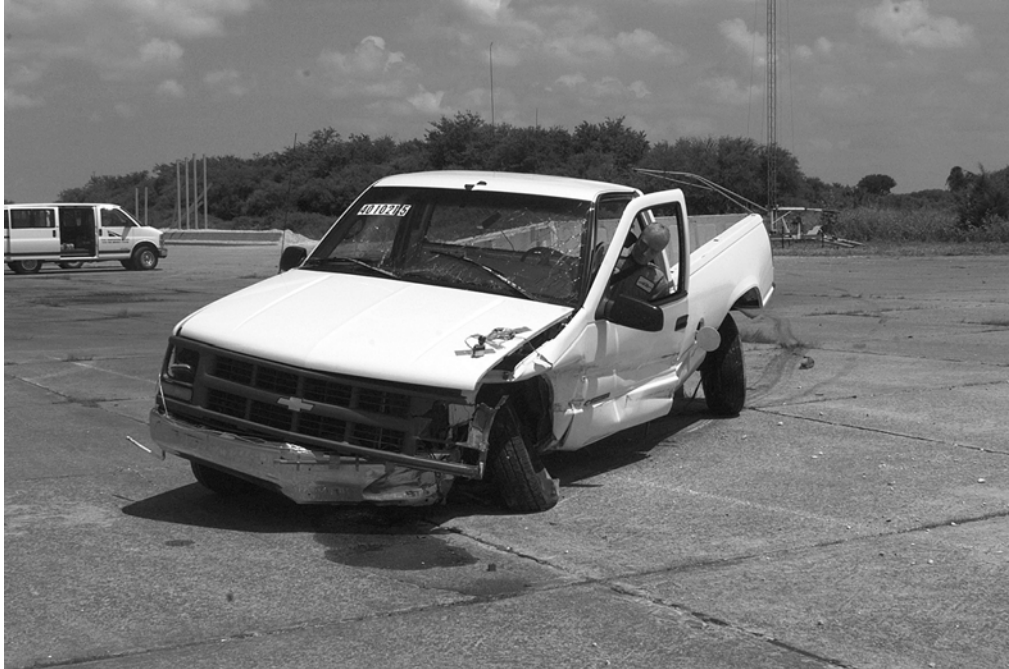
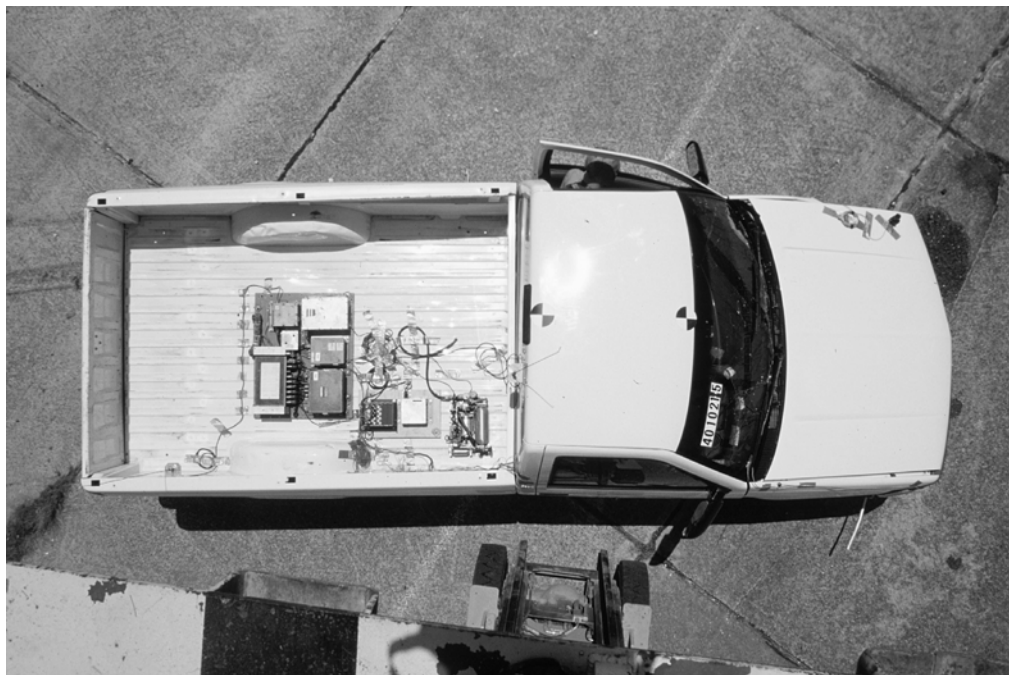
Figure 38. Vehicle after test 401021-5.

The 2000P vehicle sustained damage as shown in figure 38. The following vehicle components received structural damage: upper left side ball joint, rear U-bolts, and the rear axle was separated from the vehicle. The roof was deformed and there was a hole in the floor pan. Also damaged were the windshield (stress), front and rear bumpers, hood, grill, radiator, fan, left front and rear quarter panels, left door and glass, left front and rear wheels and rims, right front quarter panel, tail gate, and instrument panel. Maximum exterior crush to the front bumper was 570 mm. The interior of the vehicle is shown in figure 39. Maximum deformation of the occupant compartment was 120 mm in the kick panel area. The seam between the floor pan and fire wall opened. Exterior vehicle crush and occupant compartment measurements are shown in appendix B, table 19 and figure 118.

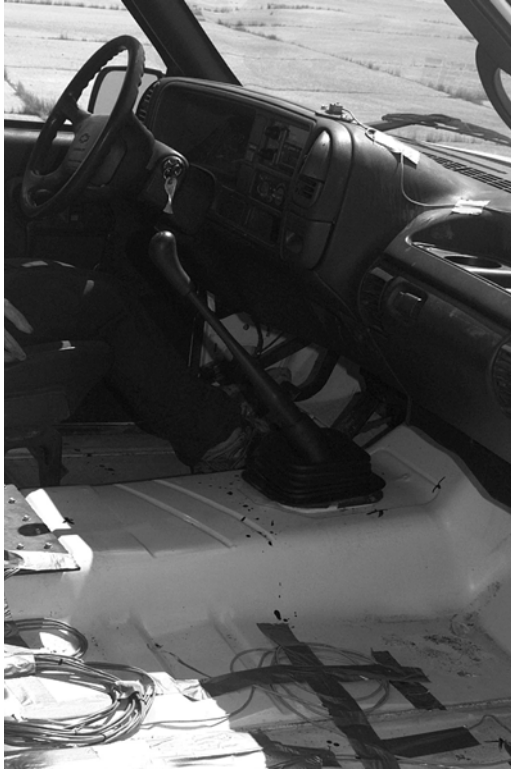
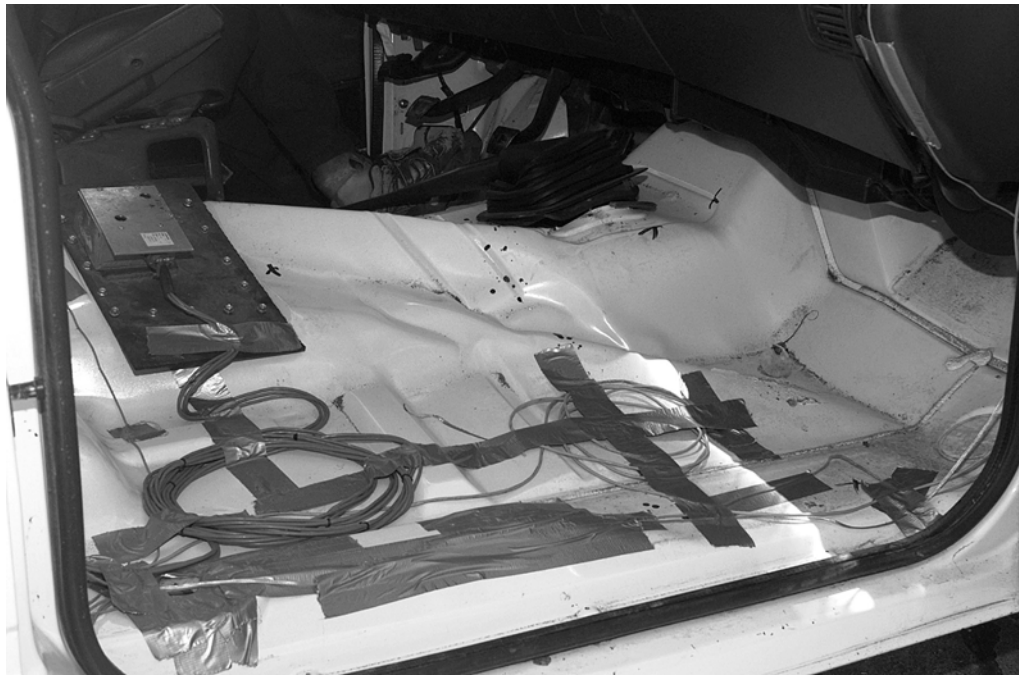
Figure 39. Interior of vehicle for test 401021-5.

Result: No detached elements, fragments, or other debris were present to penetrate or to show potential for penetrating the occupant compartment, nor to present undue hazard to others in the area. Maximum deformation of the occupant compartment was 120 mm in the kick panel, and the seam between the floor pan and firewall opened. Considerable deformation occurred in the driver floor pan area. No single dimension exceeded 150 mm, but overall deformation indicates marginal performance. (PASS)

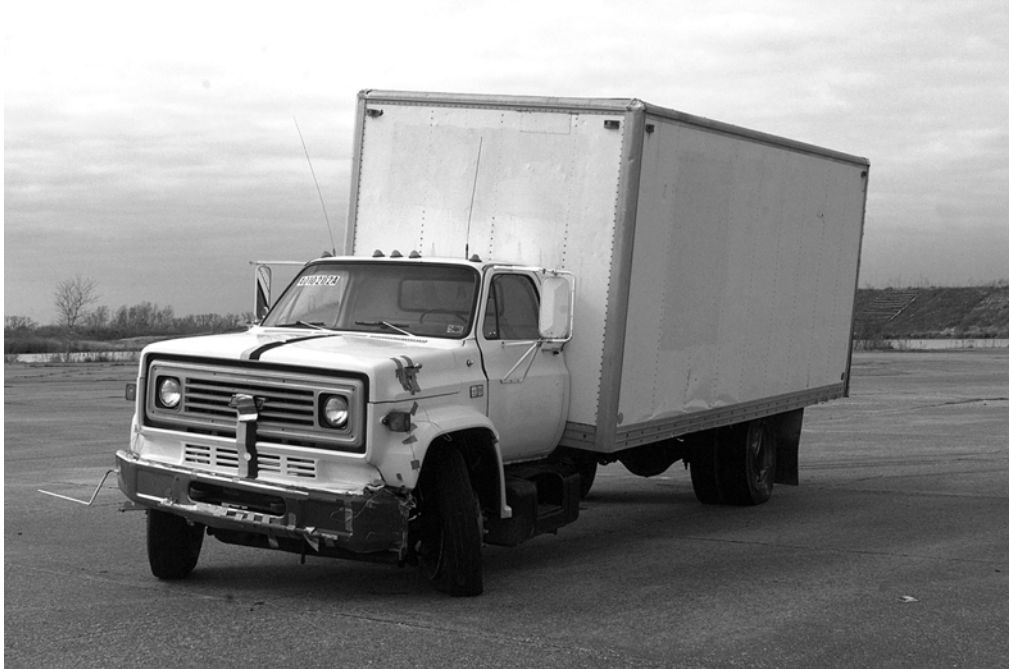
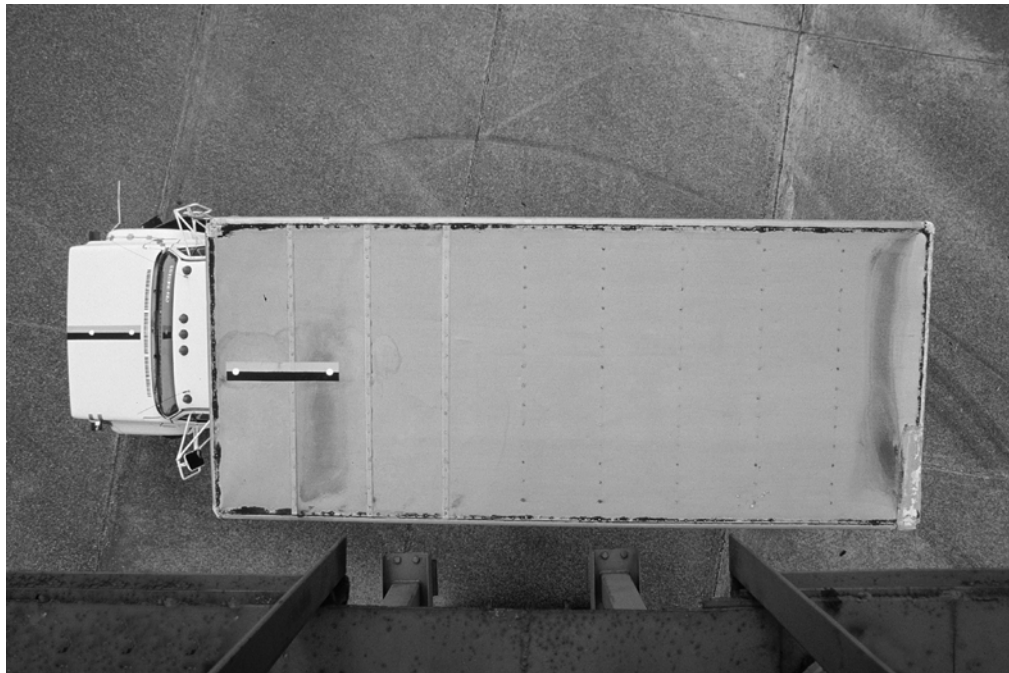
Figure 45. Vehicle after test 401021-2a.

The 8000S vehicle sustained damage shown in figure 45. The following vehicle components received structural damage: steering arm and linkage, box U-bolts, and floor pan. Also damaged were the front bumper, hood, grill, left front quarter panel, left front tire and wheel, left rear outside tire and wheel, and the lower left side of the box. Maximum exterior crush to the front bumper was 270 mm at the left front corner. The interior of the vehicle is shown in figure 46. There was no measurable deformation of the occupant compartment.

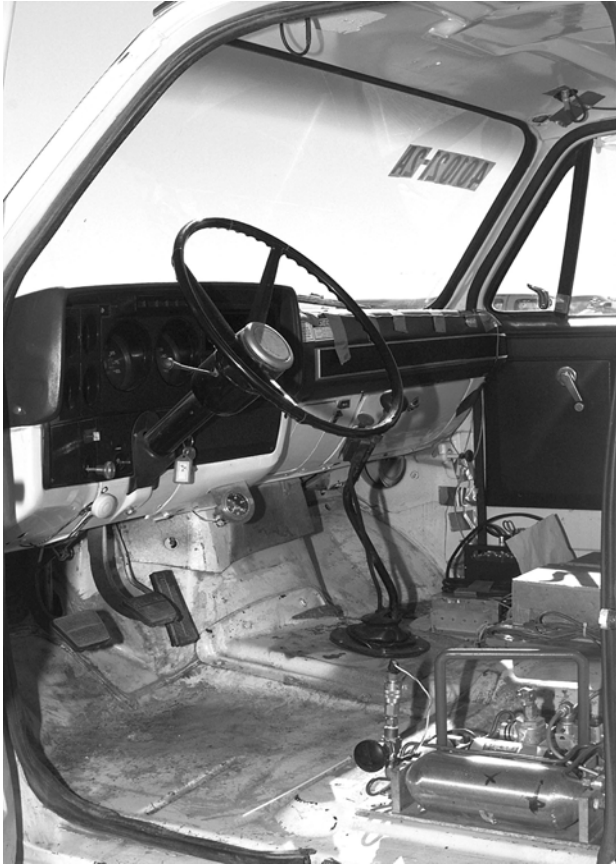
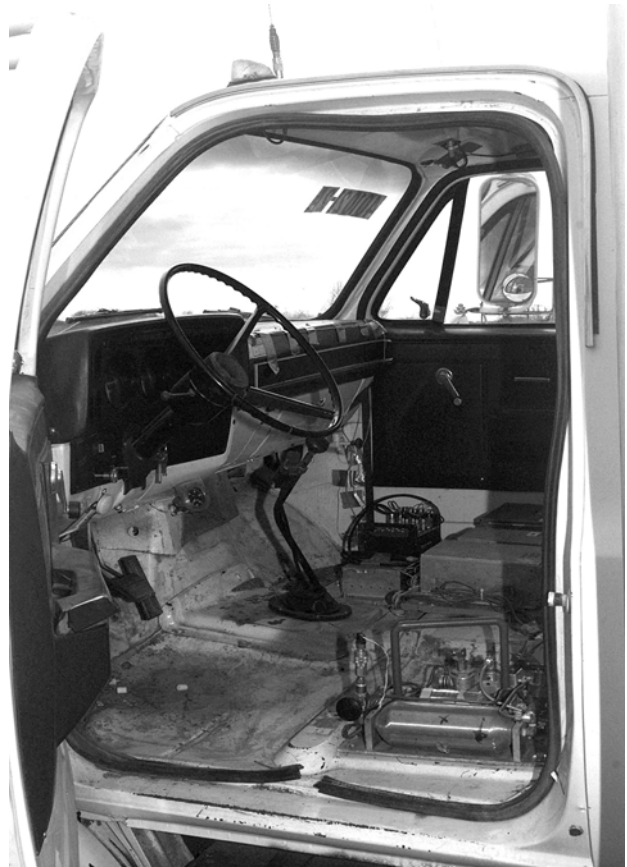
Figure 46. Interior of vehicle for test 401021-2a.

Result: No detached elements, fragments, or other debris were present to penetrate or to show potential for penetrating the occupant compartment, nor to present undue hazard to others in the area. No measurable deformation of the occupant compartment occurred. (PASS)

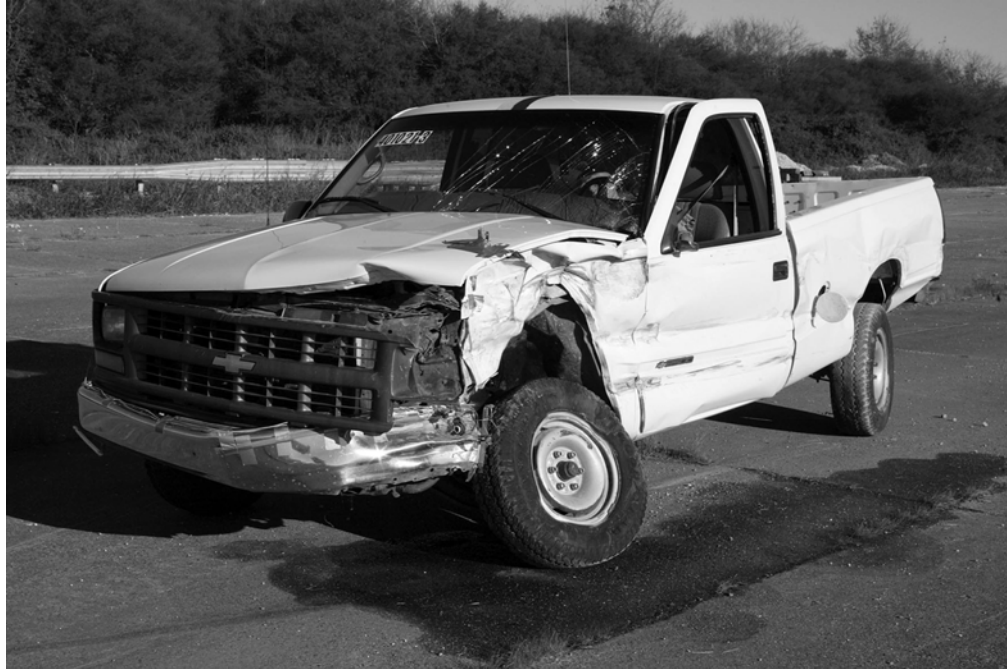
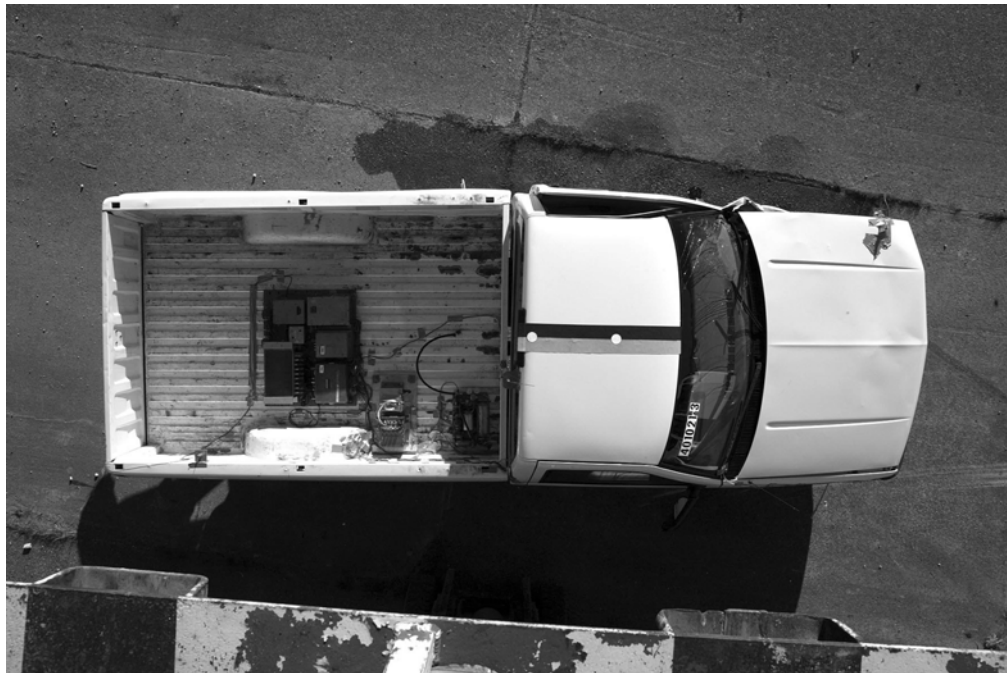
Figure 65. Vehicle after test 401021-3.

Damage to the vehicle is shown in figure 65. Structural damage was imparted to the left upper and lower A-arm, left upper ball joint, sway bar, and left front frame rail. Also damaged were the front bumper, hood, grill, radiator, fan, left front tire and wheel rim, left front quarter panel, left door and door glass, left rear exterior bed, left rear tire and wheel rim, and rear bumper. Maximum exterior crush to the vehicle was 650 mm in the frontal plane at the left front corner near bumper height. The windshield sustained stress cracks and the floor pan was deformed and separated from the firewall. Photographs of the interior of the vehicle are shown in figure 66. Maximum occupant compartment deformation was 74 mm in the kickpanel near the driver's feet. Exterior vehicle crush and occupant compartment measurements are shown in appendix B, table 20 and figure 121.

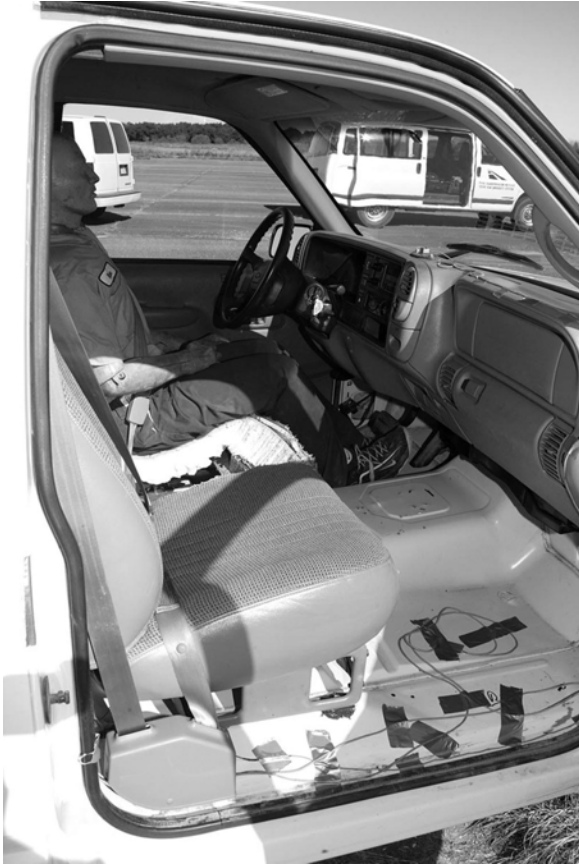
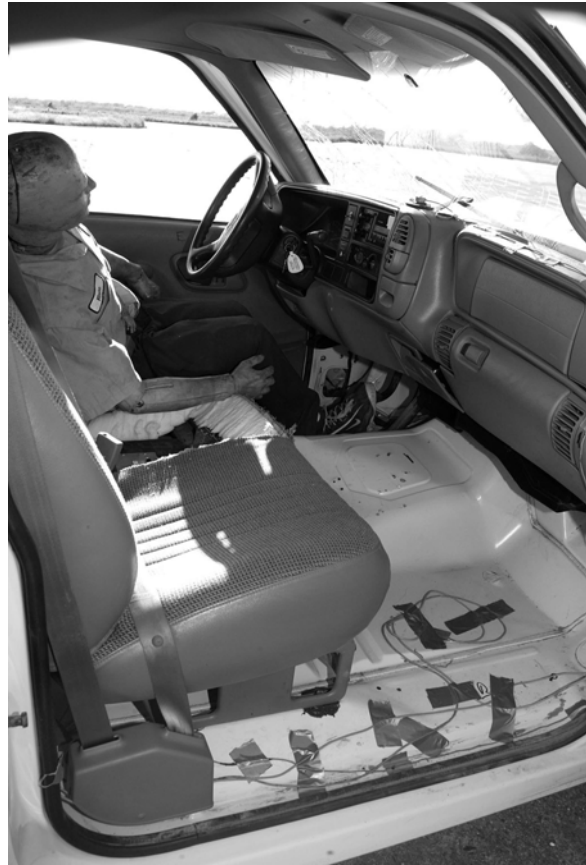
Figure 66. Interior of vehicle for test 401021-3.

Results: No detached elements, fragments, or other debris were present to penetrate or to show potential for penetrating the occupant compartment, or to present a hazard to others in the area. Maximum occupant compartment deformation was 74 mm in

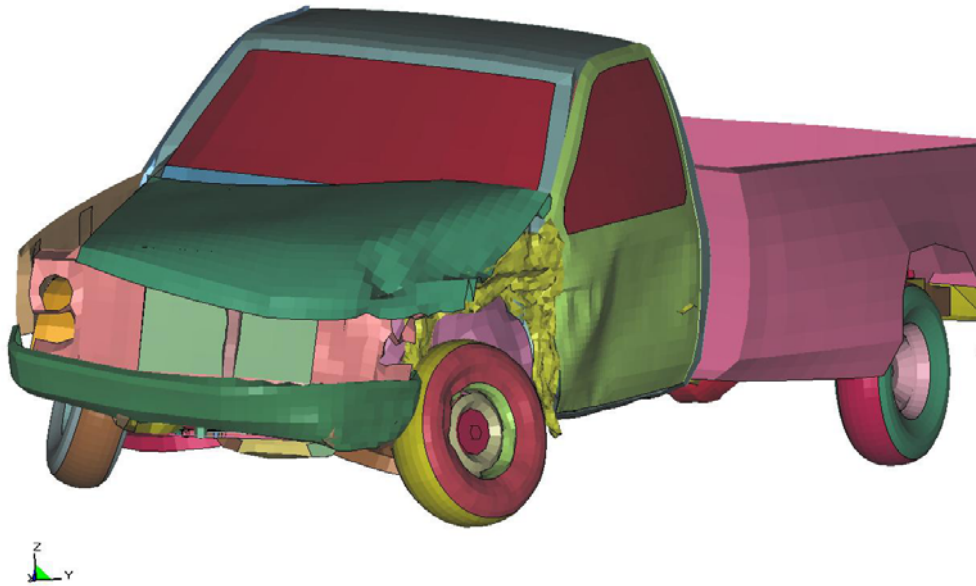
As shown in figure 72, the modification to the termination of the upper bridge rail element permitted the hood of the pickup truck to severely snag on the first bridge rail post. Although hinge failure of the hood is not present in the vehicle model, the severity of the hood snagging raises a significant safety concern that needed to be addressed. The overall vehicle damage resulting from the impact is shown in figure 73.

Figure 73. Overall damage to vehicle.

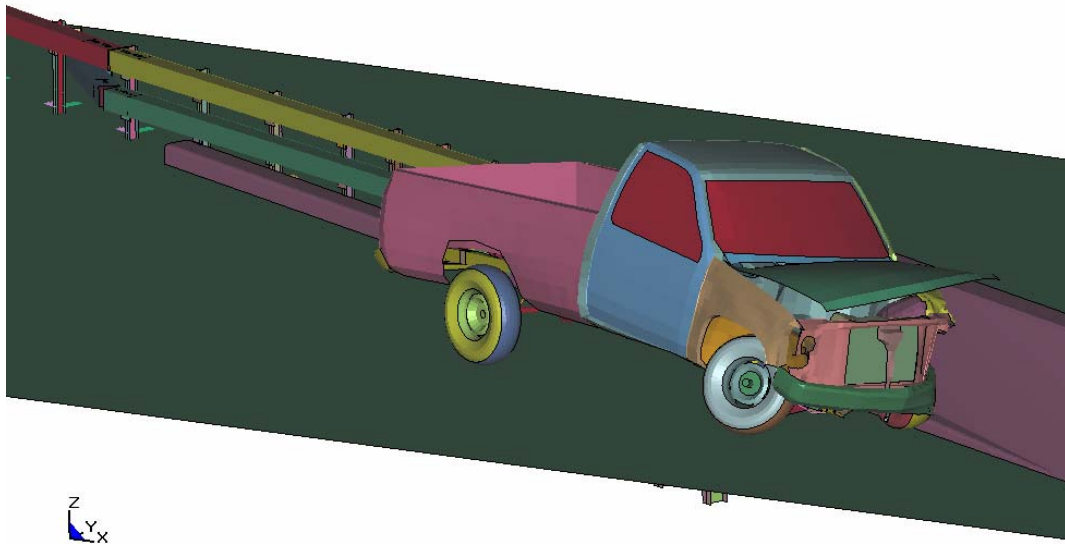
Figure 79. Pickup truck simulation at 0.2 s.

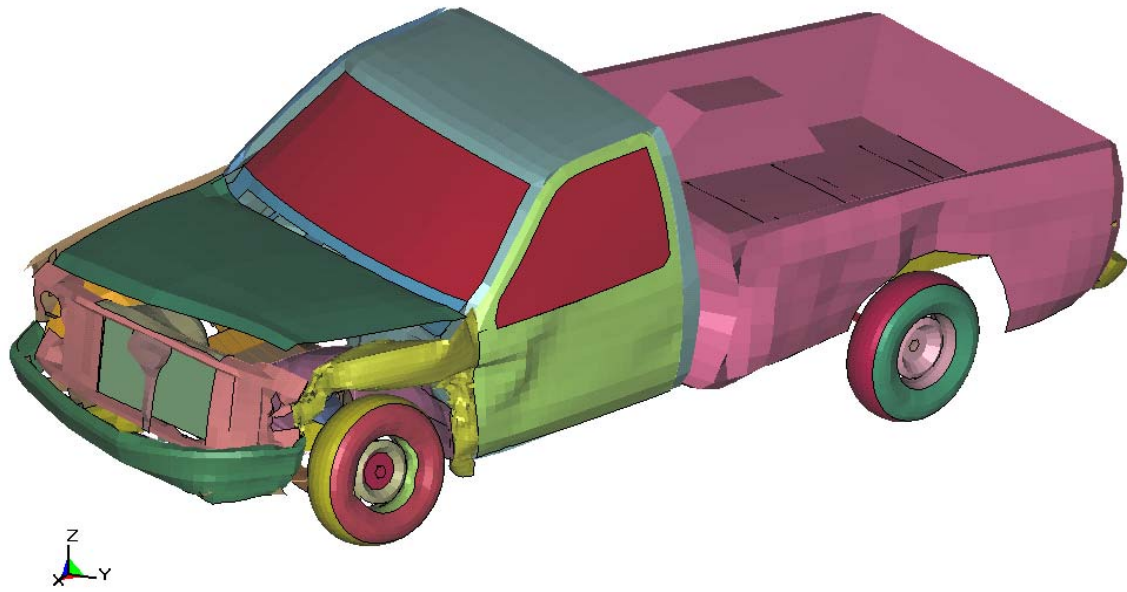
In the first analysis, the vehicle impacted the system at the same distance upstream of the expansion joint as was used in the failed crash test of the original New York box-beam transition to four-tube bridge rail and the simulation studies conducted under Tasks B1 and B2. As expected in a transition impact of this severity, the front left corner of the vehicle experienced substantial damage. Although some contact occurred between the door and the expansion splice, the door edge on the impact side did not exhibit severe snagging nor indicate a propensity to otherwise disengage from the vehicle cabin. Figure 78 shows the door edge (with other vehicle components removed for clarity) as it reaches the downstream edge of the splice. An image of the vehicle as it is exiting the transition system is shown in figure 79. The vehicle damage resulting from the impact is shown in figure 80.

Figure 80. Vehicle damage profile after impact.

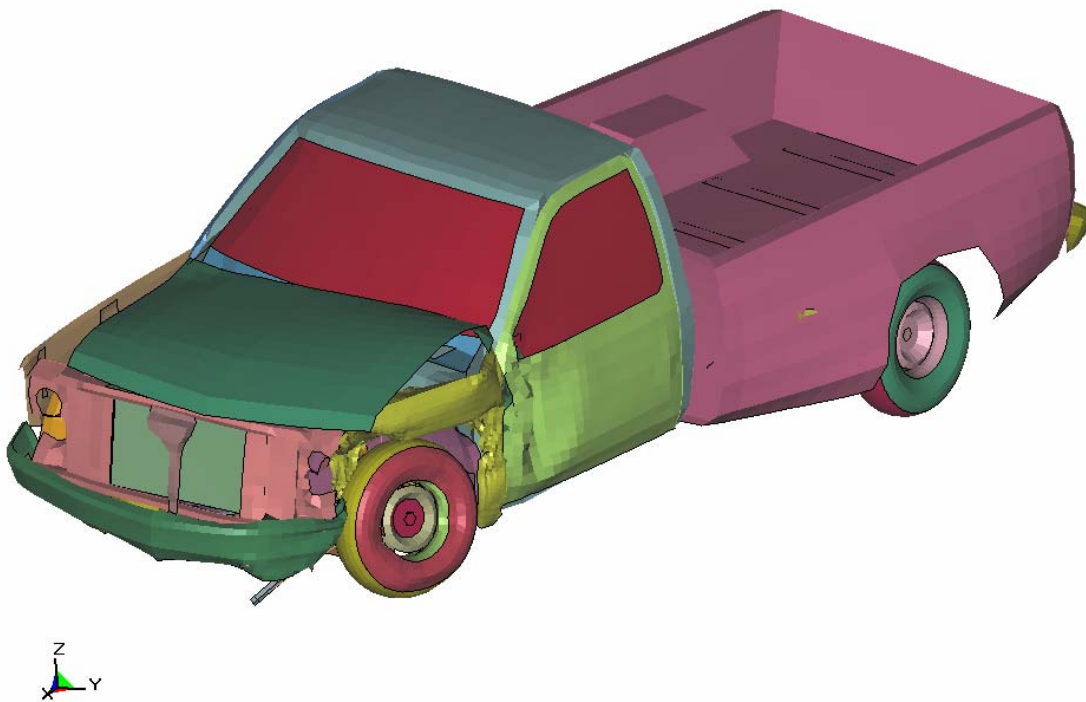
In the second simulation, the damage to the door was more pronounced. The edge of the box beam engaged some “wrinkled” sheet metal on the door just past the door edge (see figure 82). However, the contact with the splice did not force the front door edge to separate from the cabin. The damage to the vehicle after impact is shown in figure 83.

Figure 83. Vehicle damage profile after impact at alternate location.
