THREE BEAM TRANSITION CRASH TESTS

January 2005

**U.S. Department of Transportation
Federal Highway Administration**

1. Report No. FHWA-RD-04-115		2. Government Accession No.		3. Recipient's Catalog No.	
4. Title and Subtitle Thrie Beam Transition Crash Tests				5. Report Date January 2005

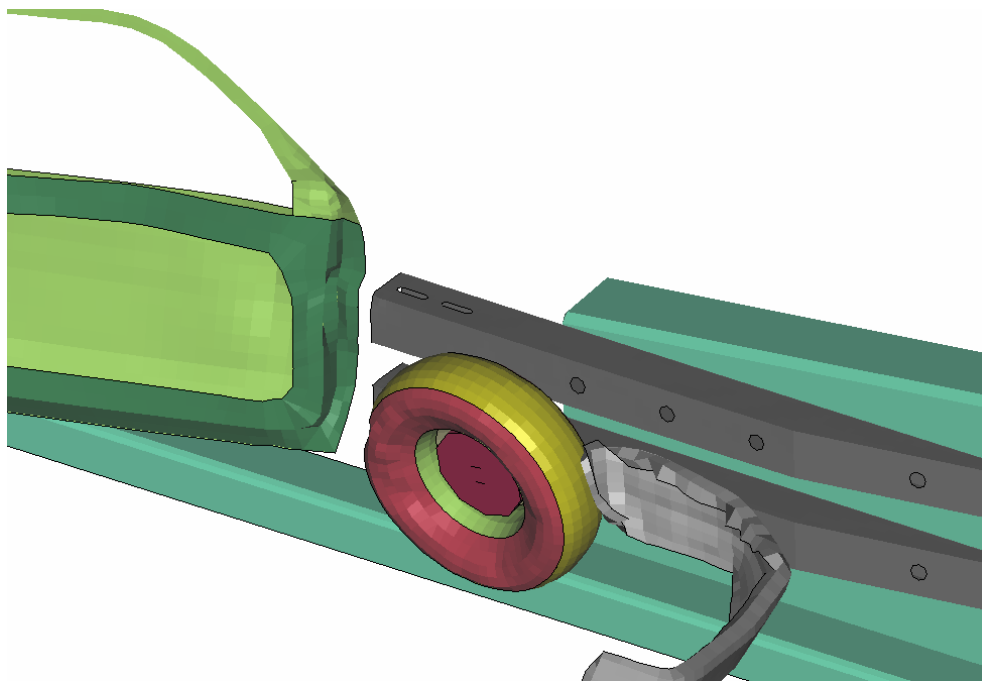
As described previously, the door-snagging problem is believed to be sensitive to a number of variables, including various vehicle characteristics, impact location, and impact conditions (i.e., speed and angle). It was noted in both simulations conducted to evaluate the performance of the box-beam transition connected to a concrete parapet that the front left tire mounted the curb during the impact. This action raised the height of the tire, causing it to engage the upper box-beam rail element. This is illustrated in figure 84 (with various vehicle and rail components removed for clarity). The result is a different load transfer mechanism between the transition system and vehicle that, from a simulation standpoint, may have influenced the interaction of the door with the splice. In an actual impact of this severity, the impact-side tires will likely air out after contact with the curb. Because the modeled tires do not include this failure capability, their presence may unrealistically influence the interaction. However, the extent to which this occurred (if any) is difficult to ascertain.

Figure 84. Position of front left tire due to the presence of curb.

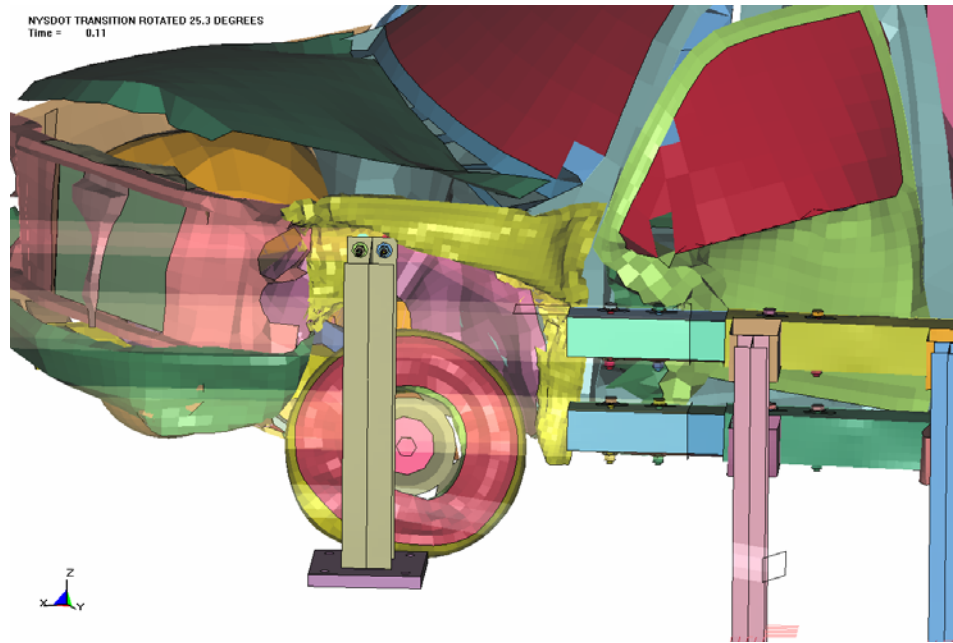
In both the test and simulation of the original transition system, the front left tire of the pickup truck rotated out of plane underneath the second rail element after impact, subsequently contacting the bend point in the rub rail and the base plate of the first bridge rail post. This behavior was more pronounced in the test than in the simulation. Images from the Task B1 simulation depicting this behavior are shown in figures 87 and figure 88.

Figure 87. Interaction of tire with bridge rail post baseplate (original design, Task B1).

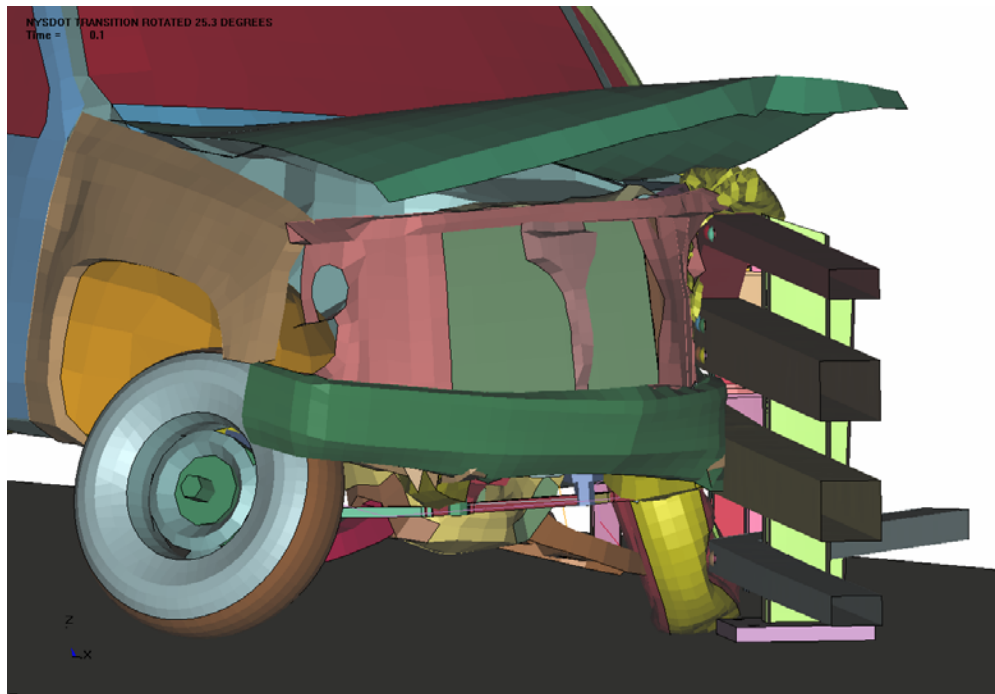
Figure 88. Downstream view of interaction of tire with bend in rail element and bridge rail post baseplate (original design, Task B1).

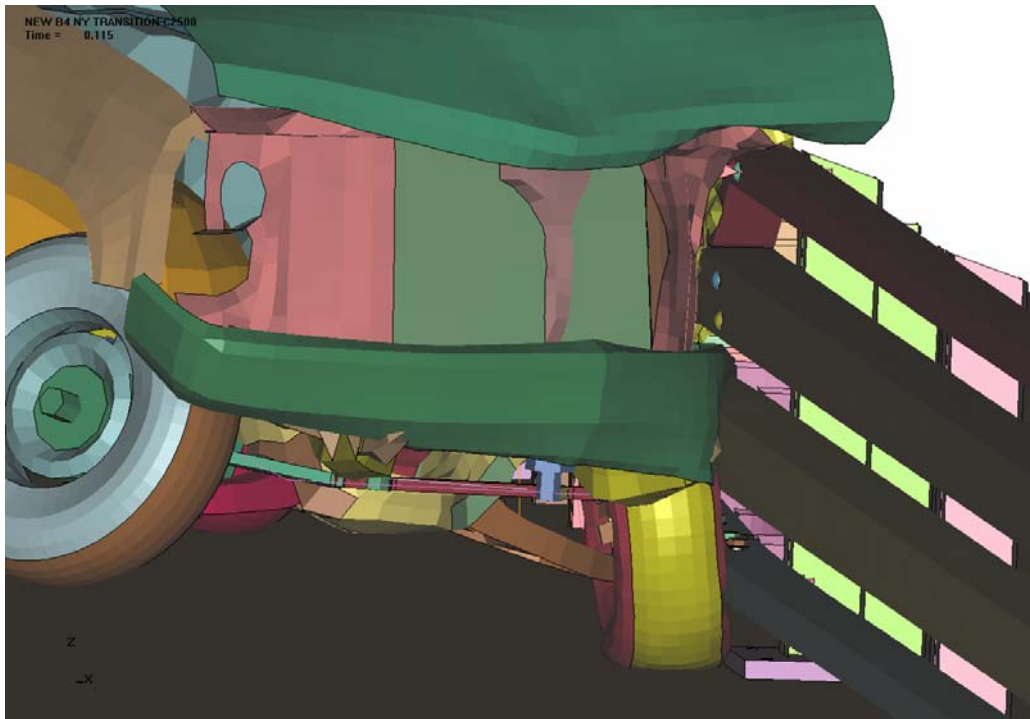
In the modified transition design evaluated under Task B4, the bend point in the rub rail was shifted further upstream. Consequently, the front left tire engaged the rub rail bend point as soon as the vehicle impacted the system and before any out-of-plane rotation of the wheel occurred. This indicates a more direct barrier-tire-vehicle force transfer mechanism that could influence the extent of occupant compartment deformation. The direct contact from the tire/wheel assembly caused the rub rail to deform toward the field side of the installation and contact the first transition post. Further, the rub rail was pushed downstream a short distance until the tolerance in the slots in the rub rail splice connection was expended. When the tire subsequently engaged the base plate of the first bridge rail post, it presented itself with a more vertically aligned profile as shown in figure 89 and figure 90 below.

Figure 89. Downstream view of interaction of tire with bridge rail post baseplate (modified design, Task B4).

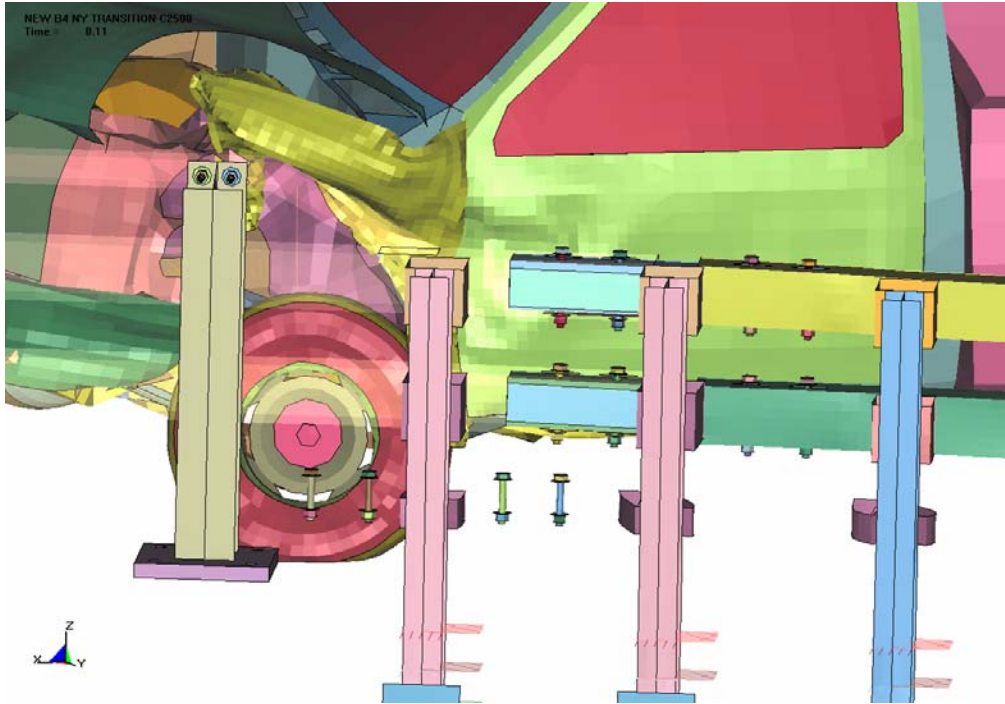
Figure 90. Interaction of tire with bridge rail post baseplate (modified design, Task B4).

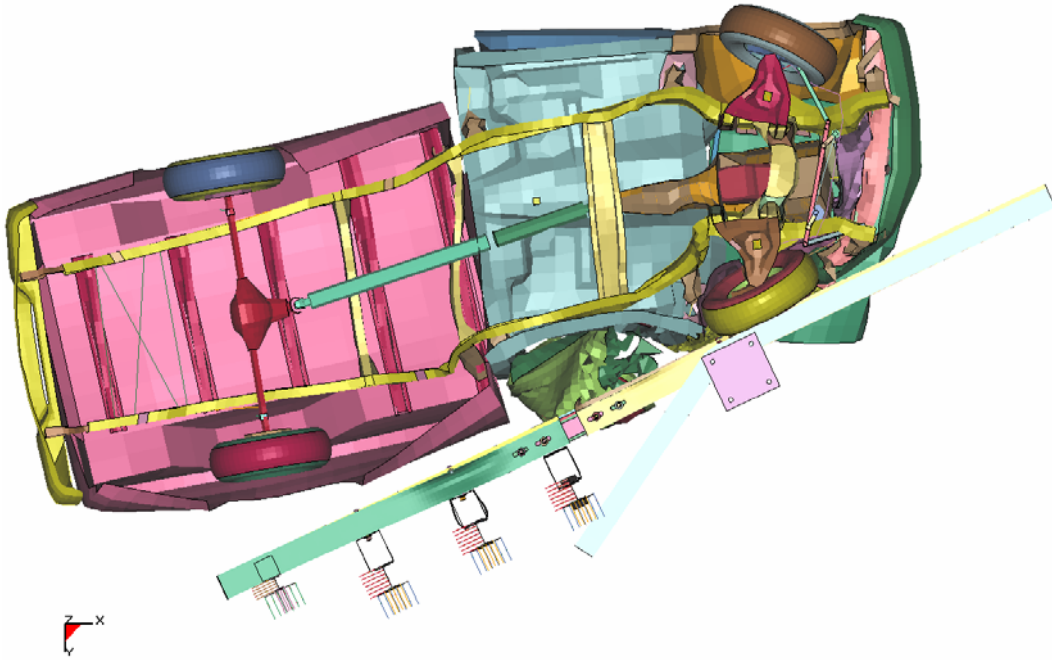
Simulations of both the original transition system (Task B1) and the modified transition (Task B4) indicated what the researchers consider to be excessive vehicle frame deformation resulting when the impact force was transferred from the front left tire/wheel to the suspension assembly as shown in figures 91 and 92. It should be noted that some deformation of the front left frame rail was reported in the crash test of the original NYSDOT box-beam transition design and that the measured occupant compartment deformation was 158 mm (which is marginal based on FHWA evaluation criteria). Due to lack of connection failure in the suspension of the pickup truck model, it is not possible to accurately capture the load transfer from the tire/wheel to the frame rail or other parts of the vehicle (e.g., floor pan, firewall). However, since both simulations showed similar magnitudes of frame deformation (figures 91 and 92), it is reasonable to conclude that a vehicle impacting the latest modified transition system would sustain a similar level of occupant compartment deformation (OCD) as in the impact of the original system. Thus, the magnitude of the OCD associated with a pickup truck impact into the modified transition design is expected to be marginal.

Figure 91. Vehicle frame deformation—original system (Task B1).

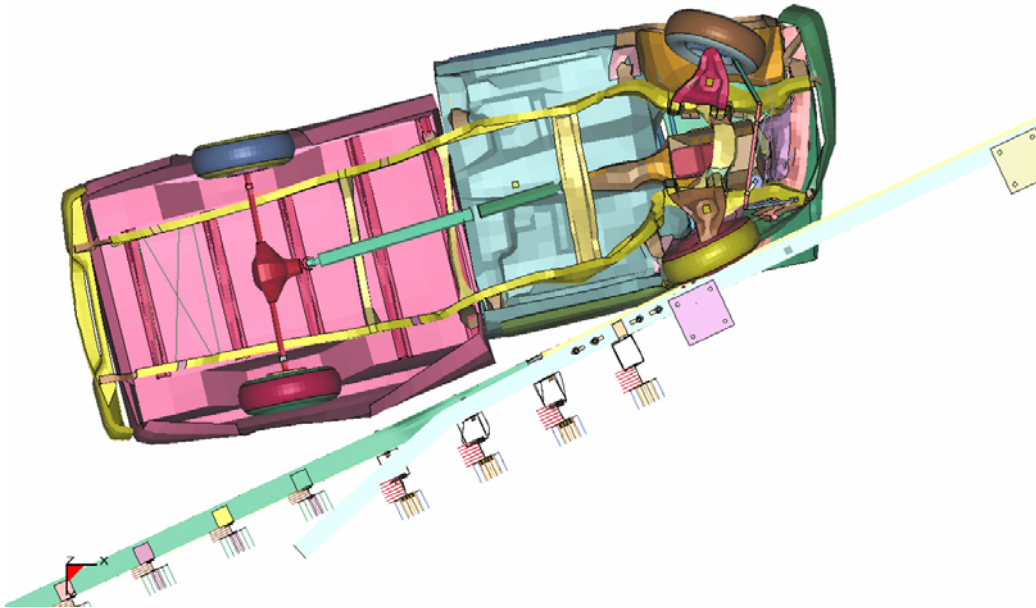
Figure 92. Vehicle frame deformation—latest modified system (Task B4).

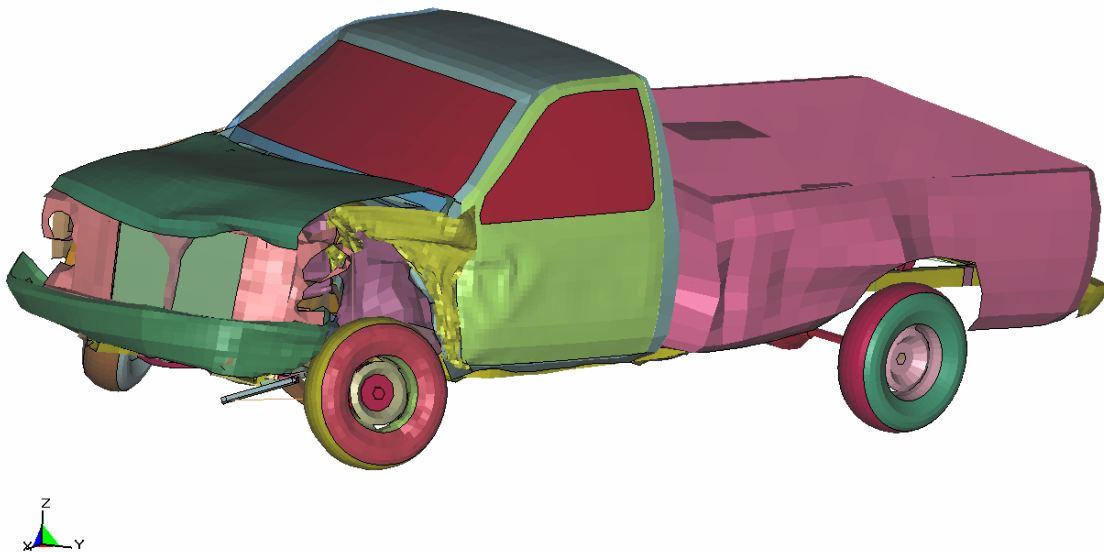
The vehicle damage resulting from the simulated impact is shown in figure 93. The overall interpretation of this simulation is that the performance of the latest modified transition design would be marginally acceptable. The vehicle was redirected in a stable and upright manner. While the possibility of door snagging on the expansion splice is still present, the simulation indicates an improvement over the original design. However, the researchers express caution in the interpretation of this aspect of the simulation due to the sensitivity of the current models in capturing this behavior.

Figure 93. Pickup truck deformed shape at 180 ms.

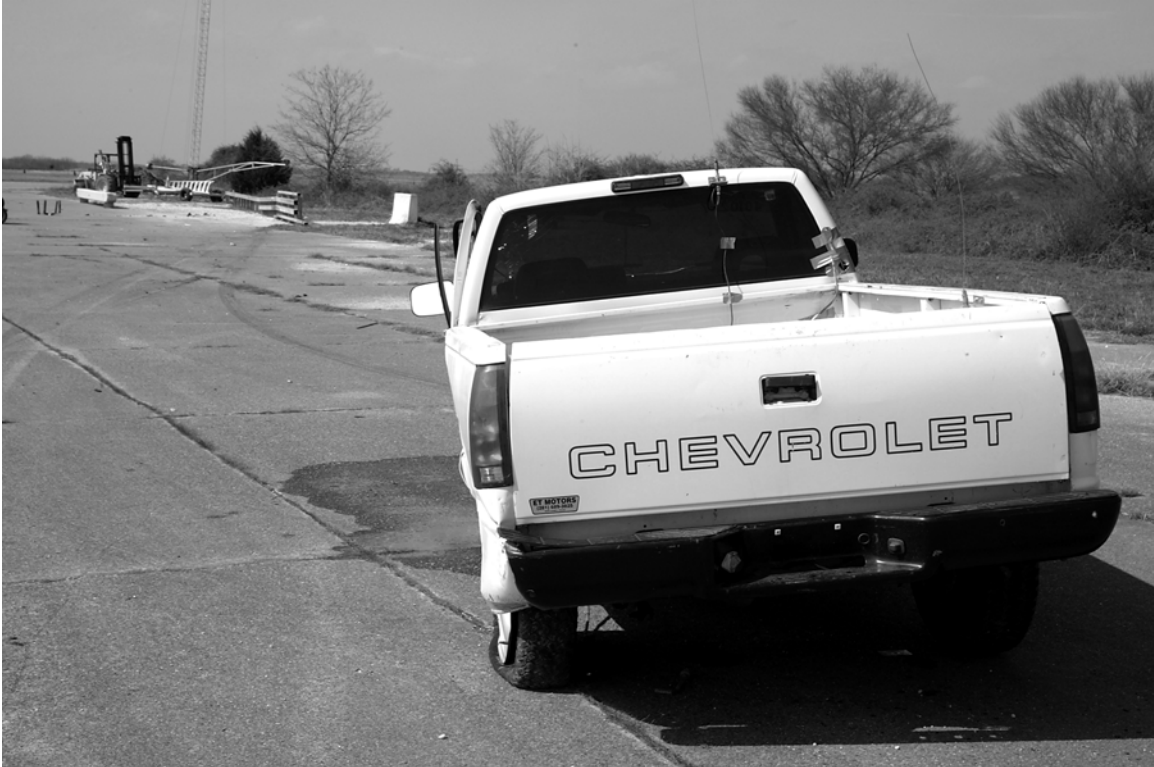
Figure 101. Vehicle trajectory path after test 401021-7.

Result: The vehicle came to rest 50.3 m downstream of impact and 3.6 m forward of the traffic face of the rail. (FAIL)

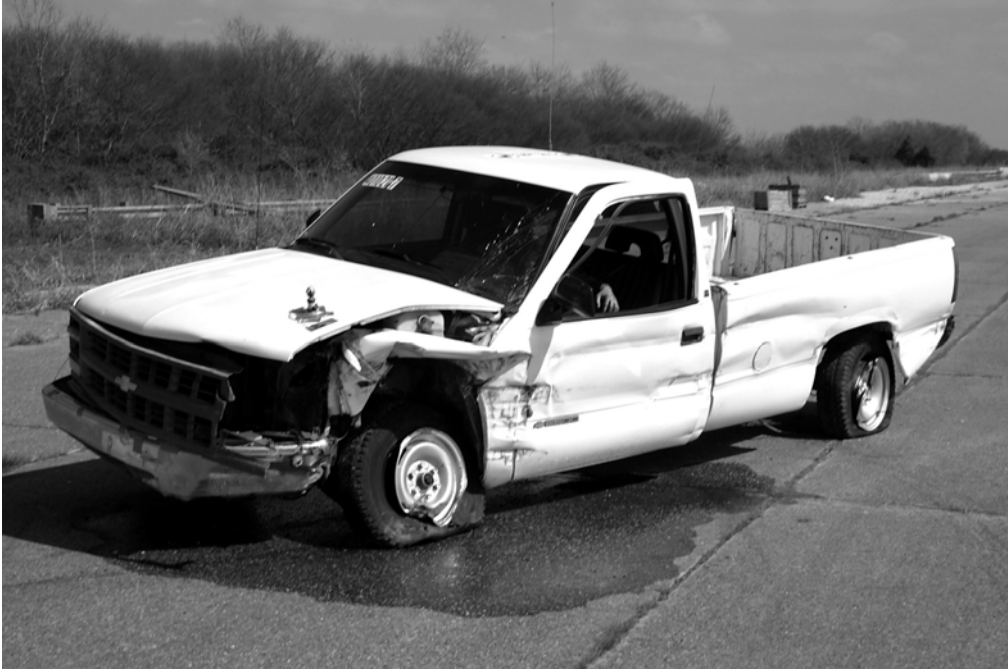
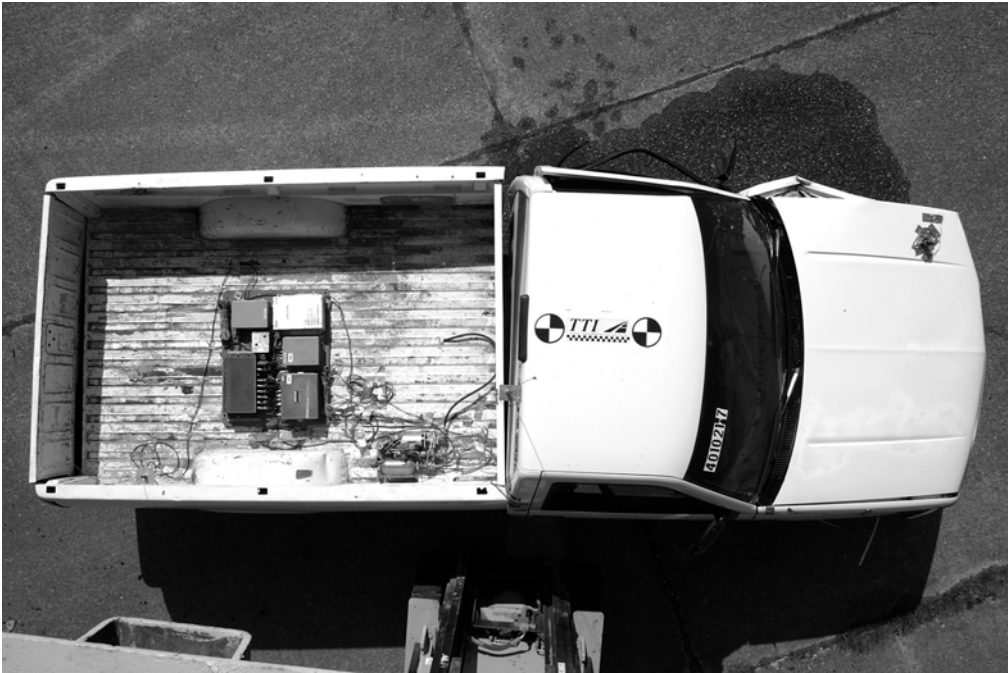
Figure 103. Vehicle after test 401021-7.

Most of the damage to the vehicle was to the left front corner and rear axle, as shown in figure 103. Structural damage to the vehicle was sustained by the left upper and lower A-arm, left frame rail, left U-bolts, and rear axle; the drive shaft also pulled out. Also damaged were the front bumper, grill, hood, left front quarter panel, left tire and wheel rim, left door and glass, left rear exterior bed, and A-post; the windshield was shattered. Maximum exterior crush to the vehicle was 500 mm at the left front corner at bumper height. Maximum occupant compartment deformation was 60 mm at the left kickpanel area laterally across the front of the cab. Photographs of the interior of the vehicle are shown in figure 104. Exterior vehicle crush and occupant compartment measurements are shown in appendix B, table 21 and figure 123.

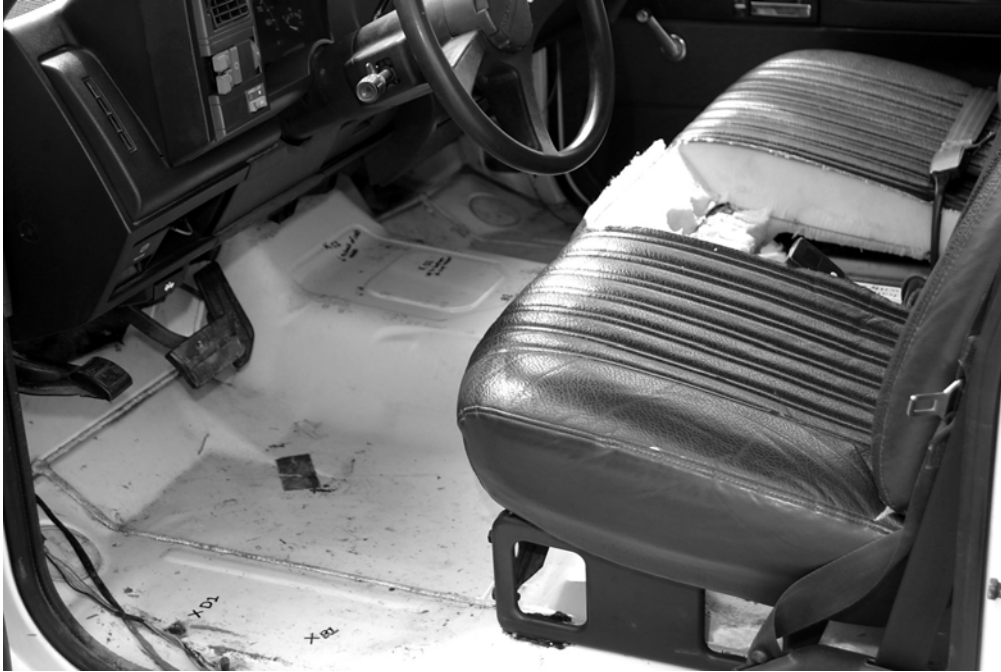
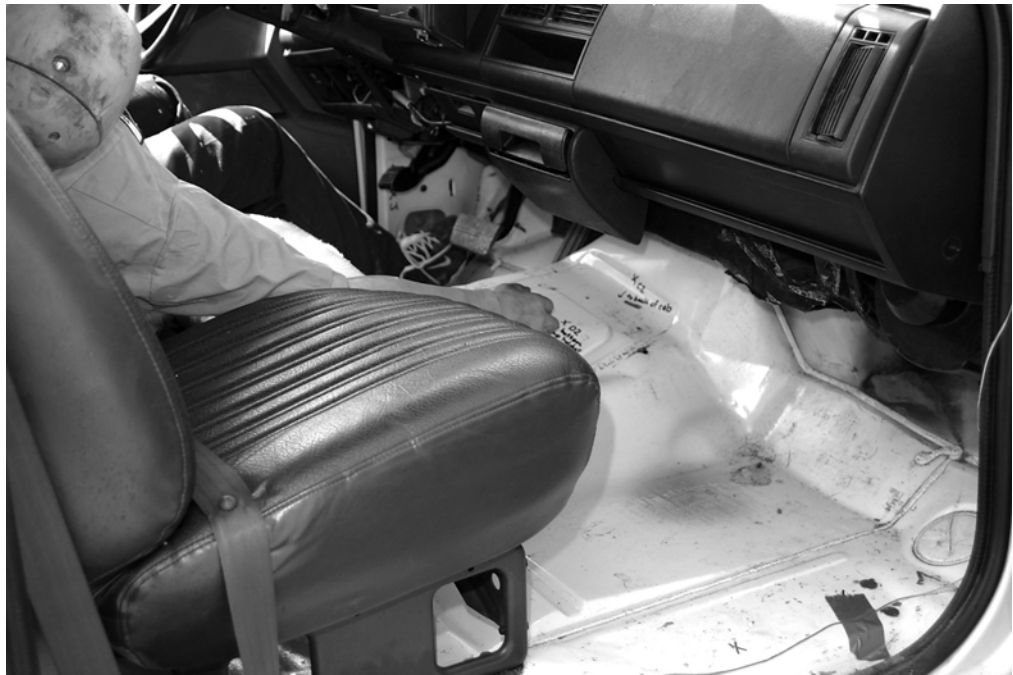
Figure 104. Interior of vehicle for test 401021-7.

Result: No detached elements, fragments, or other debris were present to penetrate or to show potential for penetrating the occupant compartment, or to present hazard to others in the area. Maximum occupant compartment deformation was 60 mm laterally at the kickpanel across the cab. (PASS)
