Structural Behavior of a Prototype Ultra-High Performance Concrete Pi-Girder

November 2009

FHWA Publication No. FHWA-HRT-10-027

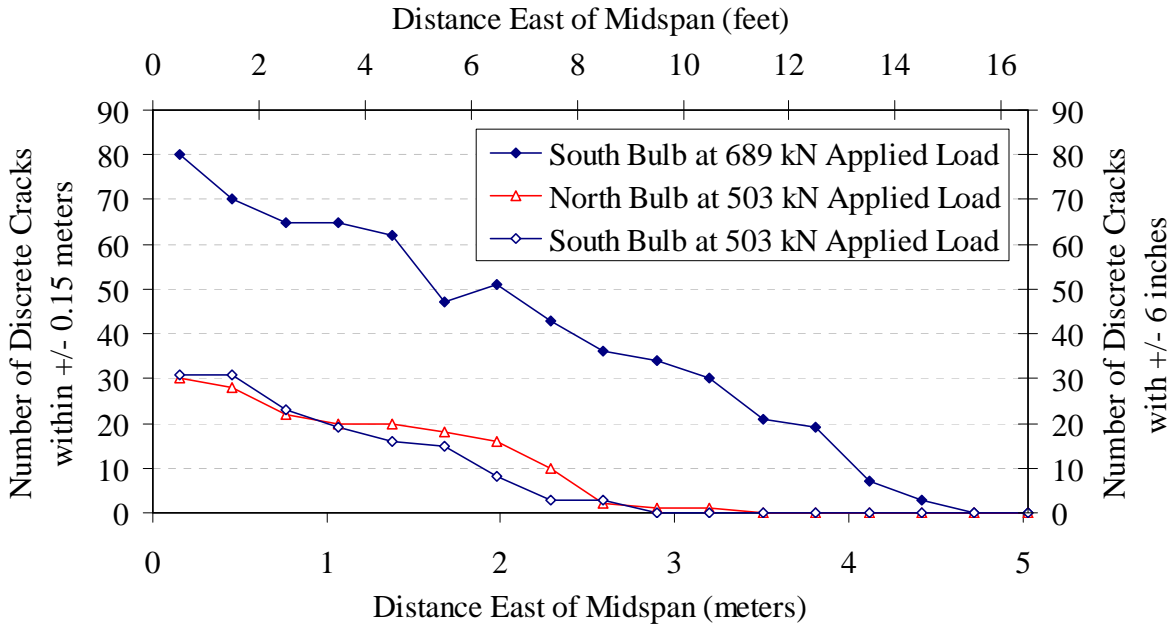
Significant audible cracking began at an applied load of approximately 330 kN (75 kips) and continued during loading steps throughout the remainder of the test. Assessment of the flexural cracks was completed at two applied load levels. The first assessment was completed at an applied load of 503 kN (113 kips) which corresponded to an overall midspan deflection of 76 mm (3 inches). A denatured alcohol spray was used to identify the cracks which were too small to be observed with the naked eye. The assessment marked every flexural crack on the outside of the north and south bulbs to the east of midspan. Figure 77 presents these results by summing the discrete cracks observed in each 0.3 m (1 foot) increment along the girders length. On average, there were approximately 2.3 cracks per 25 mm (1 inch) in the constant moment region. Also, extrapolation indicates that there were approximately 300 flexural cracks in each bulb, all occurring over a 5.5 m (18 foot) region centered on midspan.

The second crack assessment was completed at an applied load of 689 kN (155 kips) which corresponded to an overall midspan deflection of 191 mm (7.5 inches). The results are again presented in Figure 77 with only the south bulb having been assessed. On average there were approximately 6 cracks per 25 mm (1 inch) in the constant moment region. Extrapolating on the data indicates that there were approximately 1100 flexural cracks in each bulb, all occurring over a 9.1 m (30 foot) region centered on midspan.

Figure 77. Graph. Flexural cracking observed on outside faces of Girder P2-70F bulbs.

Tests P2-70F and P2-45F demonstrated the tight crack spacing and small crack widths normally associated with the bulb of a prestressed UHPC girder loaded to induce flexural failure. Figure 77 shows that at a total dead plus live load moment equivalent to 94 percent of the moment that caused failure, the bulb of the girder near midspan had approximately 1 crack every 4 mm (6.7 cracks per inch). In both of these tests and as commonly observed in conventional concrete flexural members, tighter crack spacings and crack widths were observed in the bulbs as opposed to in the webs immediately above the bulbs.

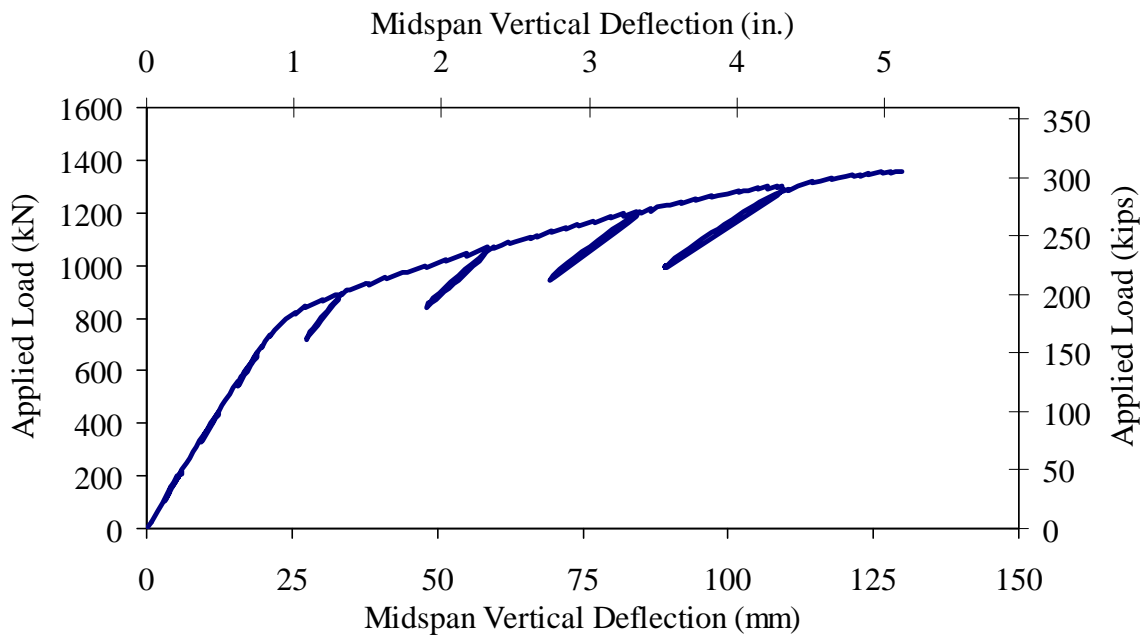
Figure 81 shows the applied load versus vertical deflection response of the girder. The reported deflection is the average value recorded from the two potentiometers measuring the displacement of the bottom face of the girder legs. The load-deflection response shows that the girder began to soften near 755 kN (170 kips) at a deflection of approximately 22 mm (0.87 inches). The girder exhibited significant additional capacity, reaching a peak load of 1350 kN (304 kips) at a deflection of 130 mm (5.1 inches). Failure occurred due to a loss of tensile capacity in the south bulb at midspan.

Figure 81. Graph. Load versus midspan deflection response of Girder P4-45F.

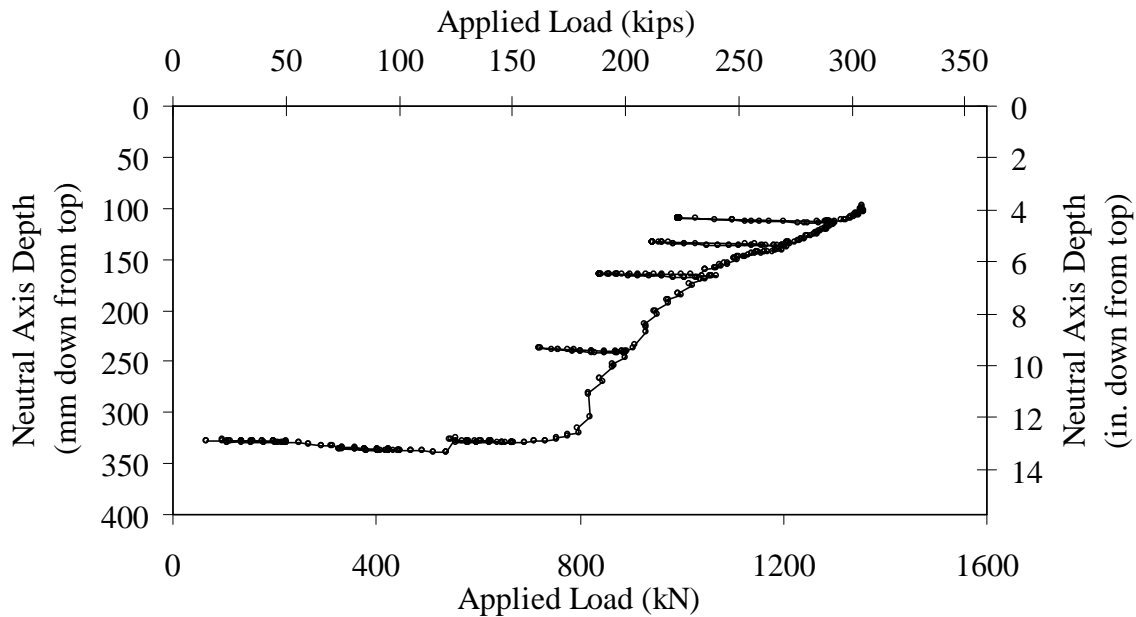
throughout the test. Note that an elastic section analysis of the cross-section indicates that the neutral axis at test initiation should have been located approximately 323 mm (12.7 inches) down from the top of the girder. The plot shows that the neutral axis began to rise at an applied load of approximately 755 kN (170 kips), quickly moved to a depth of 152 mm (6 inches), then steadily moved to a depth of 132 mm (5.2 inches) by failure. Note the stability of the neutral axis depth during the unload/reload steps.

Figure 82. Graph. Midspan neutral axis depth down from the top of Girder P4-45F.

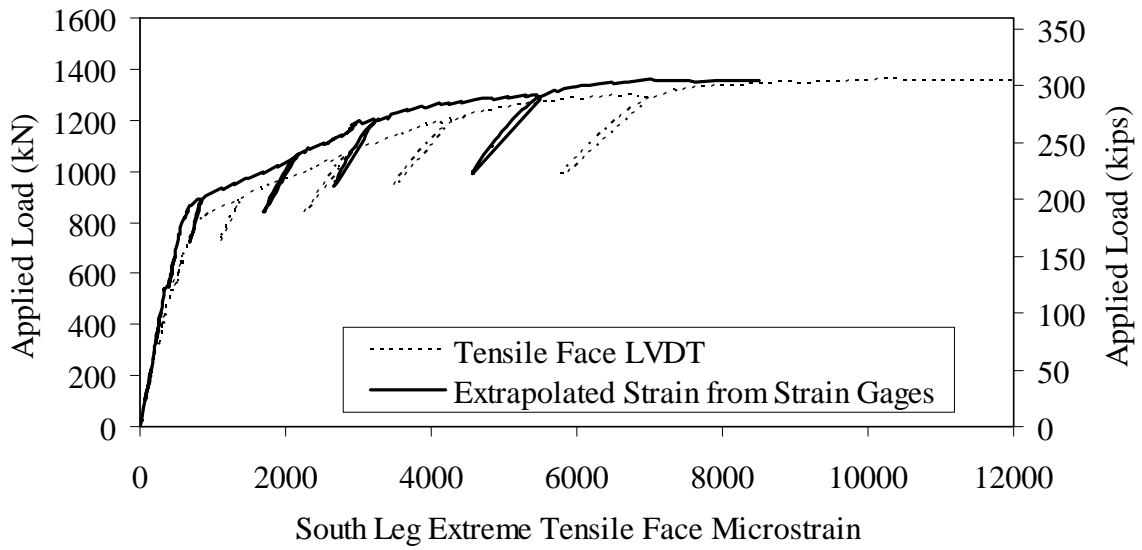
The midspan strain profiles obtained from the strain gages on each leg of the girder as well as the LVDTs affixed to the bottom faces of the bulbs provide an indication of the tensile strain in the UHPC throughout the application of load. These results are plotted in Figure 83 and Figure 84 for the south and north legs, respectively. The strain gage results are calculated based on extrapolation from operational strain gages on the midspan cross section independently in each leg of the girder. The LVDT results are based on the recorded displacement readings divided by the gage length. Note that prior to the application of load, the prestressing forces and dead load resulted in an extreme tensile face compressive strain of approximately 330 microstrain. The plots show that at peak applied load, the strain on the tensile face of the south leg was between 7,000 and 10,000 microstrain.

Figure 83. Graph. Midspan south leg tensile face strain in Girder P4-45F.

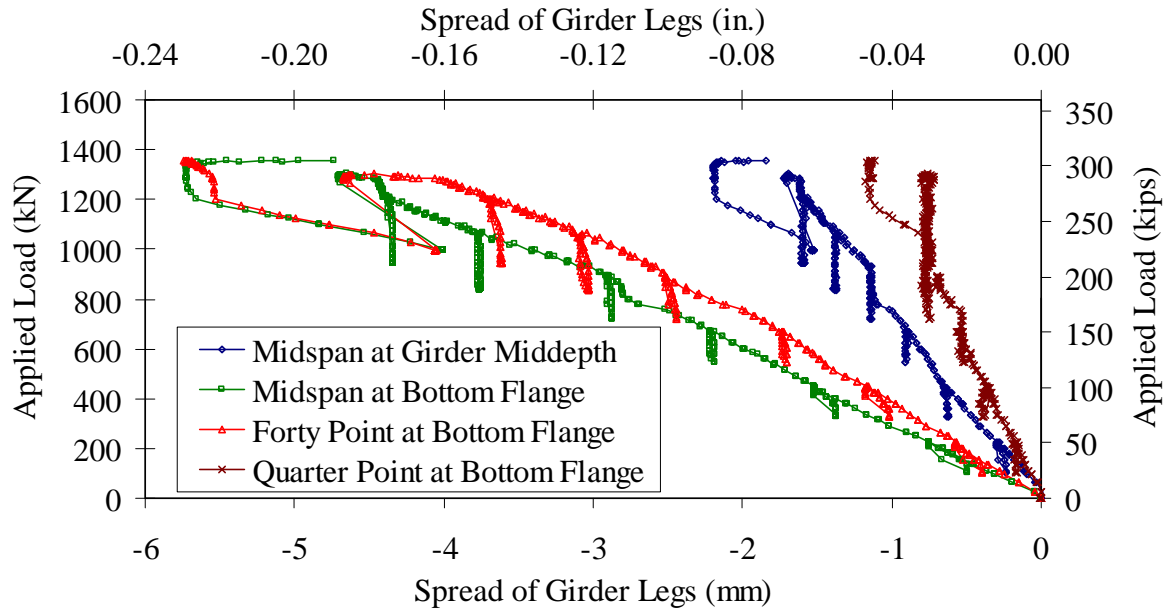
Figure 85 presents the results obtained from the four potentiometers installed to capture the spreading of the girder's legs throughout the test. These results show that the girder legs progressively moved toward one another as the load increased, with the largest relative movement occurring at the bottom of the midspan legs. In all cases, the legs moved less than 6 mm (0.24 inches) throughout the test, indicating that the loads were nearly symmetrically applied over the webs.

Figure 85. Graph. Spreading between webs of Girder P4-45F.

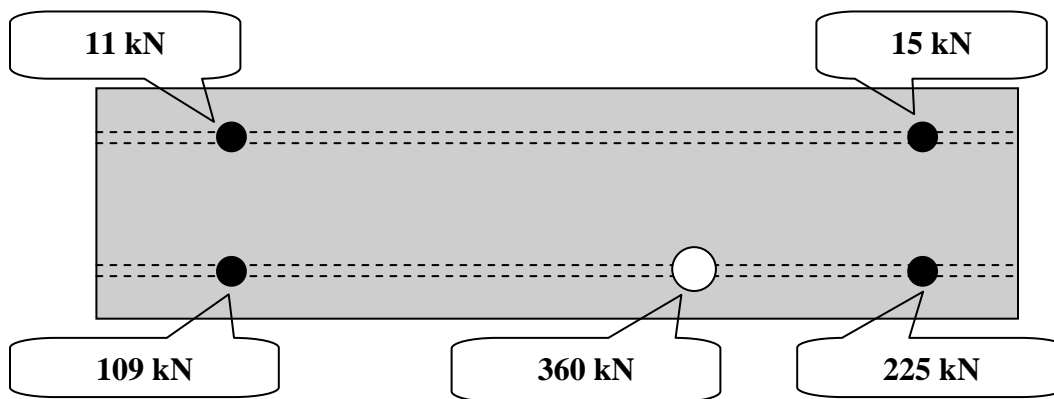
The distribution of load resulting from Load Configuration A occurred as anticipated, with the load being appropriately distributed to the four support points. The distribution of load resulting from Load Configuration B was investigated through two means. First, the strain gages affixed to the girder webs at instrumentation lines C, D, and E as shown in Figure 24 were used to quantify the principal tensile and compressive strains at these locations. These results indicated that minimal if any shear force was being carried by the north web in the shear span. The load distribution was also investigated through the reactions observed at the support points. Figure 93 illustrates the reaction forces observed when the applied load was 360 kN (81 kips). Nearly 93 percent of the applied load is reacted through the south leg support points. Further insight into the load distribution behavior is provided through Figure 94 and Figure 95. These figures show that the north overhang at the load point cross-section deflected upward and that the longitudinal strain on top of the deck at the mid-shear span was tensile, respectively, when the specimen was subjected to the 360 kN (81 kip) load.

Figure 93. Illustration. Load and reactions for Girder P4-21S at 360 kN (81 kips) of load.

The load distribution testing associated with P2-21S provides some limited information on the ability of the girder cross section to laterally distribute loads applied in traditionally high shear regions of a span. As shown in Figure 93, the large majority of the load applied above the south girder leg is directly reacted by the supports under this leg. The cross section displays limited ability to laterally distribute applied point loads in high shear portions of the span. The Lever Rule can provide an approximation of live load shear distribution, again assuming that each girder leg acts as an individual ‘girder’ for the purposes of the definition.

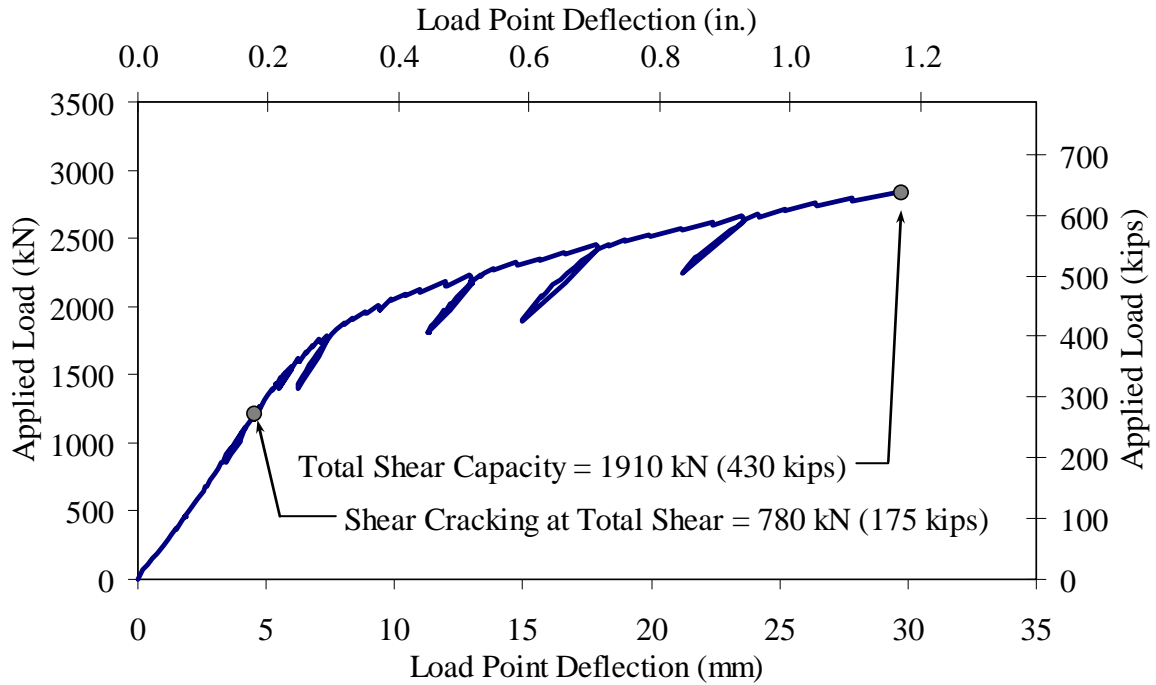
Figure 96 shows the applied load versus vertical deflection response of the girder. The reported deflection is the average value recorded from the two potentiometers measuring the displacement of the bottom face of the girder legs. The load-deflection response shows that the girder began to soften near 1,420 kN (320 kips) of applied load at a load point deflection of approximately 5 mm (0.2 inches). The girder exhibited significant additional capacity, reaching a peak load of 2,930 kN (636 kips) at a deflection of 29.7 mm (1.17 inches). As shown in the figure, the total dead load plus live load shear in the shear span at first shear cracking was 780 kN (175 kips). The total overall dead plus live load shear in the shear span at girder failure was 1,910 kN (430 kips).

Figure 96. Graph. Load versus load point deflection response of Girder P2-21S.

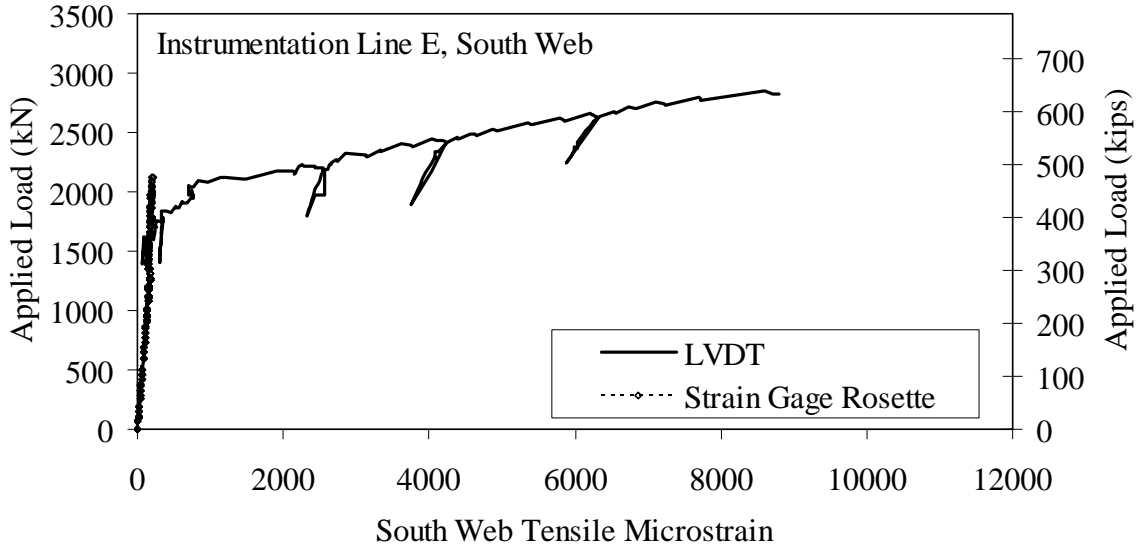
The diagonal tensile strains in the webs were captured through both strain rosettes affixed to the surface of the webs as well as by LVDTs which monitored deformations over predefined gage lengths. The results of greatest interest were captured along Instrumentation Line E; the shear failure plane intersected this instrumentation line precisely at the strain rosette. The results are plotted in Figure 104 and Figure 105 for the south and north webs, respectively. The principal tensile strain from the strain gage rosette is only plotted until the results become suspect due to cracking of the underlying concrete. The single LVDT on each web was installed at an orientation of 39 degrees counterclockwise from the horizontal based on the elastic principal tensile strain angle as calculated from the strain gage rosette. Note that prior to the application of load, the prestressing forces and dead load resulted in less than 50 microstrain precompression in the web along the angle of the principal tension. The plots show that at peak applied load the tensile strain in the north web (which failed) was approximately 11,000 microstrain, and the tensile strain in the south web (which remained intact) was greater than 8,000 microstrain.

Figure 104. Graph. Web tensile strain at Line E in Girder P2-21S south leg.

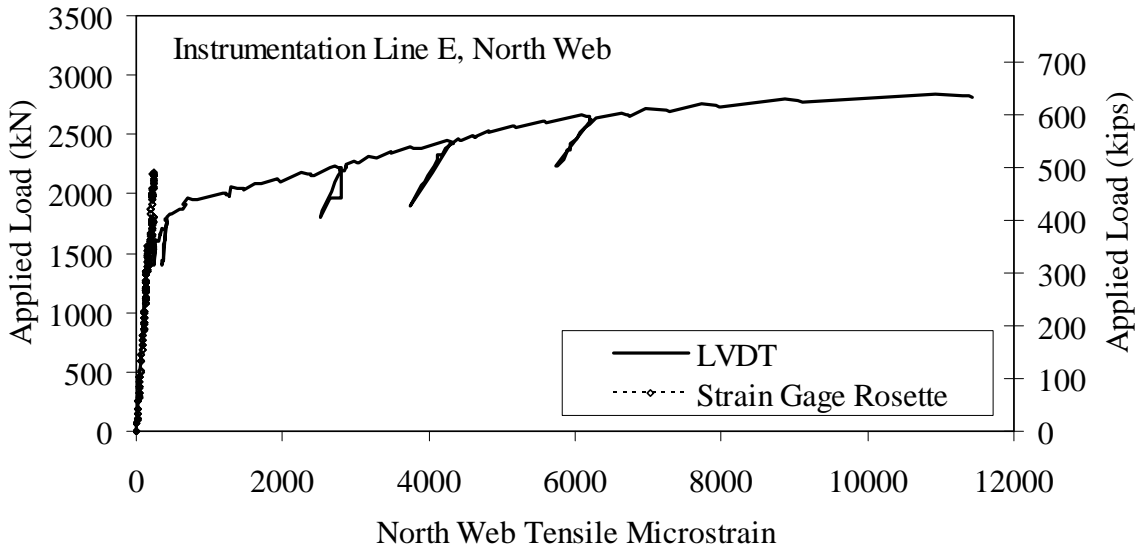
Figure 105. Graph. Web tensile strain at Line E in Girder P2-21S north leg.

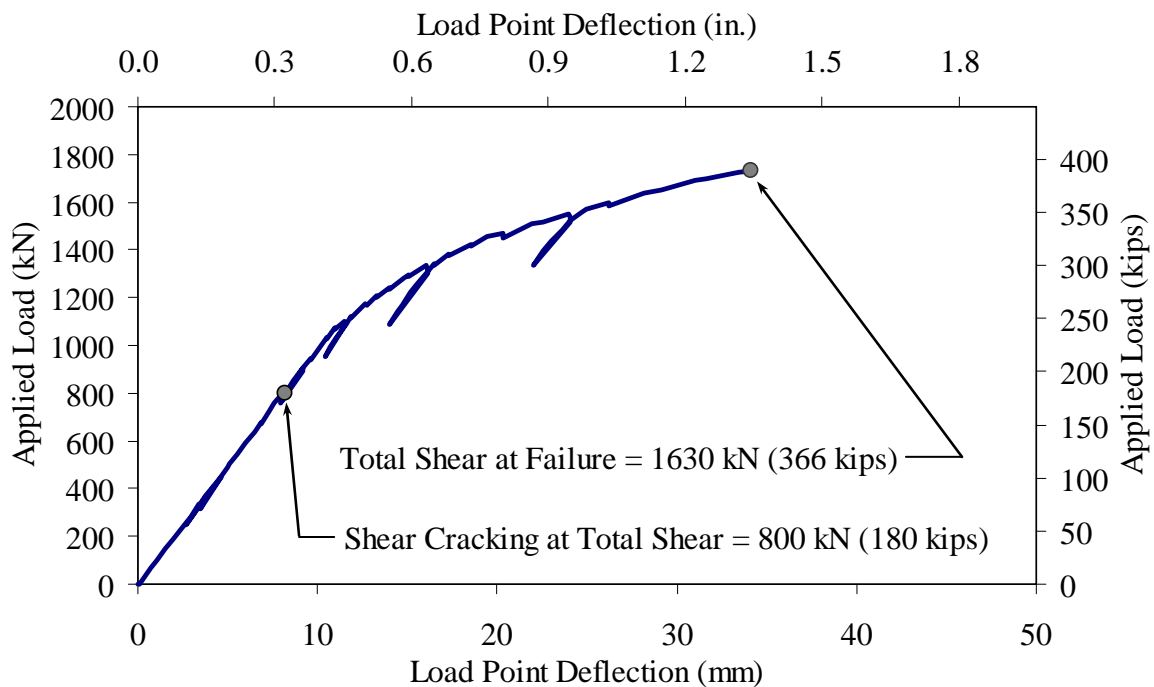
Figure 109 shows the applied load versus vertical deflection response of the girder. The reported deflection is the average value recorded from the two potentiometers measuring the displacement of the bottom face of the girder legs. The load-deflection response shows that the girder began to soften near 980 kN (220 kips) of applied load at a load point deflection of approximately 10 mm (0.4 inches). The girder exhibited significant additional capacity, reaching a peak load of 1740 kN (390 kips) at a deflection of 34 mm (1.35 inches). As shown in the figure, the total dead load plus live load shear in the shear span at first shear cracking was 800 kN (180 kips). The total overall dead plus live load shear in the shear span at girder failure was 1,630 kN (366 kips).

Figure 109. Graph. Load versus load point deflection response of Girder P4-57Sh.

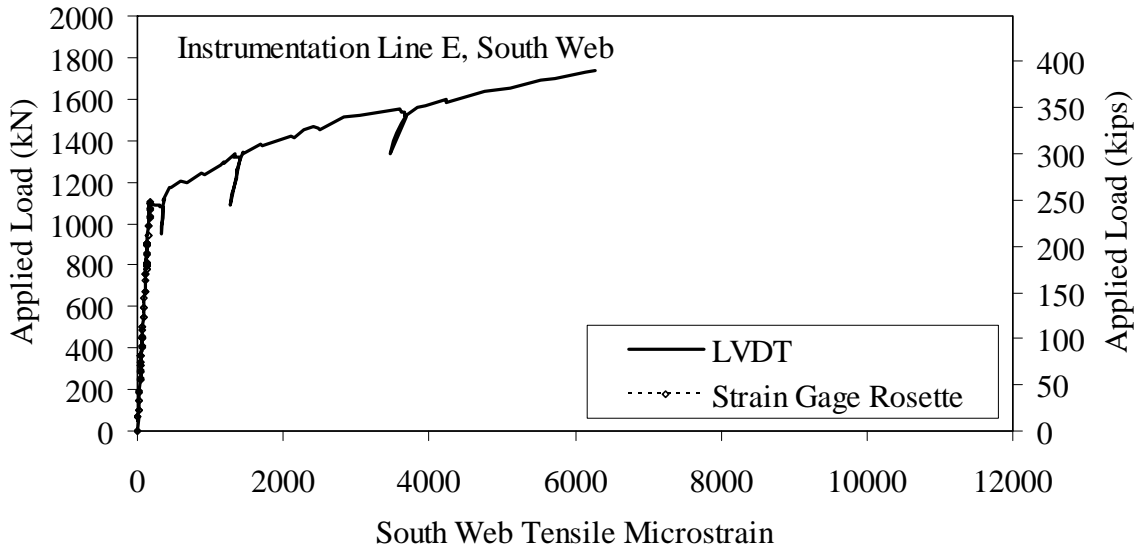
The diagonal tensile strains in the webs were captured through both strain rosettes affixed to the surface of the webs as well as by LVDTs which monitored deformations over predefined gage lengths. The results of greatest interest were captured along Instrumentation Line E; the shear failure plane passed within 50 mm (2 inches) of the strain rosette. The results are plotted in Figure 117 and Figure 118 for the south and north webs, respectively. The principal tensile strain from the strain gage rosette is only plotted until the results become suspect due to cracking of the underlying concrete. The single LVDT on each web was installed at an orientation of 45 degrees from the horizontal. Note that prior to the application of load, the prestressing forces and dead load resulted in less than 50 microstrain precompression in the web along the angle of the principal tension. The plots show that at peak applied load the tensile strain in the north web (which failed) was greater than 9,000 microstrain, and the tensile strain in the south web (which remained intact) was greater than 6,000 microstrain.

Figure 117. Graph. Web tensile strain at Line E in Girder P4-57Sh south leg.

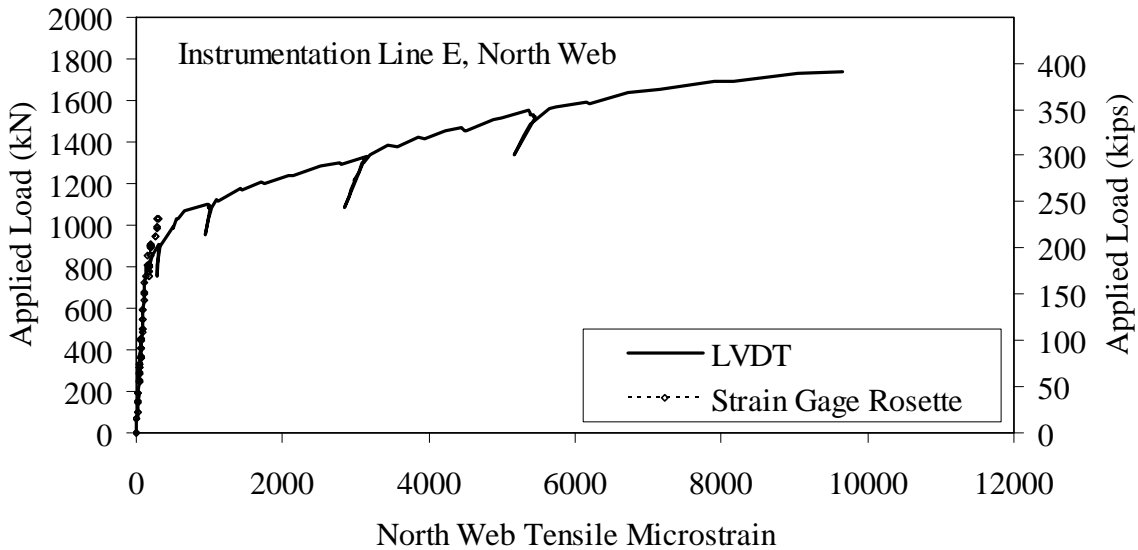
Figure 118. Graph. Web tensile strain at Line E in Girder P4-57Sh north leg.
