Destructive Testing of IDOT Bridge Structure Number 020-3087

Research Report No. FHWA-ICT-20-008

Destructive Testing of IDOT Structure Number 020-3087

August 2020

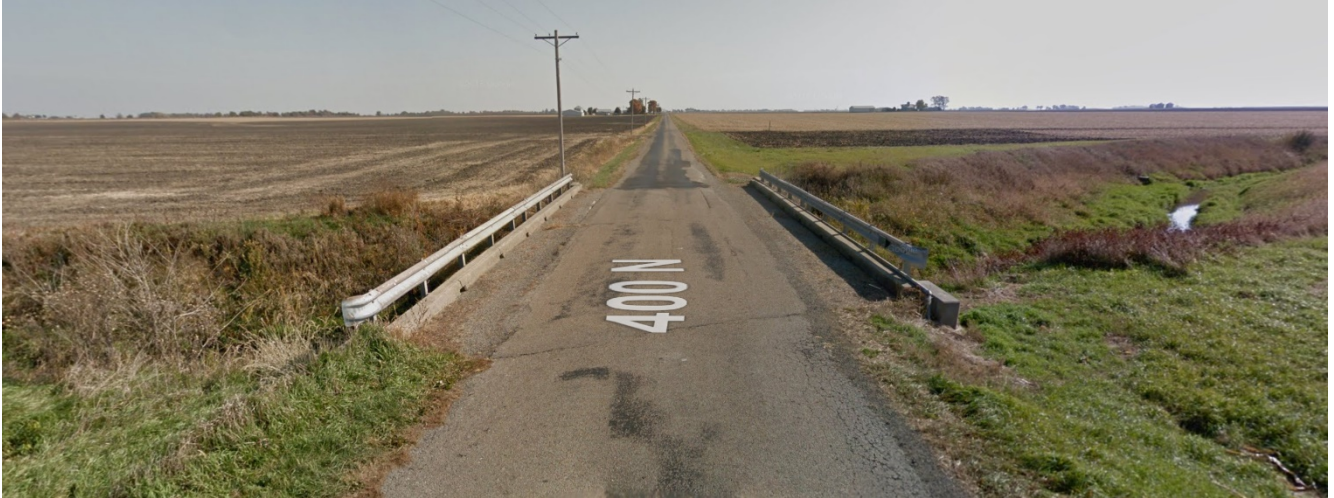
Figure 2. Photo. A picture of structure number 020-3087 taken in October 2015 via Google Maps.

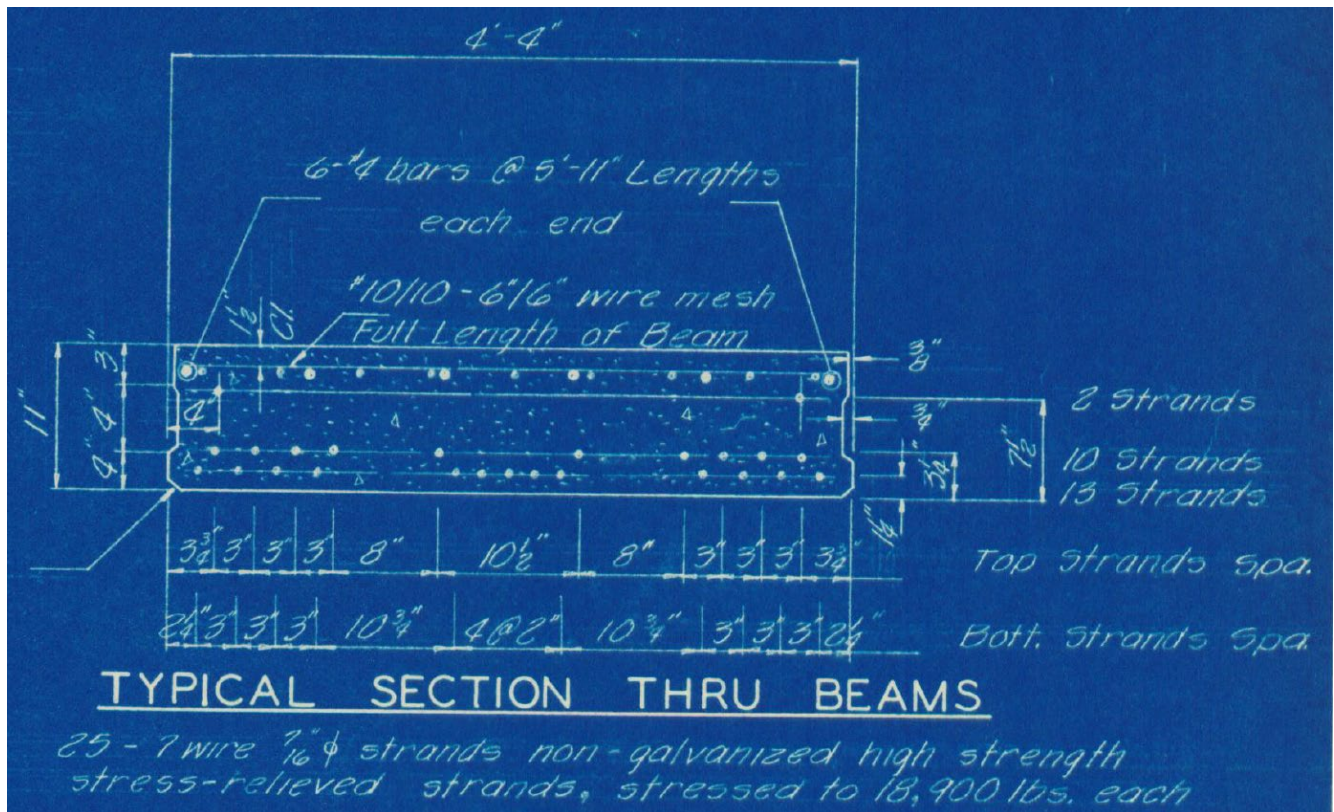
Figure 4. Photo. Cross-section of PPC deck beam per original design drawings.

The design drawings indicate 25-7 wire high-strength, stress-relieved strands that are non-galvanized, stressed to 18,900 lbs each. This corresponds to 0.108 in² cross-sectional area stressed to 70% of its ultimate strength of 250 ksi per appendix A-5 in Nawy (2009).

**Figure 15. Photo. Cross-section of the beam specimen after cutting prestressing strands.
Note that the configuration of the strands is different than shown in Figure 4.**

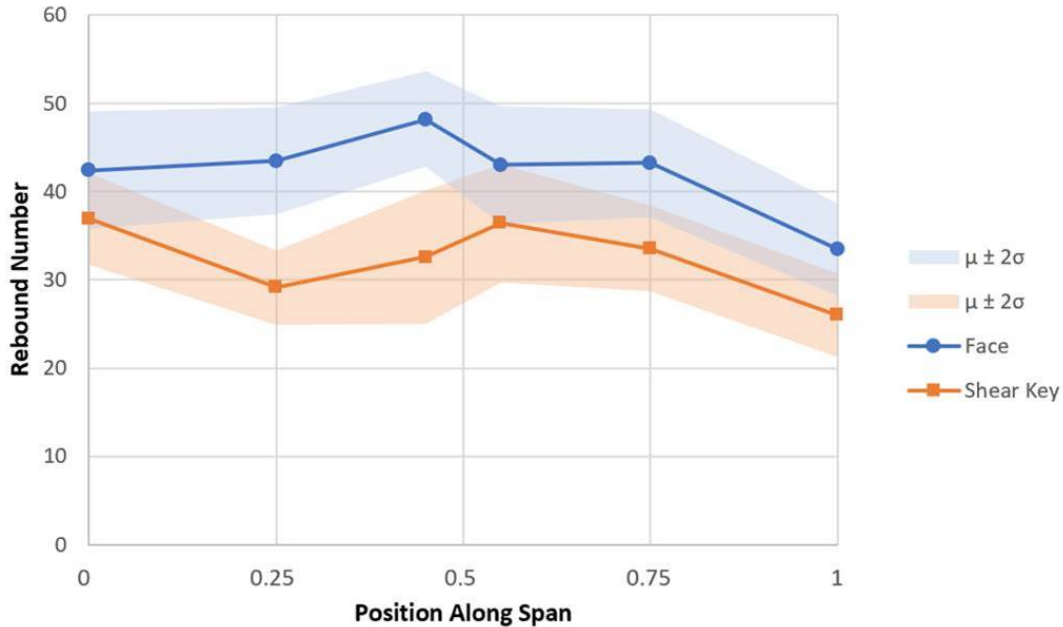
The rebound hammer test results were used to determine that the concrete quality was not significantly different at the beam ends, compared to the midspan location. This result justified the decision to support the beam near its ends.

Figure 6. Graph. Rebound number along the length of the beam.

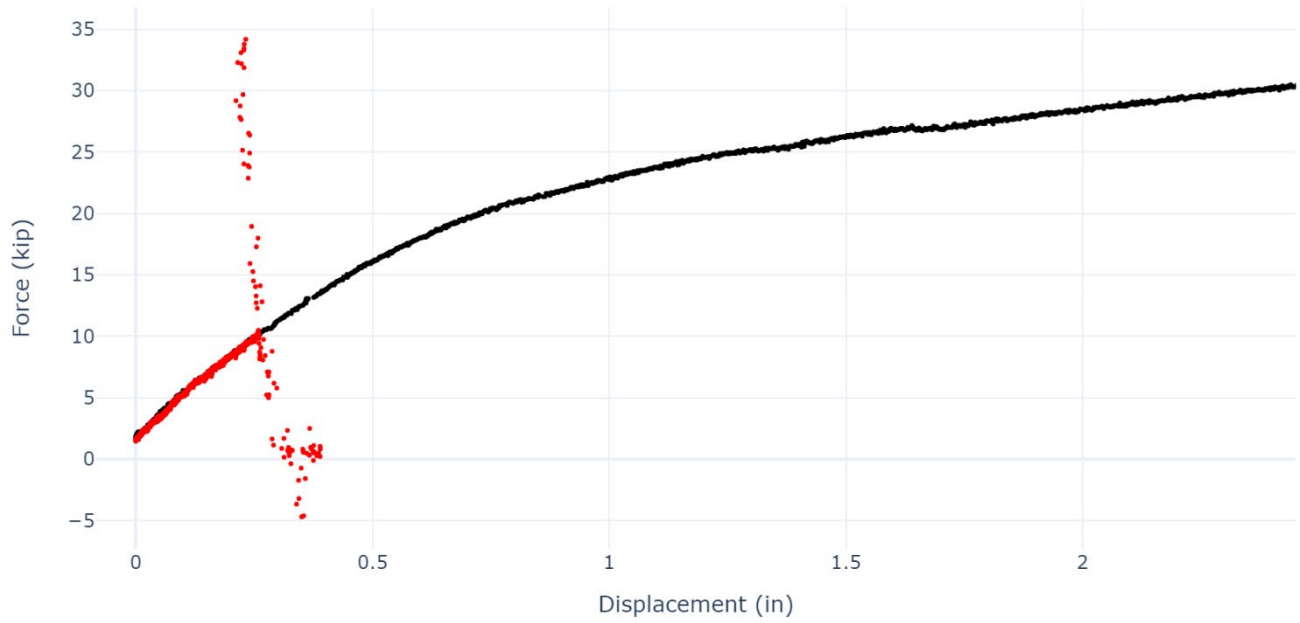
The test was carried out using displacement-controlled loading at a rate of 1/4 inch per minute. The three-point bending test results are shown in Figures 12 and 13. The initial loading showed an instability in the load application, which resulted in large jumps of applied force in very short time increments. This test was immediately halted and the actuator tuning corrected. As seen in Figure 12, the restarted test showed nearly identical results in the low displacement range compared to the initial test. This result indicates that the instability in the initial test likely did not damage the specimen, as there was no change in initial stiffness. The complete load vs displacement plot is shown in Figure 13. A peak load of 33.1 kips was reached at a displacement of 3.5 in, after which a steep drop in applied load is seen. This drop is the result of crushing the concrete on the surface of the beam. The post-peak plateau sustained around 21 kips of loading for an additional inch of displacement before the cracks propagated completely through the depth of the beam, causing collapse. The noncontact displacement measurements closely match the string potentiometer measurements. The peak load of 33.1 kips corresponds to a moment of 227.5 kip-ft.

Figure 12. Graph. Force vs displacement plot of the initial loading (in red) and the corrected loading (in black)

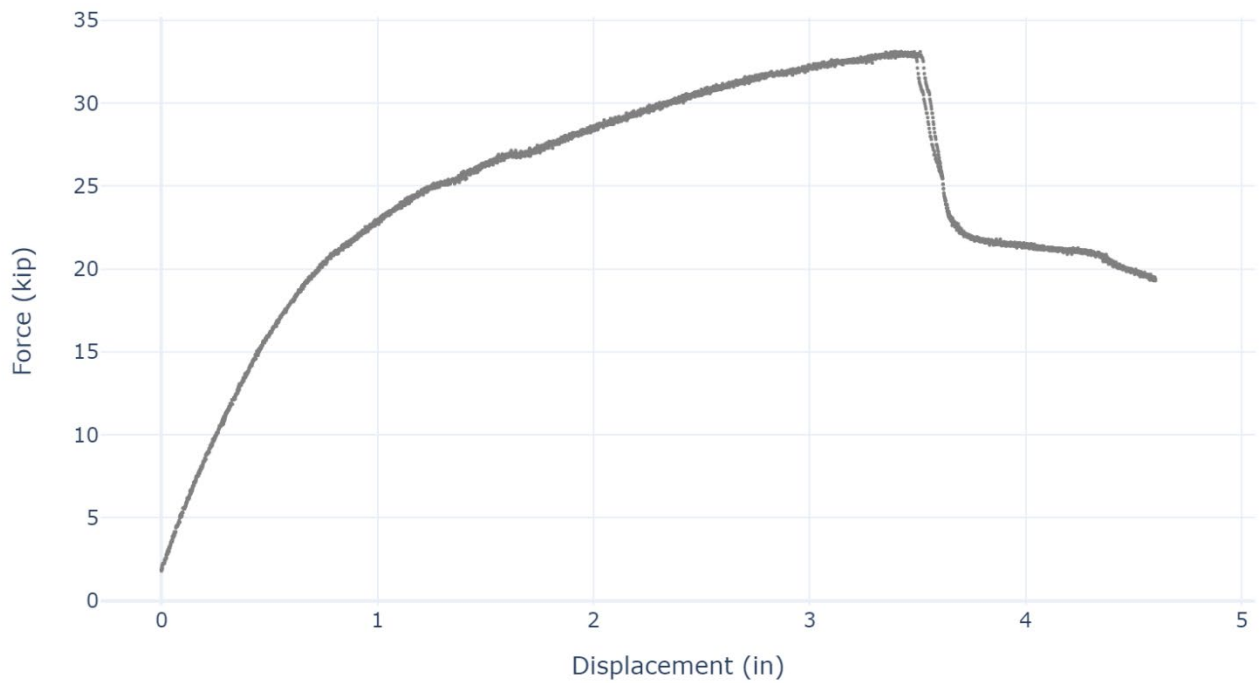
Figure 13. Graph. Force vs displacement plot of the complete load test showing displacement data from both string potentiometers.
